National Transportation Safety Board

Railroad Accident Brief

Accident Number:	DCA-03-FR-005
Location:	City of Commerce, California
Date and Time:	June 20, 2003, 11:58 a.m. ¹
Accident Type:	Derailment
Company:	Union Pacific Railroad
Injuries:	13
Fatalities:	None

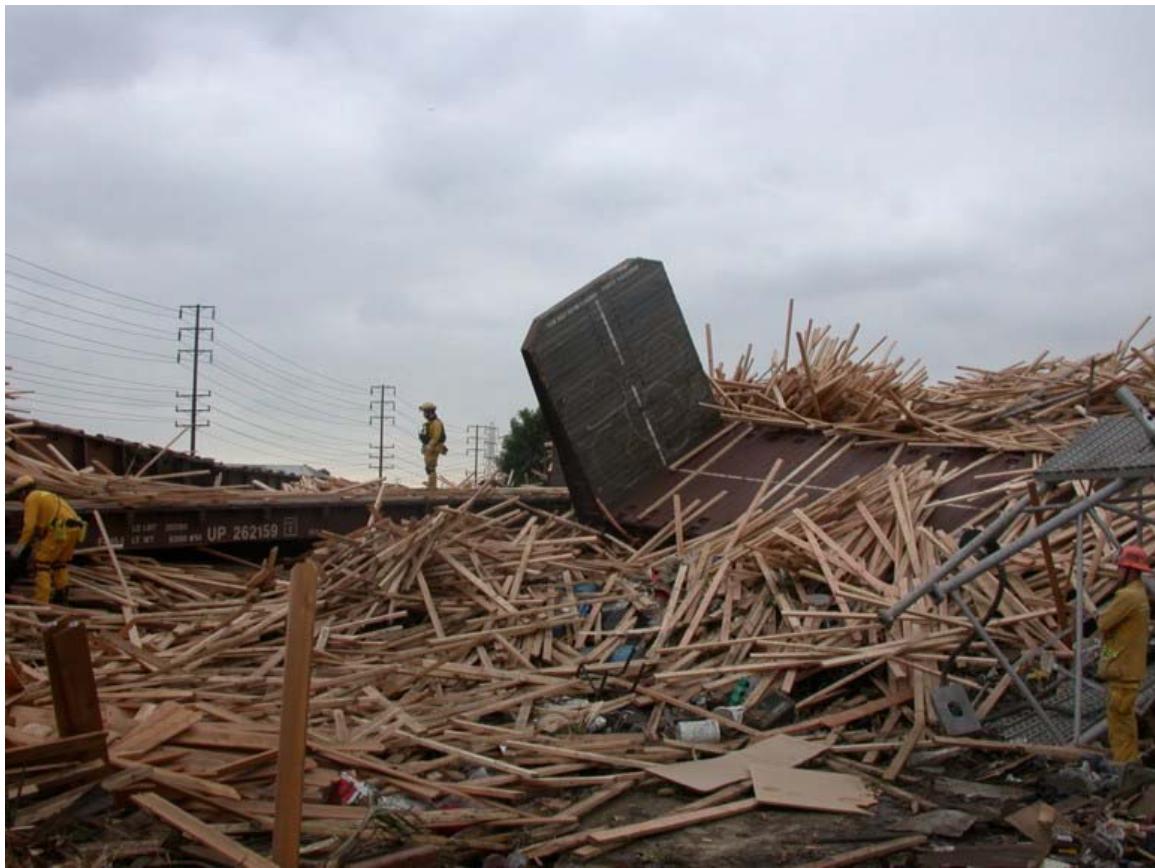
Figure 1. A portion of the derailment area.

At 11:58 a.m., 28 of the 31 cars derailed due to excessive speed as they passed over the turnout into House Track No. 4. Cars 1 through 6 derailed but stayed on the right-of-way. Cars 7, 8, 11, and 13 departed the right-of-way and struck neighborhood residences. Cars 29, 30, and 31, the rearmost cars as the 31 cars rolled downgrade, did not derail. The runaway cars had traveled about 28 miles from Montclair Yard to the switch at House Track No. 4 in City of Commerce. Before derailing, the cars had

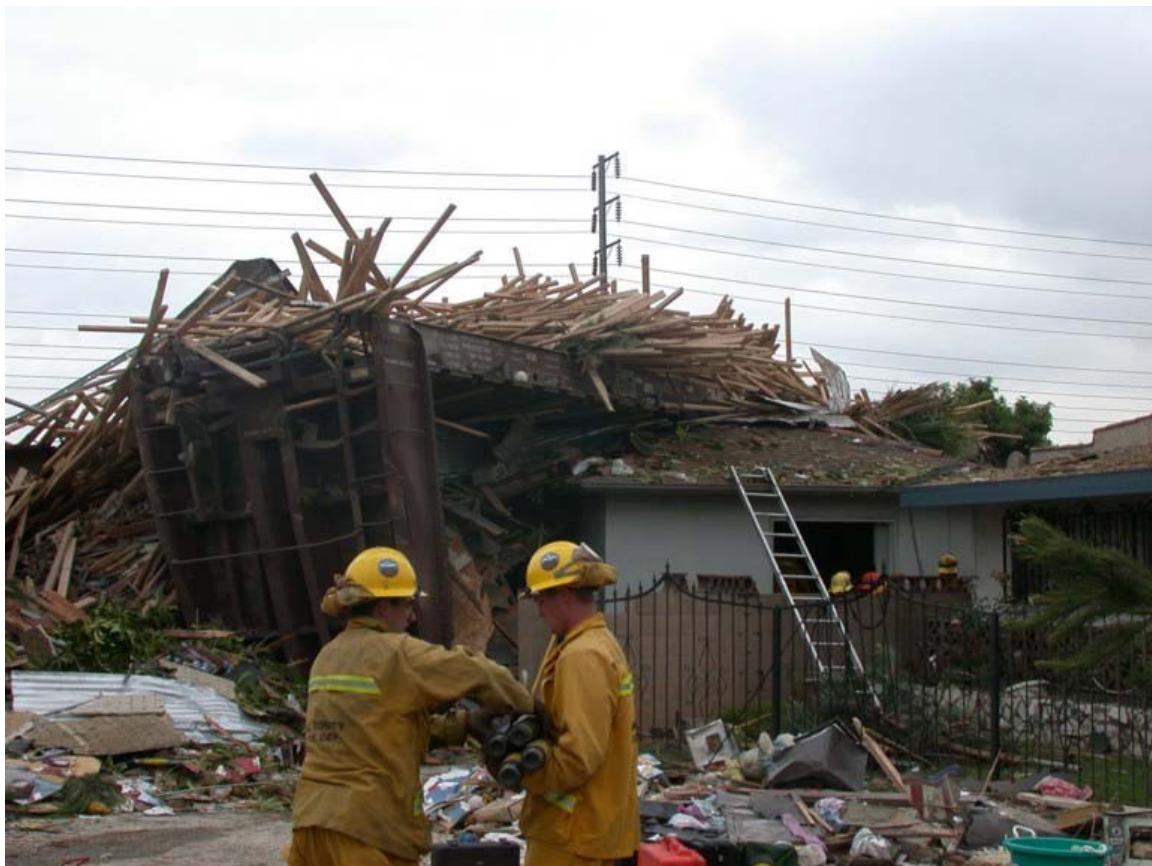
Figure 2. One of the eight residences struck by derailed equipment.
