# National Transportation Safety Board

## Railroad Accident Brief

Accident Number: DCA-02-MR-005  
Location: Kensington, Maryland  
Date and Time: July 29, 2002, 1:55 p.m.  
Accident Type: Derailment  
Companies: CSX Transportation  
National Railroad Passenger Corporation (Amtrak)  
Injuries: 95  
Fatalities: None

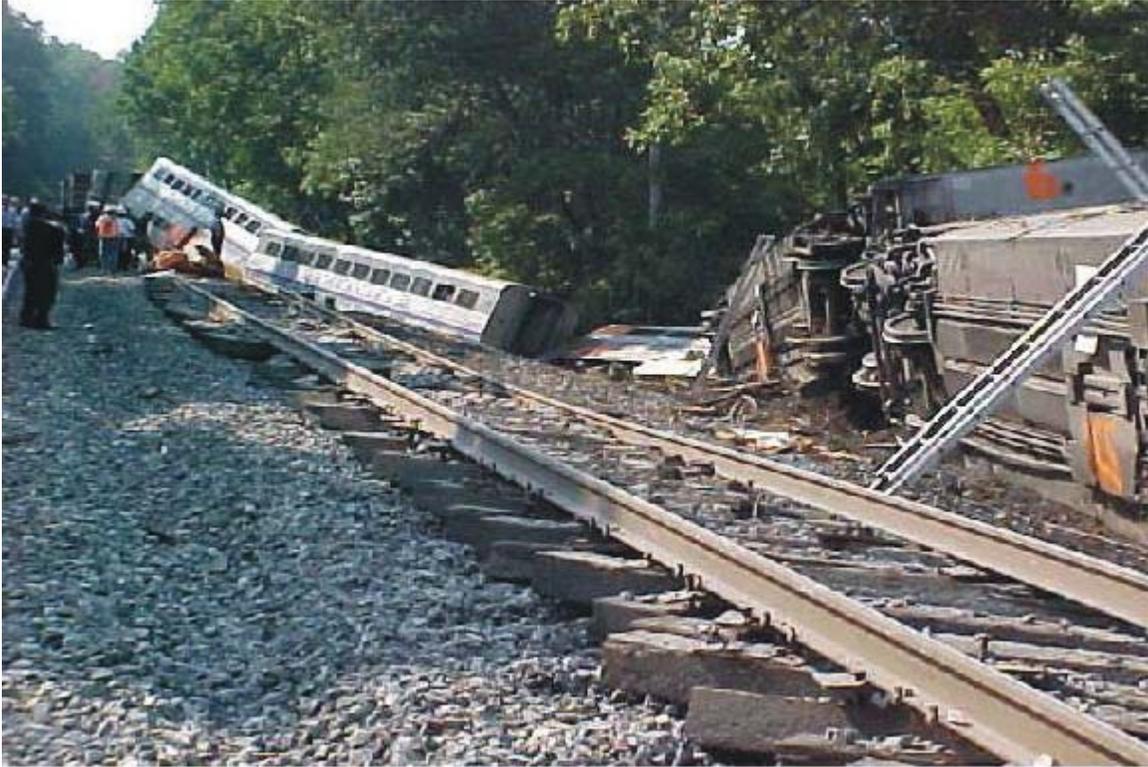
The engineer told investigators that as the train exited a curve just west of milepost 11.78, he observed a misalignment<sup>1</sup> in the tangent track ahead. The engineer estimated the track misalignment to be about 18 inches to the right. Although the locomotives passed over the track defect without derailing, 11 of the following cars of the train derailed and departed the roadbed to the north and south. The derailed cars included one baggage car, three sleepers, one diner, four coaches, and two mail-handling cars. Of the derailed cars, two sleepers, one coach, and a diner came to rest on their sides.

**Figure 2.** View of wreckage looking south.
