National Transportation Safety Board

Railroad Accident Brief

Accident No.: DCA-05-FR-004
Location: San Antonio, Texas
Date: November 10, 2004
Time: 9:10 a.m. central standard time¹
Railroad: Union Pacific Railroad
Train: YEY55-10
Type of Accident: Collision and derailment into the Crystal Cold Storage warehouse maintenance building
Injuries: 1
Fatalities: 1
Property Damage: \$308,637

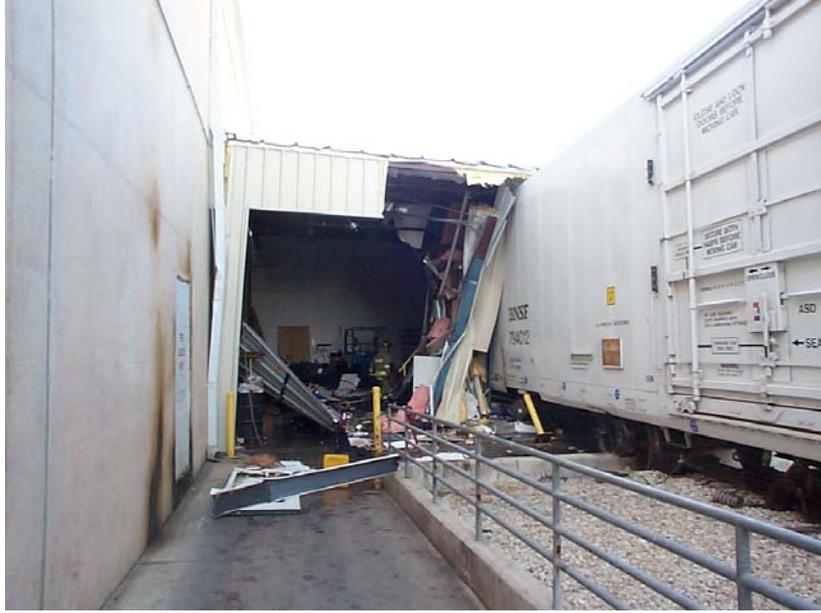
Figure 1. Damage to Crystal Cold Storage maintenance building.

When the moving train collided with the car mover and the parked freight cars, an employee of a rental car company was killed as one of the cars was shoved over a pair of wheel stops and into the Crystal Cold Storage maintenance building. A Crystal Cold Storage employee was injured while he was unloading frozen food from one of the parked boxcars.

Since the accident, UP has installed a derail at the entrance to Crystal Cold Storage track, and only Crystal Cold Storage employees can unlock the derail. Further, the following instructions are now issued to all train crews working at Crystal Cold Storage:

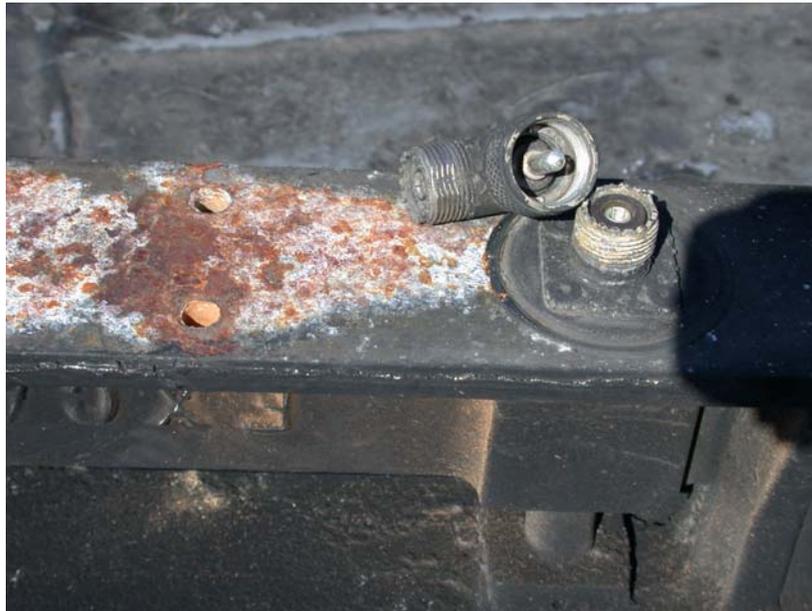
Because the train crewmembers reported a loss of radio communication, investigators field-tested the handheld radios and the radio and antenna on the lead locomotive, UP 1966. These field tests determined that the handheld radios and the locomotive radio were functioning properly, but the radio antenna on locomotive UP 1966 was not fully functional because of a corroded cable connection.⁷ (See figure 2.) All field radio and antenna tests were verified during further laboratory analysis.

Thirty-seven transmission tests were conducted between the locomotive radio and the handheld radios used by the conductor and the brakeman. There were 16 radio communication failures. Fourteen of those failures occurred when the radio was placed near the conductor's reported position at the time of the accident, alongside the concrete wall of the Crystal Cold Storage building.

Figure 2. Corroded cable connection on locomotive UP 1966.

⁷ UP has replaced the corroded cable on UP 1966.
