National Transportation Safety Board

Railroad Accident Brief

Accident No.: DCA-05-FR-010
Location: Home Valley, Washington
Date: April 3, 2005
Time: 9:35 a.m., Pacific daylight time¹
Railroad: BNSF Railway Company
Property Damage: \$854,000
Injuries: 30
Fatalities: None
Type of Accident: Amtrak passenger train derailment

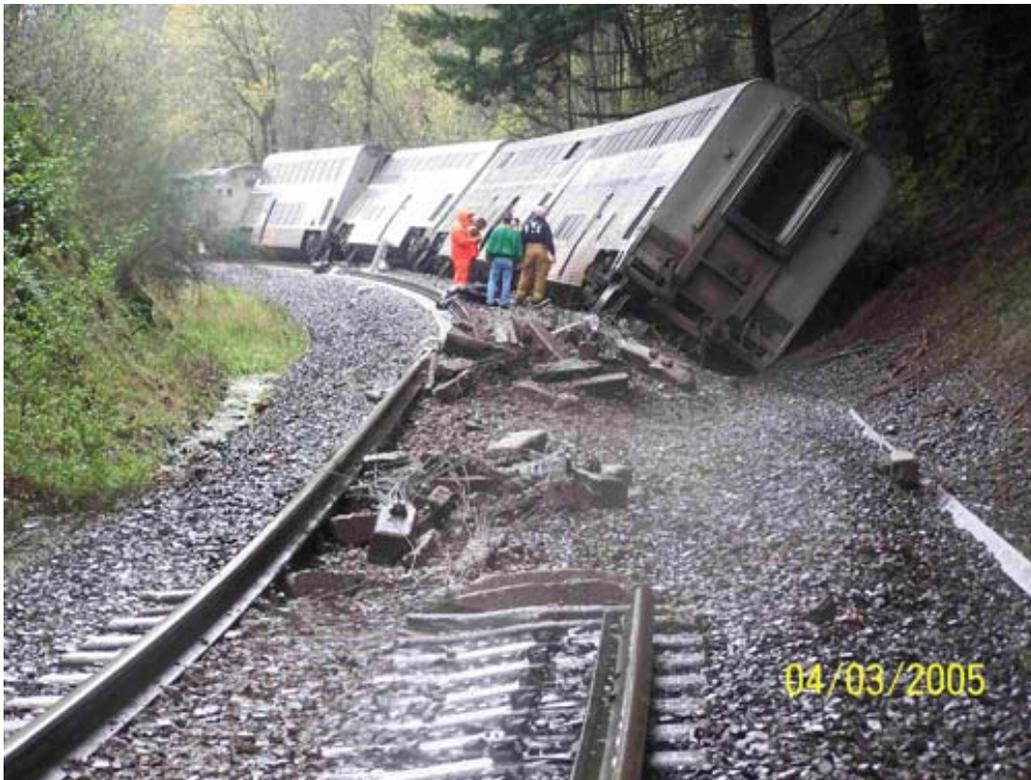
Figure 1. Derailment site.

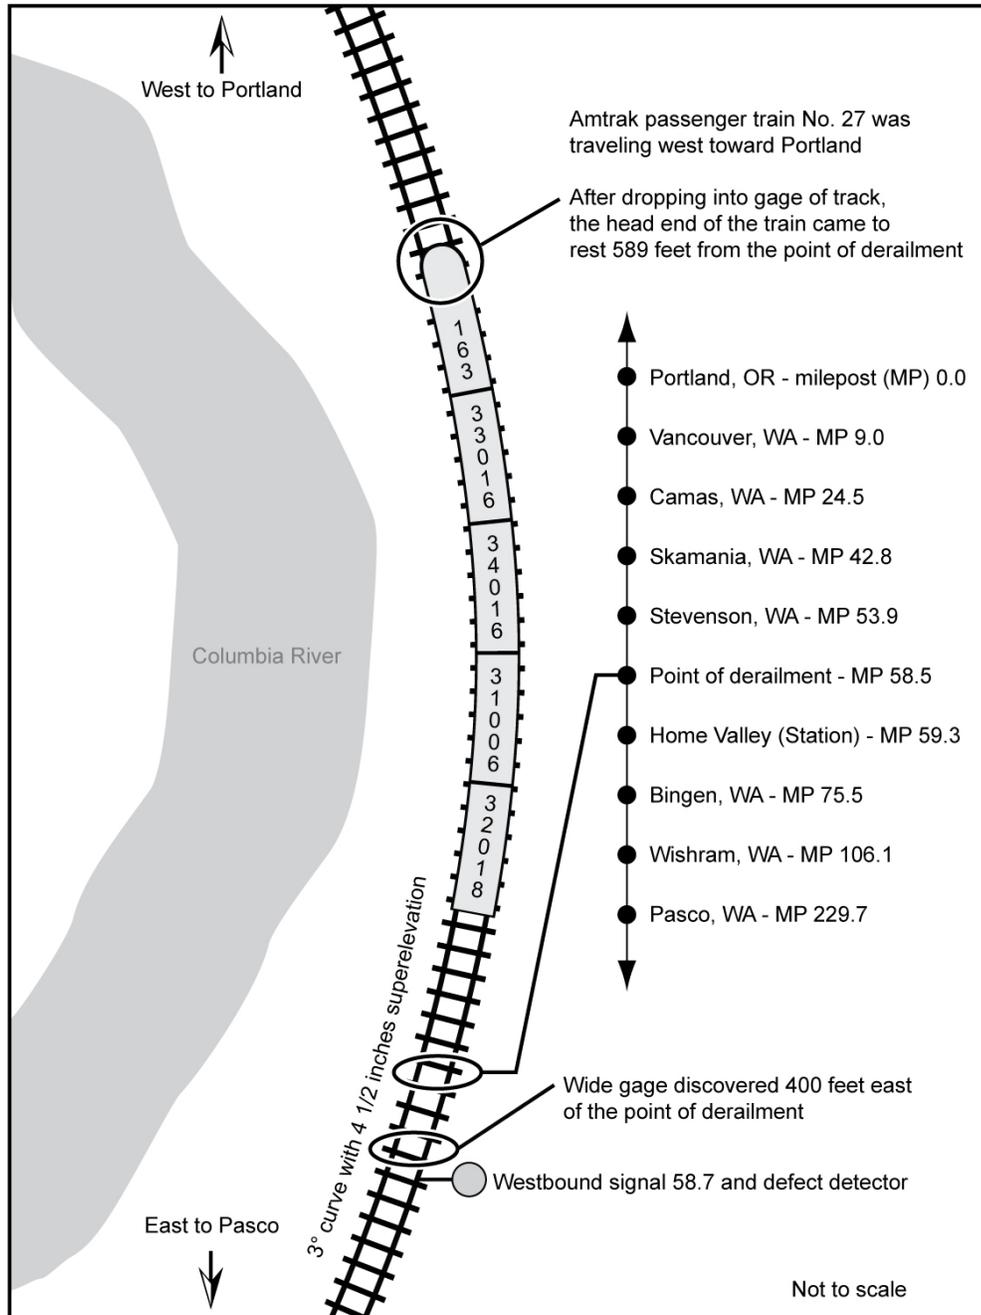
The Amtrak train traversed about 1 1/4 miles of straight (tangent) track before it entered a 3° left-hand curve and derailed. (See figure 2.) The engineer stated that he first became aware of the derailment when an emergency brake application occurred that he had not initiated. The conductors and passengers stated that they became aware of the derailment when they were thrown around and jostled in the coach cars, followed by clouds of dirt and debris entering the cars.

Figure 2. Sketch of accident site.

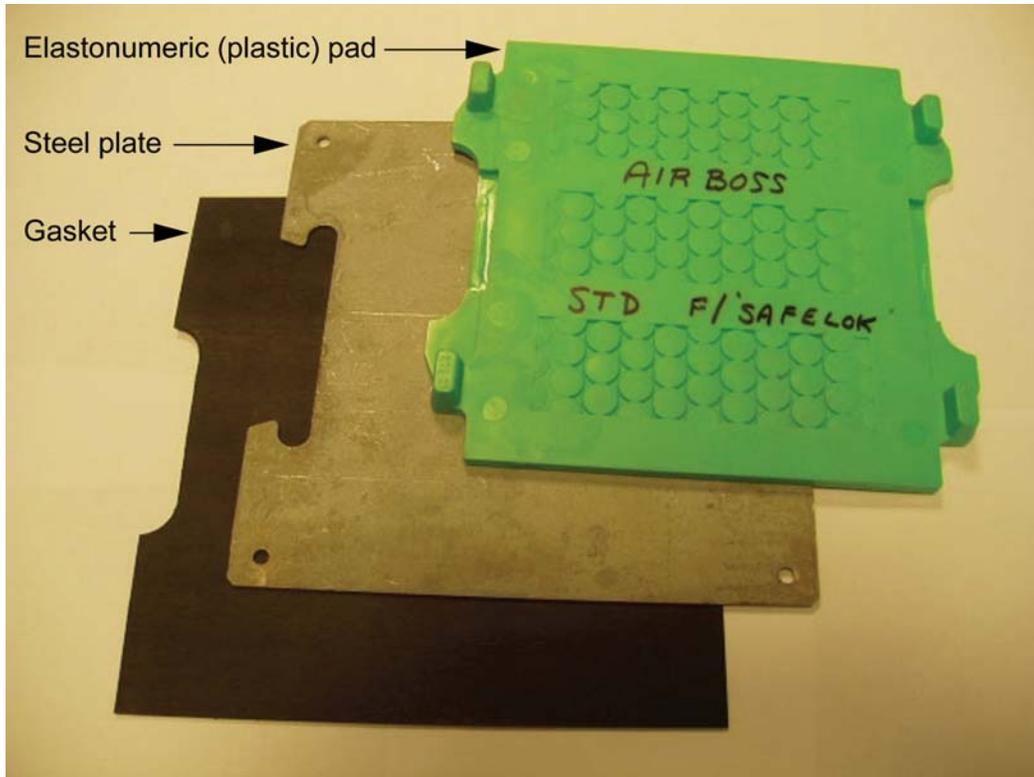
The track structure was built with 136-pound sections of continuous welded rail (CWR)¹⁰ on concrete crossties. The CWR was affixed to the crossties with “Safelok” clips and insulators. A special concrete tie pad separated the CWR from the concrete crosstie rail seat. (See figure 3.) The concrete tie pad consists of a three-piece pad system. The polyethylene gasket pad is about 1.5 millimeters (mm) thick, and it is placed on the seat of the concrete crosstie underneath a layer of 1.4-mm thick steel and a 6.0-mm heavy-duty plastic pad beneath the base of the rail.

Figure 3. Three-piece tie pad system.

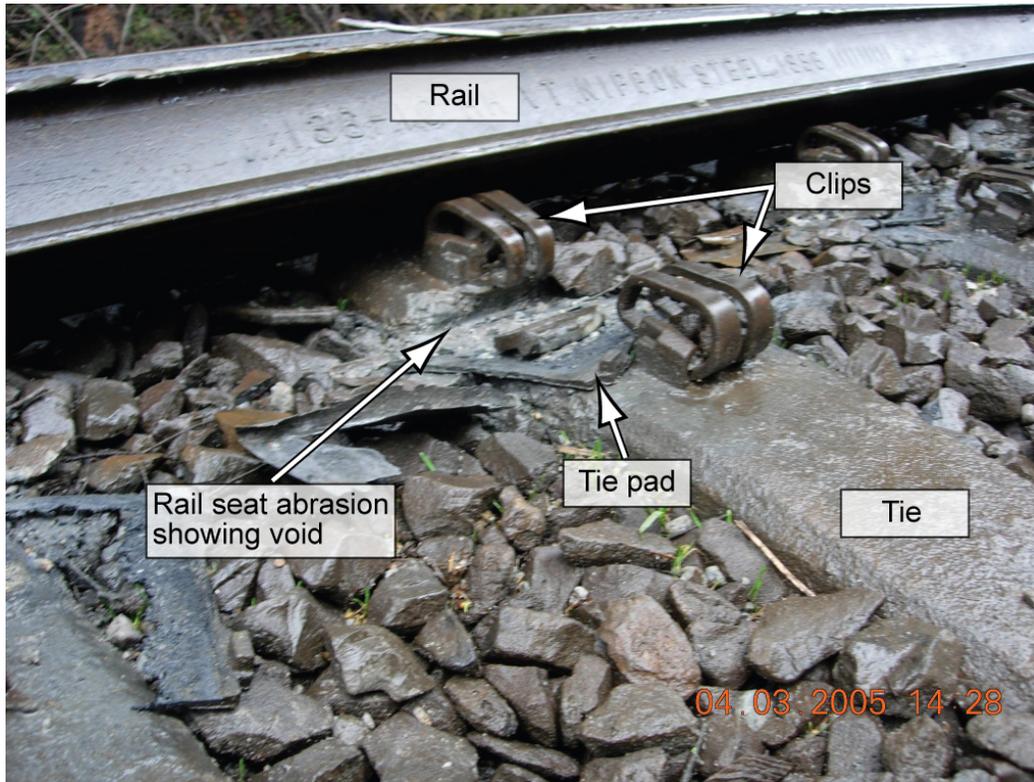
The investigation determined that the point of derailment was at MP 58.56 in curve No. 58B. Around that location, there were 19 consecutive concrete crossties that exhibited rail seat abrasion, which ranged in depth from 1/16 inch to 1 1/4 inches into the concrete surface on the field side²³ of the outside curve rail. The abrasions created voids between the bottom of the rail base and the top of the concrete crossties, which allowed the rail to deflect downward and rotate outward under load. (See figures 4 and 5 for two

views of the rail seat abrasion at the derailment site.) This rotation of the rail resulted in gage widening as trains passed over the area. Another sign of the gage widening under the load of the train was the streaking²⁴ in the center of the rail head of the inside curve rail. The locomotive unit of Amtrak passenger train No. 27 was the first vehicle to derail. It appeared that a wheel first derailed near the deepest abrasion.

Figure 4. Rail rollover and rail seat abrasion at derailment site.

The National Transportation Safety Board determines that the probable cause of the April 3, 2005, derailment of Amtrak passenger train No. 27 near Home Valley, Washington, was the BNSF Railway Company's inadequate response to multiple reports of rough track conditions that were subsequently attributed to excessive concrete crosstie abrasion, which allowed the outer rail to rotate outward and create a wide gage track condition. Contributing to the accident was the Federal Railroad Administration's failure to provide adequate track safety standards for concrete crossties.

Extend to all classes of track safety standards for concrete crossties that address at a minimum the following: limits for rail seat abrasion, concrete crosstie pad wear limits, missing or broken rail fasteners, loss of appropriate toeload pressure, improper fastener configurations, and excessive lateral rail movement. (R-06-19)

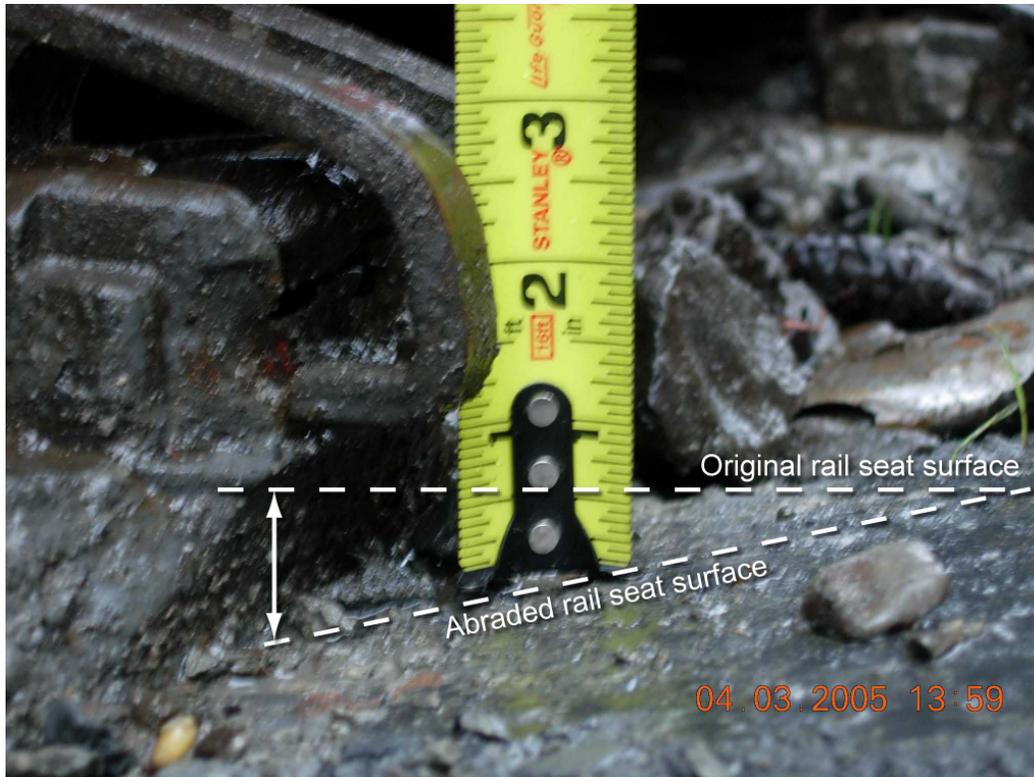
Figure 5. Concrete cross-tie abrasion of about 1 inch at derailment site.
