National Transportation Safety Board
Washington, D.C. 20594

Railroad Accident Brief

Accident No.: DCA-06-FR-003
Location: Quantico, Virginia
Date: January 5, 2006
Time: 6:44 a.m. eastern standard time¹
Railroad: Virginia Railway Express train on CSX Transportation property
Damage: \$425,000
Injuries: 9
Fatalities: 0
Type of Accident: Derailment

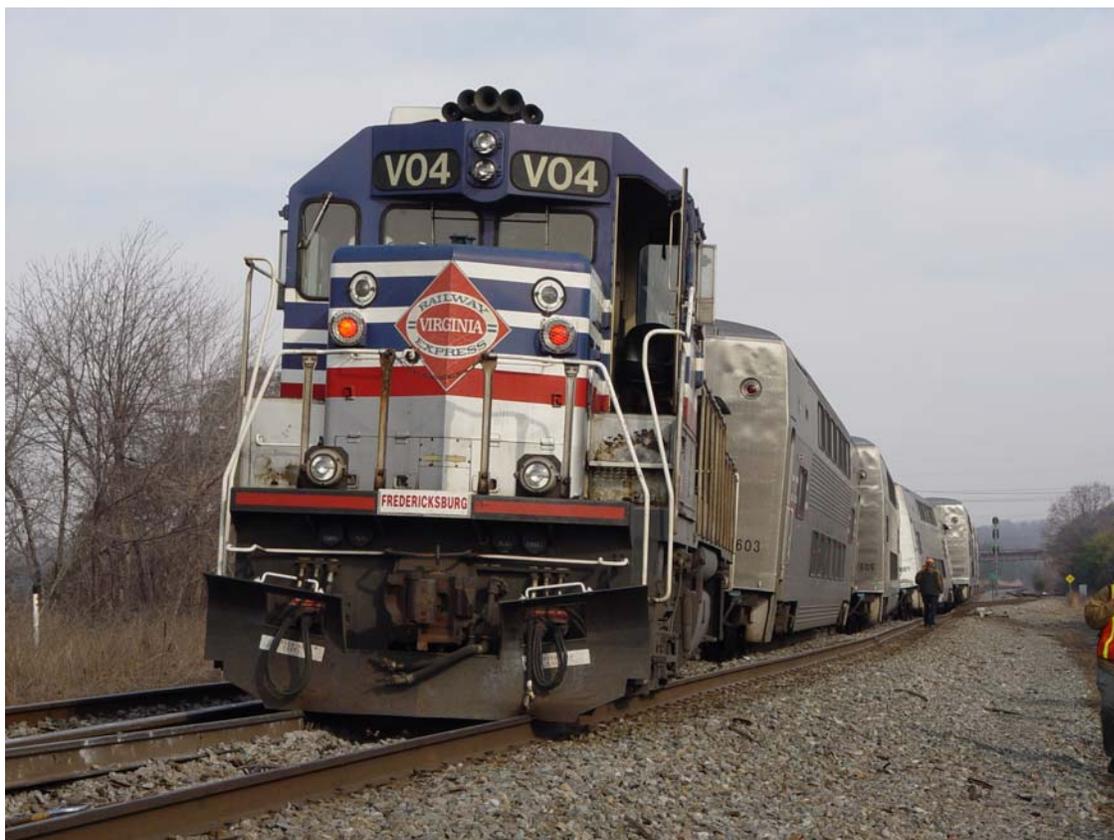
The crewmembers said that the trip had been “uneventful” up to Possum Point. The engineer and conductor stated that they had not seen any track anomalies or felt anything unusual as they left the single main track and traversed the turnout. As the train was moving over the turnout, the fourth car derailed in the switch point area. Because of the resulting damage to the turnout and the misalignment at the frog² area, the fifth and sixth cars and the locomotive derailed when they reached it. The lead car stopped about 800 feet north of the switch point. The derailed equipment remained upright when it came to rest.

Figure 1. Looking north at resting position of train.

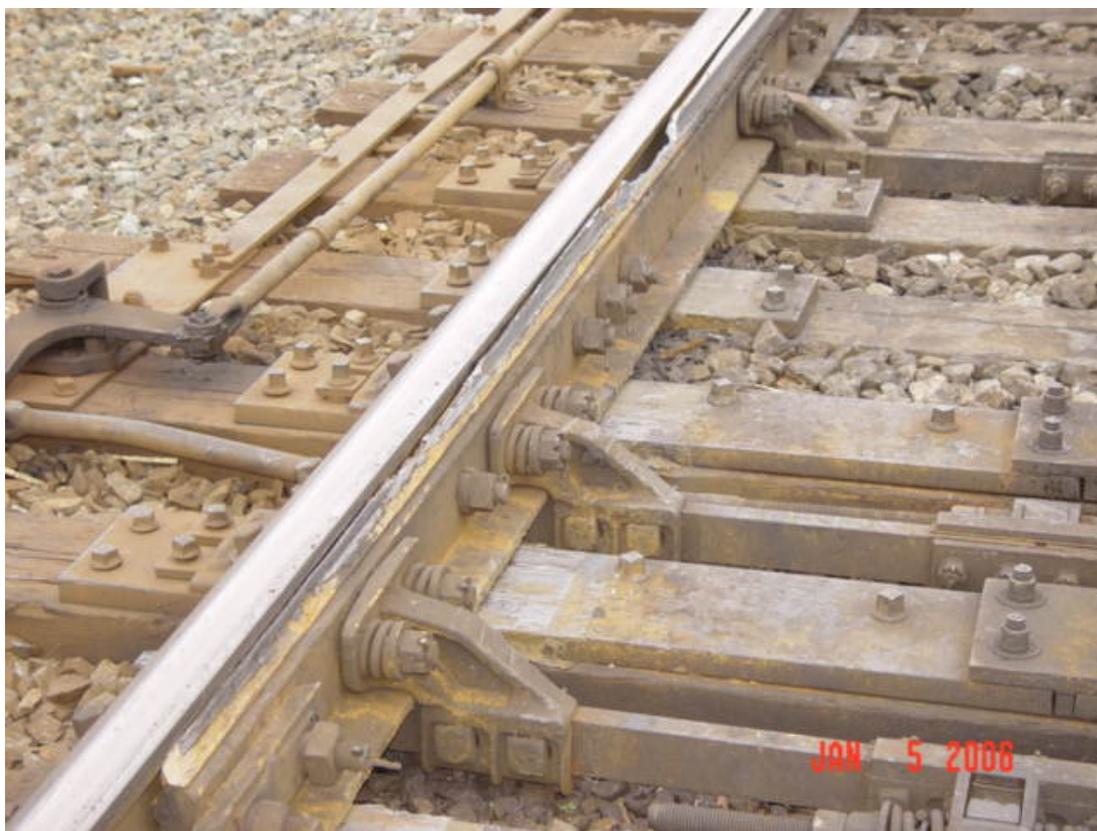
The Possum Point turnout was made of continuous welded rail, 39-foot welded switch points, and stock rails fastened to wooden crossties with appropriate switch apparatus. Investigators found wheel markings that began about 22 inches from the end of the left switch point. The markings continued along the top of the stock rail and “fell down” between the field side of the left switch point and the gage side of the stock rail. The markings continued northward toward the frog. The investigators determined that the lead axle of the fourth passenger car derailed first and, in the process, damaged the track and caused the track structure to shift at the frog. Consequently, when the wheels of the trailing passenger cars and the locomotive reached the same spot, they also derailed.

Figure 2. Looking north at the reverse, or left, switch point, which was the point of derailment.

Before the accident, the left switch point was unusually chipped or worn, and several pieces of the top edge of the switch point were broken. Because the edge was broken, the left wheel of the fourth passenger car had “ramped up” onto the top of the stock rail. After the accident, investigators found that a much larger piece of the switch point, about 66 inches from the end of the switch point, was broken. However, they determined that the break had been caused by the accident; a derailed wheel had fallen between the switch point and stock rail.

The National Transportation Safety Board determines that the probable cause of the January 5, 2006, derailment of Virginia Railway Express train 304-05 near Quantico, Virginia, was an excessively worn and chipped switch point, which caused the lead truck of the fourth passenger car to derail. Contributing to the accident was CSX's delay in replacing a switch point that had been repeatedly identified as deteriorating.

Immediately after the accident, CSX verbally instructed its engineering personnel that all mainline switch point welding was prohibited. CSX also verbally instructed its roadmasters that

any deficient switch point should be kept out of service until its replacement could be installed. The company began stocking switch points at various key locations on its divisions so that deficient switch points could be replaced more quickly. On February 15, 2006, CSX formally updated its welding manual:

Main track switch points are not to be repaired by any welding process. In the event that it becomes necessary to repair a switch point in an emergency situation, a 10 mph speed restriction must be placed on the turnout until the point is replaced.
