# National Transportation Safety Board

## Railroad Accident Brief

**Accident No.:** DCA-06-FR-005  
**Transit System:** Washington Metropolitan Area Transit Authority Metrorail System  
**Train:** Metrorail Red Line train  
**Location:** Near Dupont Circle Metrorail station, Washington, D.C.  
**Date:** May 14, 2006  
**Time:** 10:16 a.m.<sup>1</sup>  
**Fatalities:** 1  
**Type of Accident:** Train strikes wayside worker

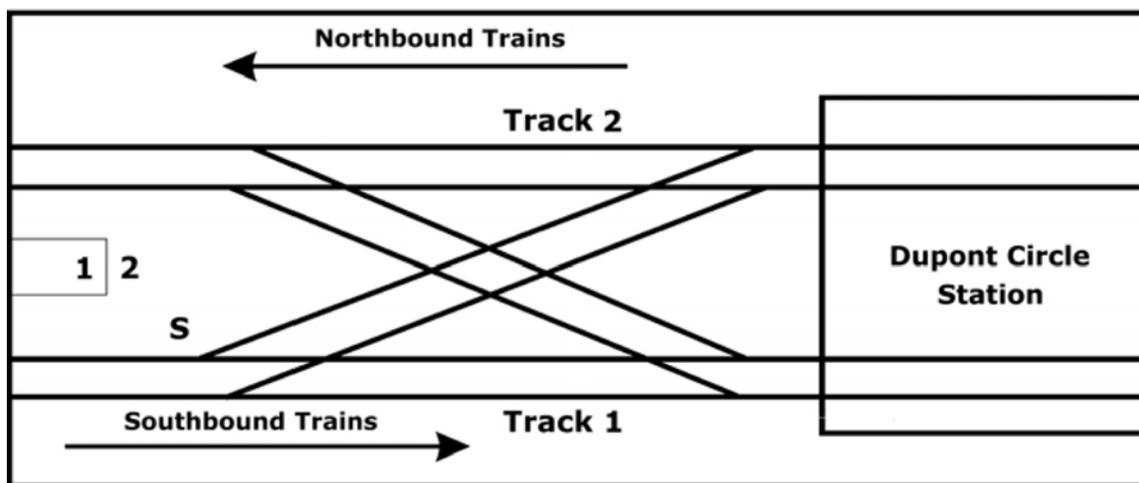
<sup>9</sup> The two main tracks at the accident site are spaced at 14 feet on center, and the dynamic width of a Metrorail car is 10 feet 11 1/4 inches. Thus, the clearance between passing trains at this location is 3 feet 3/4 inch.

location, the senior mechanic was within the dynamic envelope of a train moving along track 1. (See figure 1.)

**Figure 1.** Approximate positions of the first mechanic (1), the second mechanic (2), and the senior mechanic (S) as the northbound train was leaving the Dupont Circle station and the southbound accident train was arriving.

The National Transportation Safety Board determines that the probable cause of the Dupont Circle accident was the failure of the automatic train control system (senior) mechanic to stay clear of the approaching southbound train either because he was not aware of the presence of the train or because he lacked a physical reference by which to identify a safe area outside the train's dynamic envelope. Contributing to the accident were Washington Metropolitan Area Transit Authority Metrorail right-of-way rules and procedures that did not provide adequate safeguards to protect the wayside personnel from approaching trains, that did not ensure that train operators were aware of wayside work being performed, and that did not adequately provide for reduced train speeds through work areas. Also contributing to the accident was the lack of an aggressive program of rule compliance testing and enforcement on the Metrorail system.

1. Review your *Metrorail Safety Rules and Procedures Handbook* and revise it as necessary to create additional layers of protection for wayside workers, including:
  - Adding requirements for wayside pre-work job briefings to ensure that all workers are informed of their duties, of their respective roles in work crew safety, and of the areas that are to be used to stay clear of trains.
  - Requiring that when train operators request permission to either enter a main track, or when a train is turned for a return trip, the train operators along the affected lines must acknowledge receipt of the updated radio announcement from the control center regarding wayside workers.

- Establishing procedures to be used for members of a work crew to acknowledge a lookout's warning that a train is approaching on a particular track from a particular direction before a lookout gives an *all clear* signal to a train. (R-08-01)
