# National Transportation Safety Board

## Railroad Accident Brief

**Accident No.:** DCA-07-MR-009  
**Location:** Oneida, New York  
**Date:** March 12, 2007  
**Time:** 6:58 a.m., eastern daylight time<sup>1</sup>  
**Railroad:** CSX Transportation  
**Property Damage:** \$2.07 million  
**Environmental Cleanup:** \$4.66 million  
**Injuries:** None  
**Fatalities:** None  
**Type of Accident:** Derailment

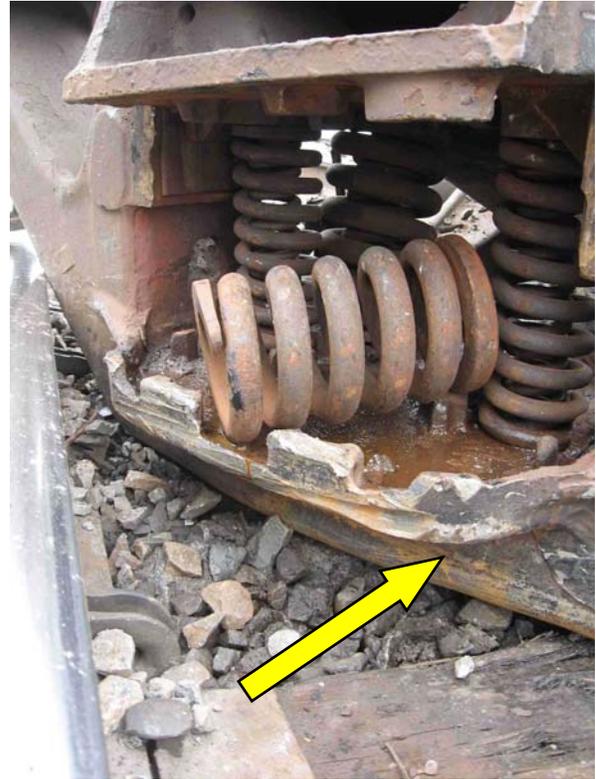
The intact truck assembly on the front of the 25th car was inspected, and no unusual wear or measurements were found. The detached truck assembly from the 25th car also was inspected, and the areas that normally contact the car did not have unusual wear patterns. The northern side frame of the 25th car showed rail burns<sup>7</sup> on the underside. (See figure 2.) This type of rail burn occurs when the wheels drop between the rails and the side frame of a derailed railroad car moves along the top of the rail. The rail burn damage had scoured and disfigured the surface of the underside of the side frame of the rear truck.

**Figure 2.** Rail burn on underside of northern side frame of 25th car.

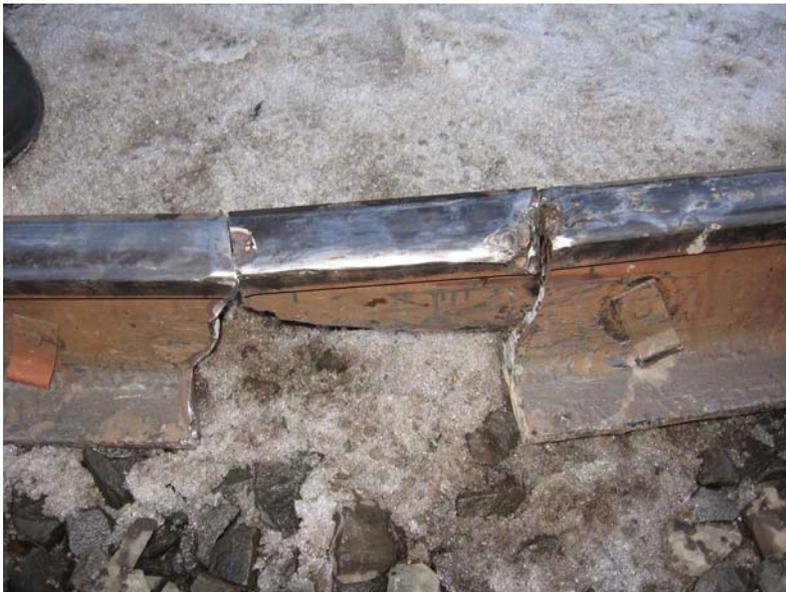
At milepost QC 266.0, a section of the south rail was recovered that had a portion of the head of the rail broken out. (See figure 3.) The break in the rail was 55.5 inches west of the tip of the adjacent switch point of the crossover. The track was destroyed from milepost QC 266.0 to 700 feet east of the milepost. The next 1,000 feet of track were moderately damaged. The signal equipment case and the power crossover switches at control point 266 were destroyed. Estimated equipment, track, and signal damage was \$2.07 million.

**Figure 3.** Section of south rail with portion of rail head broken out.

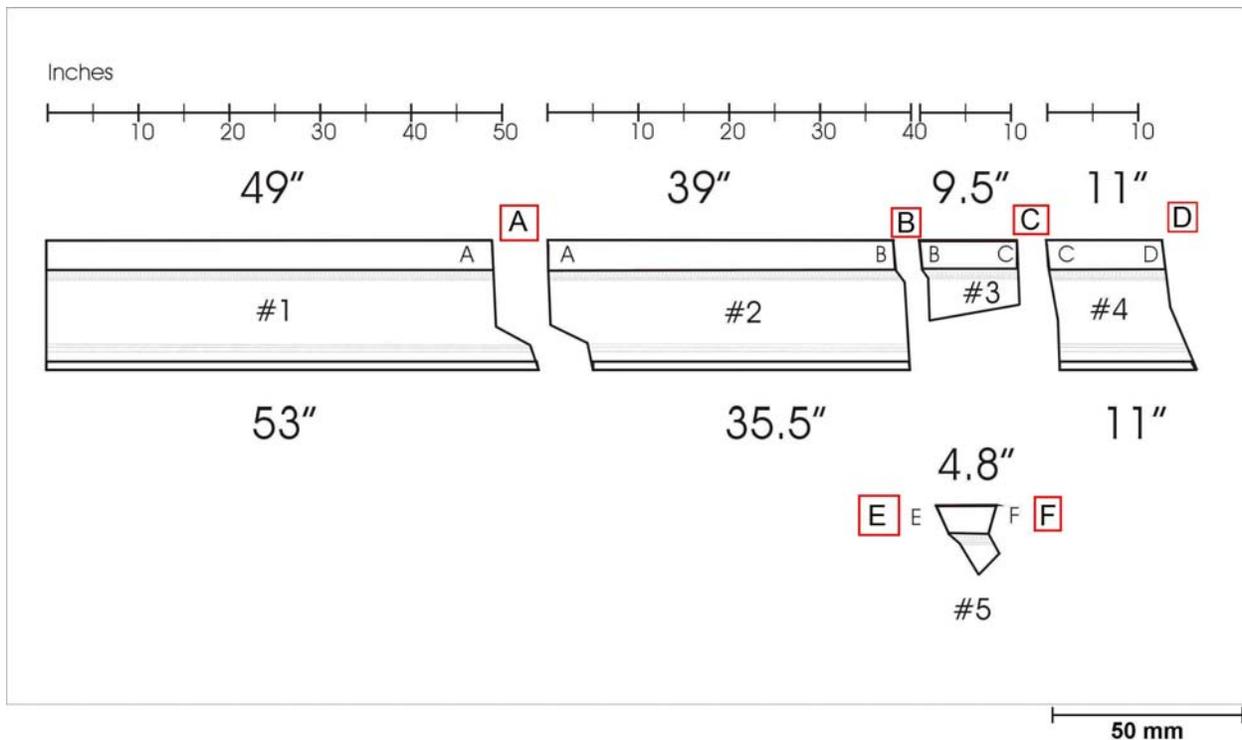
**Figure 4.** Broken rail sections. (Fractures labeled A through F.)

The running surfaces of each piece were examined visually. Extensive surface cracks and flat spots (smooth local depressions) were noted. All pieces showed shell cracks intersecting the running surface near the upper gage corner. Pieces 3 and 4 had a nearly continuous series of shell cracks along the length of each piece. The entire length of piece 5 displayed shell cracking. All pieces exhibited areas of shell cracks on the gage side of the running surface. Typical flat spots were 1 to 2 inches long. Measurements showed that most of the flat spots were depressed less than 0.010 inches below the adjacent surfaces. The flat spot adjacent to the east end of piece 4 measured 0.025 inch at its deepest. Cross sections of the rail were cut through pieces 1 and 2. No noticeable wear of the rail head was noted when the rail profiles were compared to each other and to profiles contained in the American Railway Engineering and Maintenance-of-Way Association *Manual for Railway Engineering*.

The six fractures between the sections of rail were inspected and labeled A through F. Fractures A, C, D, E, and F, although showing some signs of internal defects, contained primarily features typical of an overstress separation.<sup>9</sup>

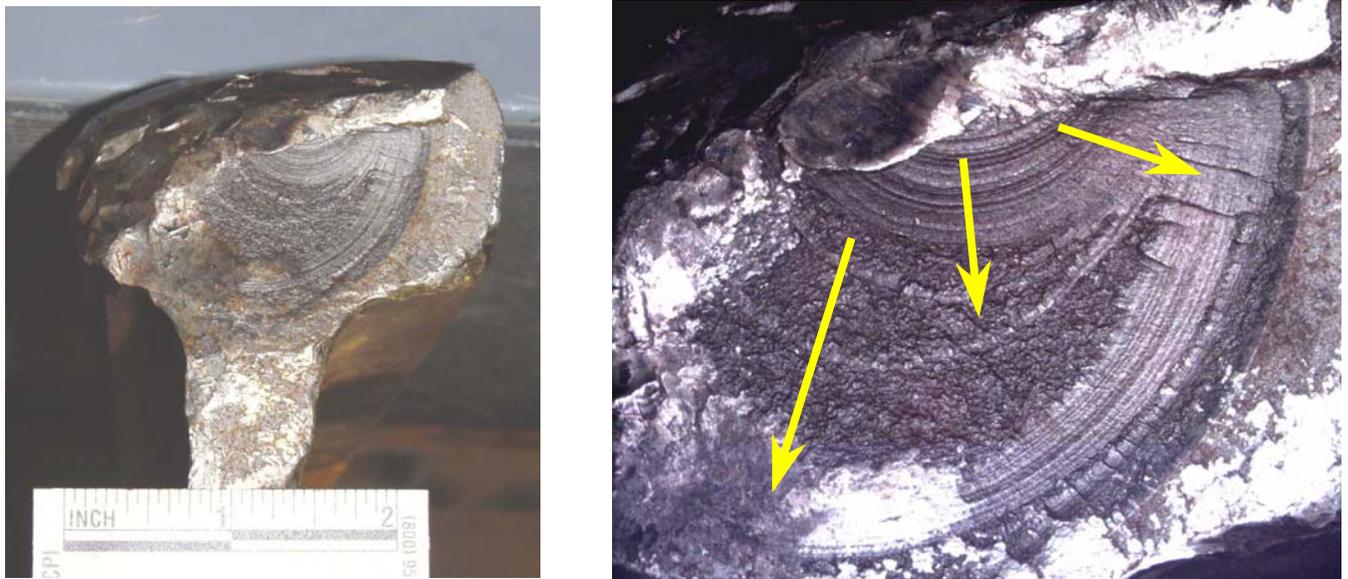
Fracture B was dominated by a large detail fracture in the rail head that most likely was the primary fracture. (See figure 5.) A longitudinal shelling crack propagated below the running surface of the rail and turned downward to form the detail fracture. This fracture propagated in fatigue until it penetrated more than 70 percent of the existing head cross section. The detail fracture region was darkly oxidized with alternating bands of fine fatigue arrest lines and areas of

coarse fracture. The detail fracture measured 2.2 inches wide and 2 inches deep and extended into the web of the rail.

**Figure 5.** Rail fracture B. (Photographs taken with different lighting and magnification.)

The National Transportation Safety Board determines that the probable cause of the March 12, 2007, derailment of CSX train No. Q39010 and subsequent release of hazardous material near Oneida, New York, was the failure of the rail from an undetected detail fracture that initiated from an area of shelling on the rail.

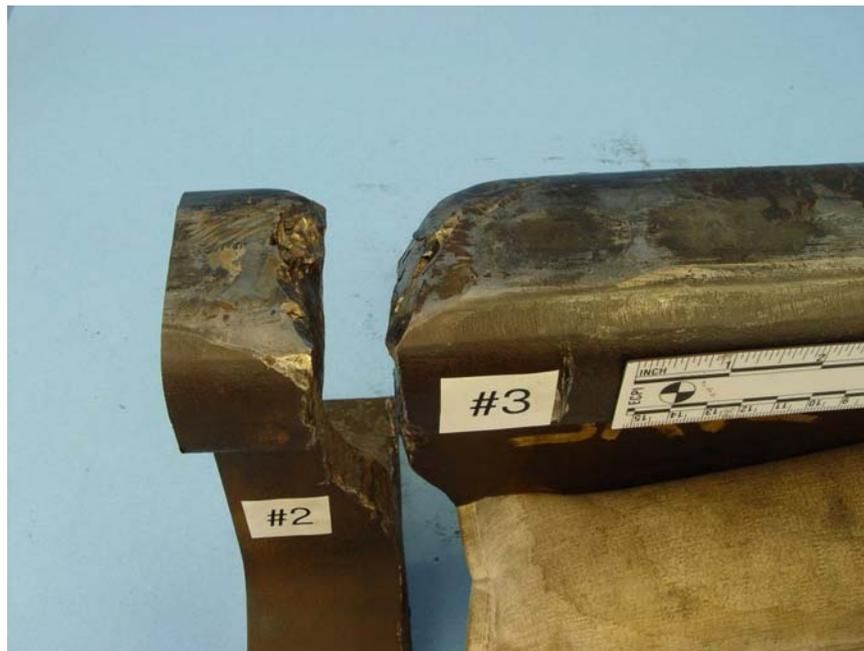
Both faces of fracture B were heavily damaged at and adjacent to the running surface of the rail. (See figure 6.) The damage appeared to be consistent with rail damage from wheel contact that occurs after the rail has fractured. Also, the rail damage correlated with the damage to the wheel treads of the cars at the front of the train that did not derail.

**Figure 6.** Damage to both faces of rail fracture B.
