# National Transportation Safety Board

## Railroad Accident Brief

**Accident No.:** DCA-08-FR-001  
**Location:** Painesville, Ohio  
**Date:** October 10, 2007  
**Time:** 12:02 p.m., eastern daylight time<sup>1</sup>  
**Railroad:** CSX Transportation  
**Property Damage:** \$1.4 million  
**Environmental Cleanup:** \$7.08 million  
**Fatalities:** None  
**Injuries:** None  
**Type of Accident:** Derailment

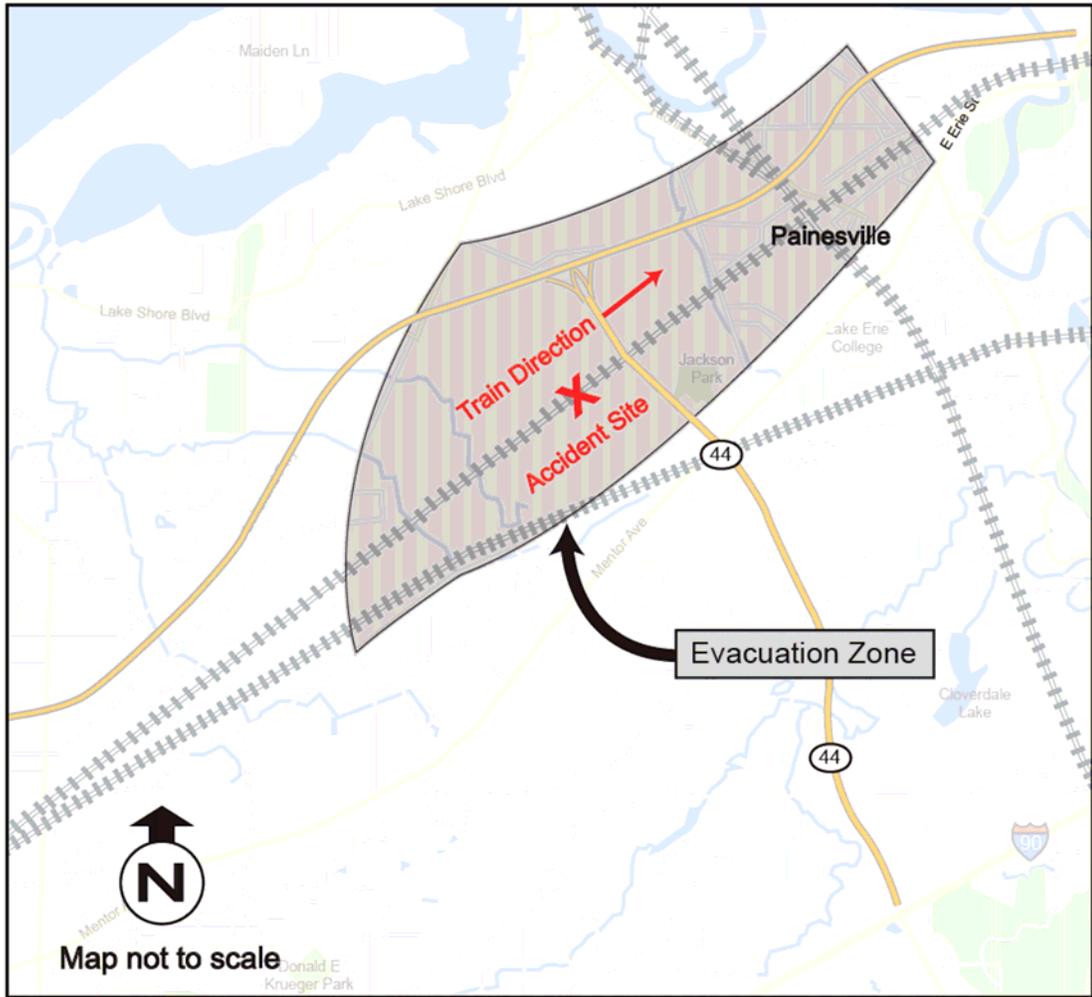
On Wednesday, October 10, 2007, about 12:02 p.m., eastbound CSX Transportation (CSX) freight train Q380-09 derailed 31 cars in Painesville, Ohio, while being operated on main track 1. The train was traveling 48 mph at the time of the derailment. The crew's last train operation had been made about 1 1/2 miles before the derailment. The train consisted of 2 locomotives and 112 cars (106 loaded and 6 empty). The 31st through 61st cars in the train derailed. The derailed cars included seven tank cars carrying ethanol, one tank car carrying liquefied petroleum gas, and one tank car carrying phthalic anhydride. Also among the 31 cars that derailed were covered hoppers carrying corn, wheat, feed, plastic, and lumber. The ethanol tank cars and many of the other freight cars caught on fire. Twenty-six of the derailed cars were destroyed. (See figure 1.)

**Figure 1.** Accident site.

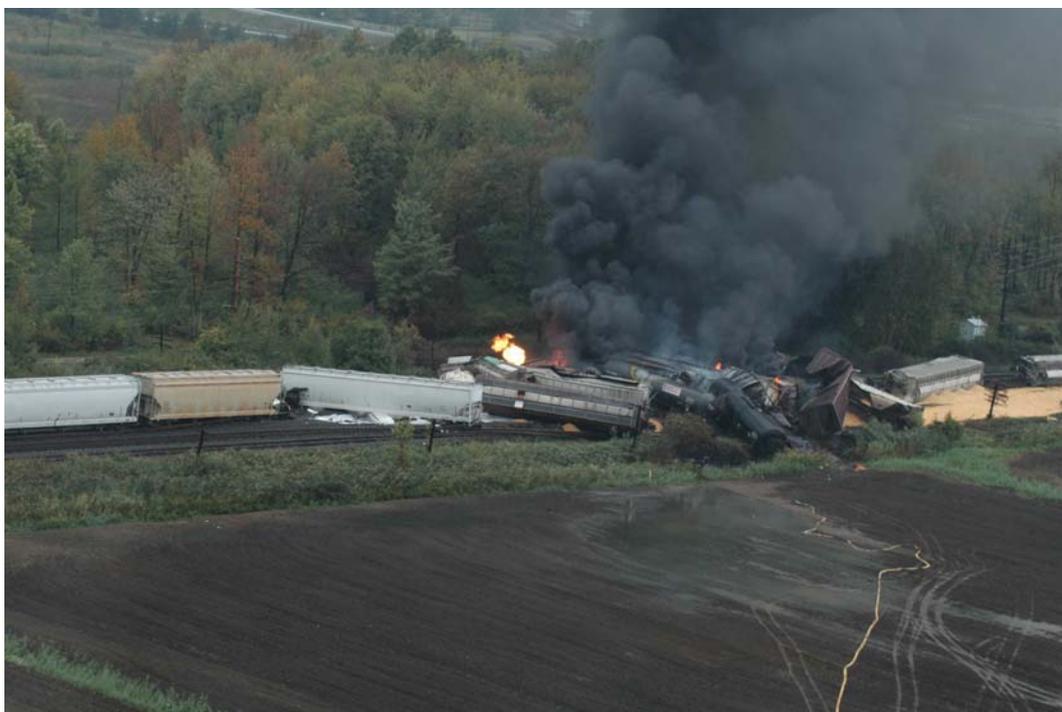
The engineer said that after he saw a large fireball in the middle of the train reflected in the side mirror, the train came to a stop. (See figure 2.) He immediately used the radio to broadcast an emergency notification three times, and he asked officials to come to the scene. The train crew provided the emergency responders with the train consist and information about the hazardous materials on the train.

**Figure 2.** Derailment.

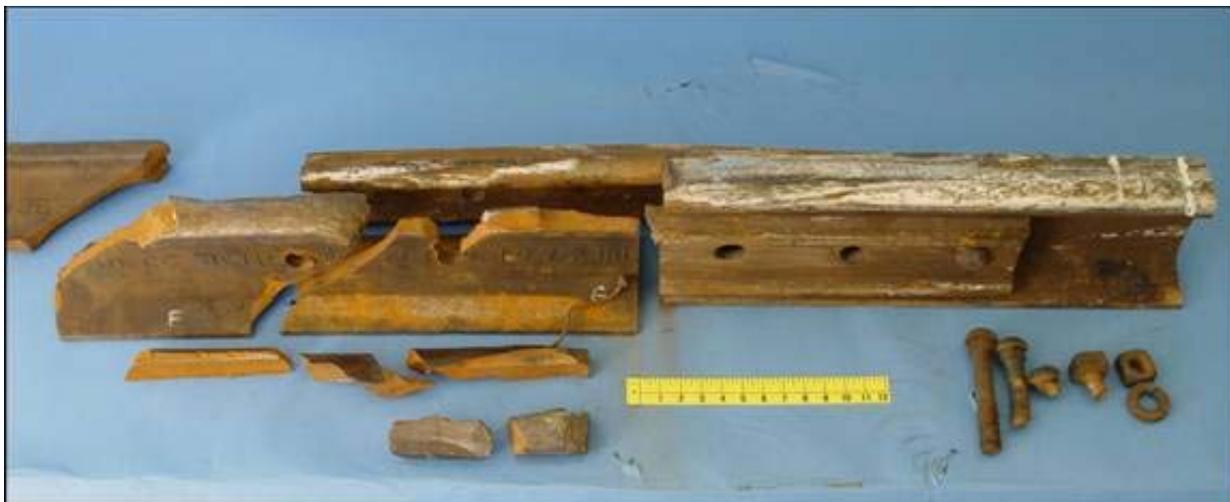
When the CSX installed the plug, it drilled 1 1/4-inch holes into the rail ends and fastened the joint bars to the ends with 1-inch-diameter bolts. For a 1 1/4-inch hole, the American Railway Engineering and Maintenance-of-Way Association recommends a 1 1/8-inch-diameter bolt. A bolt with a smaller diameter is more likely to allow longitudinal movement of the rail, which can result in a larger gap between the rail ends. As the gap between the rail ends widens, more impact force is transferred to the rail ends, which in turn creates additional rail end batter.

The Safety Board's Materials Laboratory examined the joint bars at the west end of the plug and found that one was a compromise bar and the other was a straight bar. (See figures 3 and 4.) When the track inspector changed the broken compromise joint bar in September, he incorrectly replaced it with a straight bar. The two types of bars have similar marks. The Materials Laboratory found that the straight bar had "132-136" in raised letters on its side, which means it could be used with either 132-pound rail or 136-pound rail. The compromise bar also had "132-136" in raised letters on its side. In addition, the compromise bar had one end that was stamped "132," and the other end was stamped "136."

**Figure 3.** Broken rail and joint bars from the west end rail plug joint at accident site.

The National Transportation Safety Board determines that the probable cause of the October 10, 2007, derailment of CSX Transportation freight train Q380-09 in Painesville, Ohio, was a broken rail due to a track inspector's installation of an incorrect type of rail joint bar. Contributing to the derailment was CSX Transportation's failure to weld the rail and, thereby, remove the temporary joint before the accident.

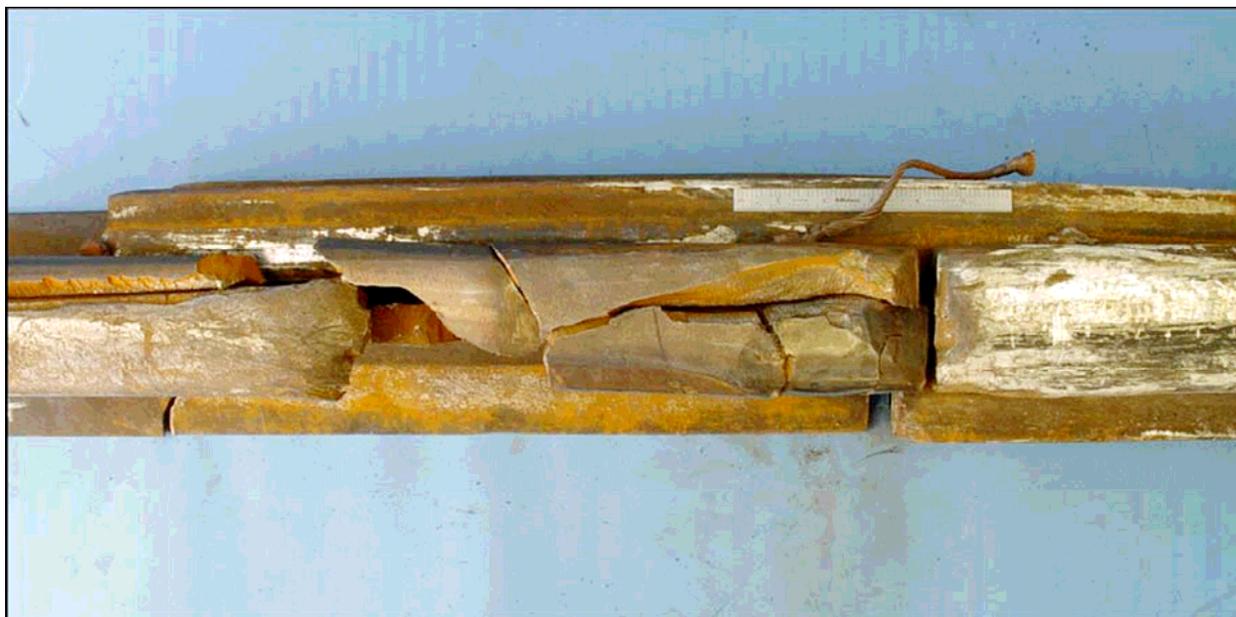
**Figure 4.** Reconfiguration of plug rail pieces from accident site.

In the Safety Board's Materials Laboratory, the 132-pound rail and the 136-pound rail were joined using a straight bar and a compromise bar similar to the accident joint. During the examination, the rail end of the 136-pound rail was found to be about 1/4 inch higher on the tread of the rail end than the tread end of the 132-pound rail. When tread rail ends are mismatched by 1/4 inch, Federal track safety standards require the track to be designated class 2
