National Transportation Safety Board

Railroad Accident Brief

Accident No.: DCA-07-FR-003
Location: Baxter, California
Date: November 9, 2006
Time: 11:00 a.m., Pacific standard time
Owner/Operator: Harsco Track Technologies
Railroad: Union Pacific Railroad
Property Damage: \$3.33 million
Fatalities: 2
Injuries: 0
Type of Accident: Uncontrolled movement

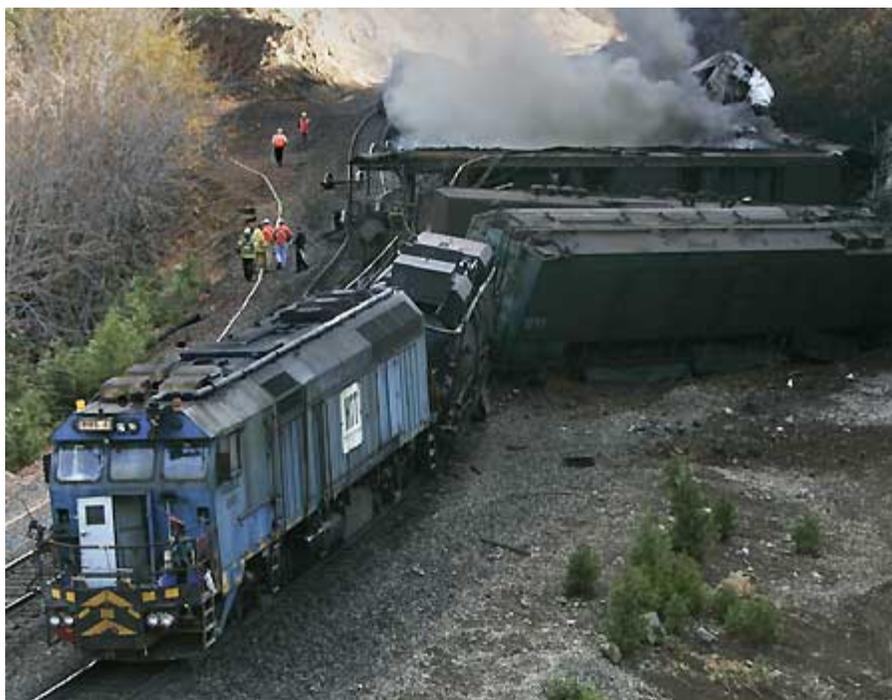
As the A-end locomotive came to a stop, a fire broke out in the derailed equipment. (See figure 1.) The conductor-pilot looked behind him and saw smoke and derailed equipment. He attempted to contact the dispatcher by radio, but all power had been lost on the A-end locomotive. He reached the dispatcher with his personal cell phone and told him about the derailment and asked for emergency assistance. Upon realizing that the adjacent main track was blocked by derailed equipment, the conductor-pilot told the dispatcher and then walked down the track and placed a red flag between the rails to warn any approaching train. Soon thereafter, a California Highway Patrol helicopter and various emergency service personnel began to arrive. The two employees killed in the derailment were found in the rear portion of the wreckage.

Figure 1. Grinder after derailment.
