National Transportation Safety Board
Washington, D.C. 20594

Railroad Accident Brief

Accident No.: DCA-08-FR-004
Location: Providence, Rhode Island
Date: March 13, 2008
Time: 1:11 p.m., eastern daylight time¹
Railroad: Amtrak (National Railroad Passenger Corporation)
Property Damage: None
Fatalities: 1
Injuries: 2
Type of Accident: Employee fatality

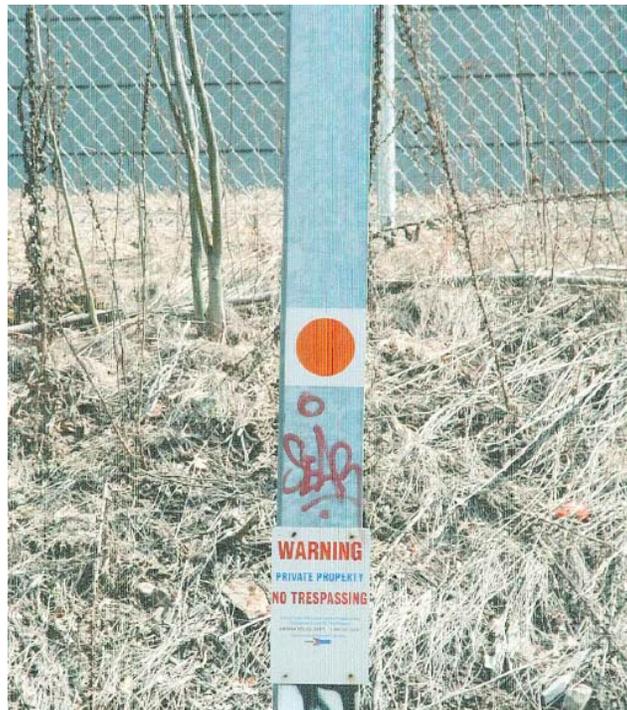
The accident occurred in a 4° 23' curve under a bridge—a hot spot, visually designated as such by orange decals on catenary poles (see figure 1) between MP 181.1 and MP 187. The HNTB inspector was walking in the gage of track 2 and the foreman was walking behind the inspector outside of the gage, but still on the ties, when Amtrak Acela train 2154 struck the inspector and the foreman. The watchman was on the field side of track 2, on the inside of the curve. During postaccident interviews, the watchman recalled looking up, seeing the Amtrak train right in front of him, and jumping. (See figure 2.) The train stopped 564 feet past the point of impact.

Figure 1. Orange decal posted on a catenary pole indicating a hot spot.

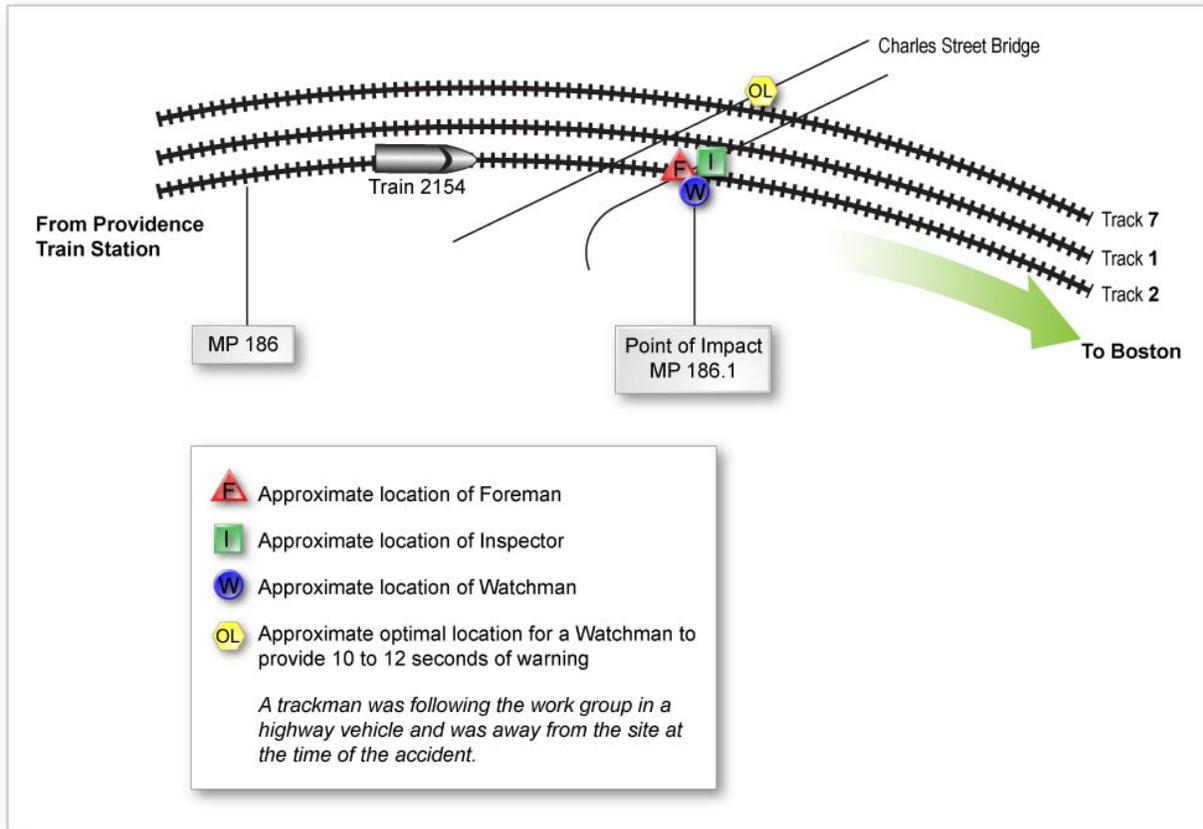
Figure 2. Accident site layout and locations of roadway workers.

Postaccident sight-distance observations determined that the optimal location for positioning a watchman was on the outside of the curve on the field side of track 7, approximately 53 feet from the center of track 2. (See figure 2.) From the optimal location, a watchman could see about 765 feet looking west and about 862 feet looking east where he would have had between 10 and 12 seconds to provide a warning of an approaching train.¹⁰ The watchman's actual location allowed him about 1 second of time to warn the work group of a train approaching from either direction at 51 mph. Regardless of the type of on-track protection in place when the accident occurred, the watchman was positioned in a spot that afforded him the least amount of visibility of approaching trains in either direction. Although directed to stand close to the work group, the watchman did not recognize that he was poorly positioned to perform his duties and he did not exercise his right to challenge¹¹ the foreman's instructions.

Since the March 13, 2008, accident in Providence, Rhode Island, Amtrak has enhanced the safety of its roadway worker protection program. Annual training now includes situational examples regarding placement of watchmen, hot spots, and the right to challenge the adequacy of on-site safety procedures. During field audits, Amtrak now focuses its attention on reviewing foul time logs and auditing both job briefings and on-track safety briefings. Amtrak has reinforced a requirement to visually inspect roadway worker protection qualification cards during job briefings and on-track safety briefings for its contractors and employees. In addition, three hot spot committees were created with participation of the Brotherhood of Maintenance of Way Employees to develop recommendations for proper on-track protection at known hot spots.

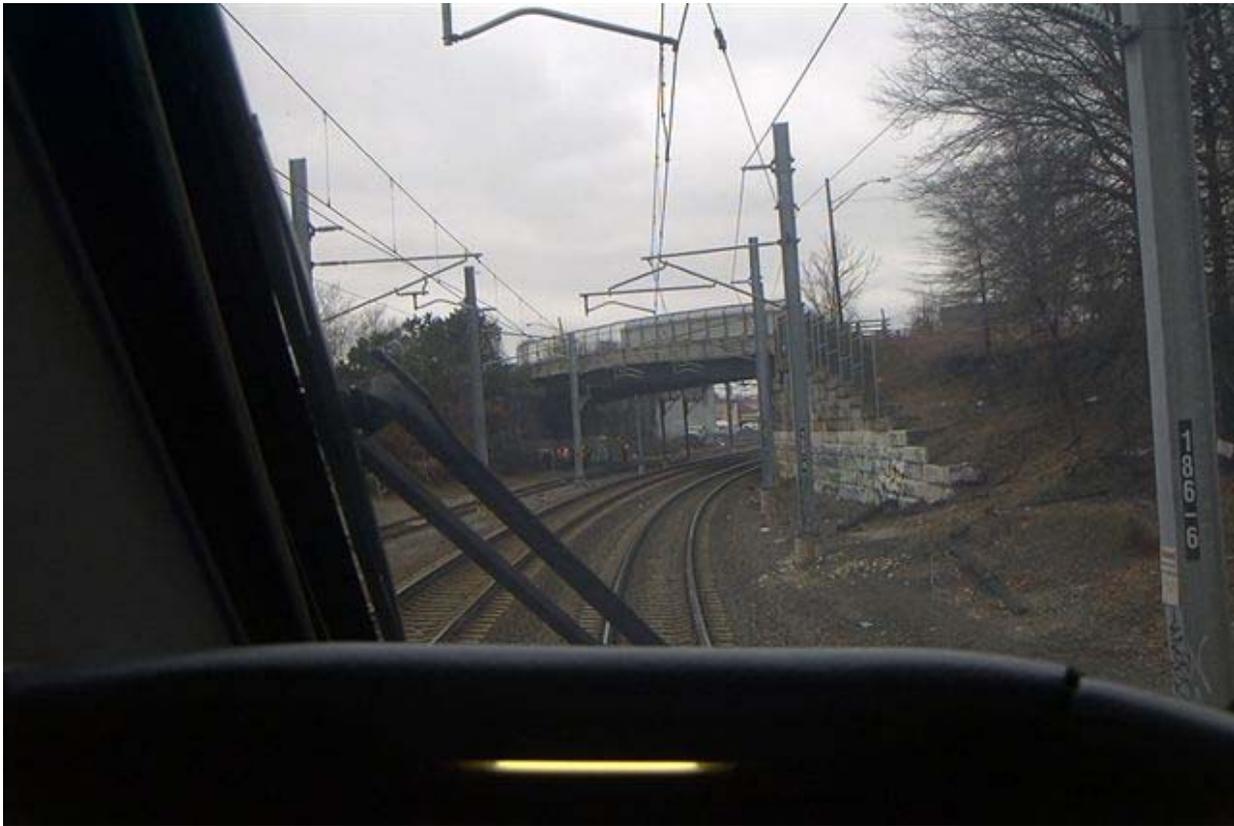
On the day of the accident, Amtrak Acela train 2154 departed from Penn Station in New York City, New York, shortly after 10:00 a.m. and arrived at Providence train station about 1:05 p.m. It departed Providence train station about 1:09 p.m.; at that time, there were four people in the locomotive cab: the engineer, a Federal Railroad Administration (FRA) deputy regional administrator, an Amtrak assistant superintendent of road operations, and a Massachusetts Bay Commuter Railroad road foreman. The train was traveling between 20 and 25 mph through the first curve out of the station, and its speed increased to about 51 mph at MP 186 as it approached the Charles Street Bridge. (See figure 3.)

Figure 3. Engineer’s view eastbound on track 2, approaching the Charles Street Bridge. Point of impact was located under the bridge.
