National Transportation Safety Board

Railroad Accident Brief

Accident No.: DCA-09-FR-005
Location: Selkirk, New York
Date: May 10, 2009
Time: 6:38 PM, Eastern daylight time¹
Railroad: CSX Transportation
Fatalities: 1
Type of Accident: Remote control locomotive switching operation

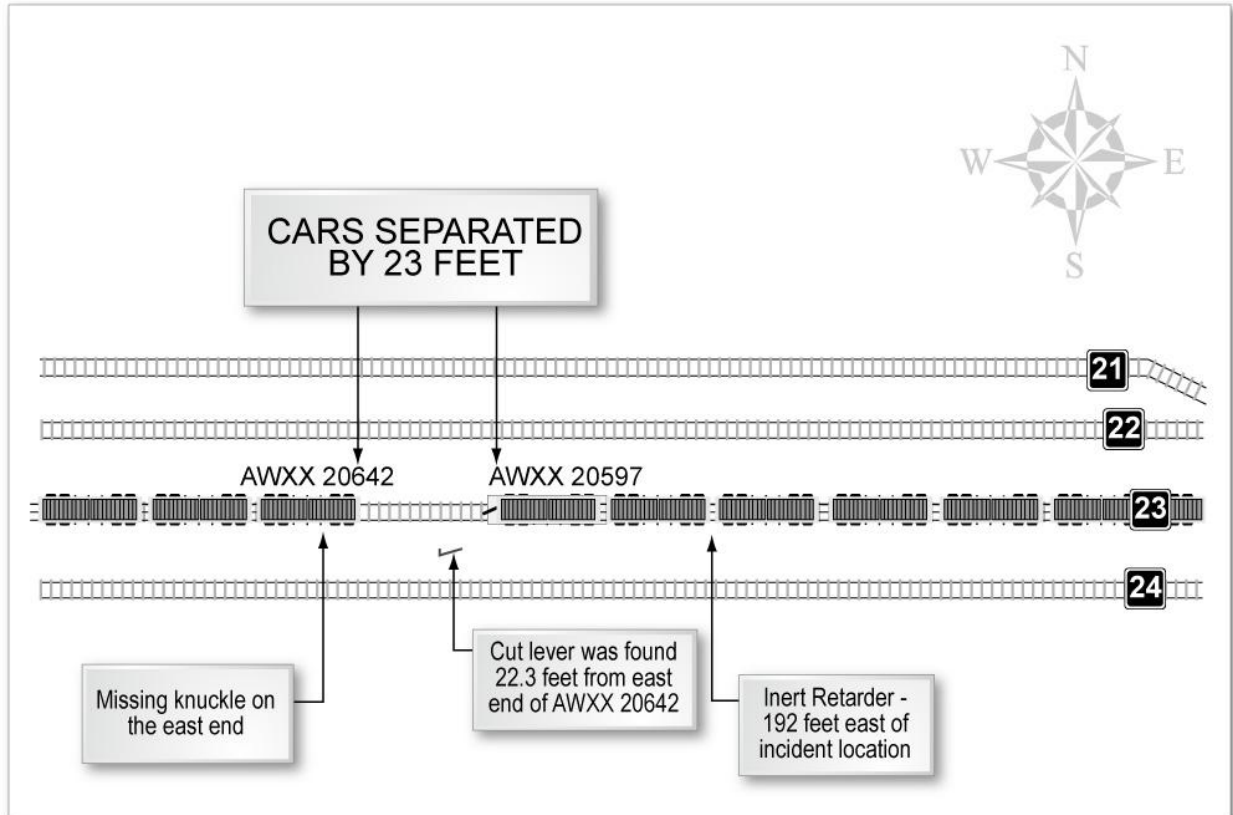
Several other CSX employees in the area heard the emergency announcement and went to the accident site. The RCO was found between tracks 23 and 24, with his OCU on the ground between the seventh and eighth cars. The RCO had worn the OCU on a large Velcro belt. There were marks in the coupler pocket¹⁰ of the seventh car and on the OCU consistent with one having been struck by the other. One of the responding CSX employees had received training in remote control operation and used the OCU to move the equipment. He left a gap between the seventh and eighth cars of about 23 feet to provide access room for EMS personnel. (See figure 1.)

Figure 1. Accident site on track 23.

Postaccident observations by witnesses indicated that the knuckle of the eighth car was hanging from the east end coupler and was tilted outward from the top about 3 inches. The knuckle pin, which would normally have been inserted in the coupler and knuckle as a hinge, was found on the ground next to the RCO. One of the witnesses stated that he picked it up and placed it between the wheel and rail of the eighth car to act as a stop. The coupler of the west end of the seventh car was found skewed to the south with the knuckle closed.

It is likely that after the RCO started the train movement, he may have thought that the cars might not couple properly because of the position of the coupler. He then stepped between the moving equipment to reposition the knuckle of the eighth car without stopping the train. However, it could not be determined whether the knuckle on the seventh car was closed before the accident or closed because of striking the eighth car.

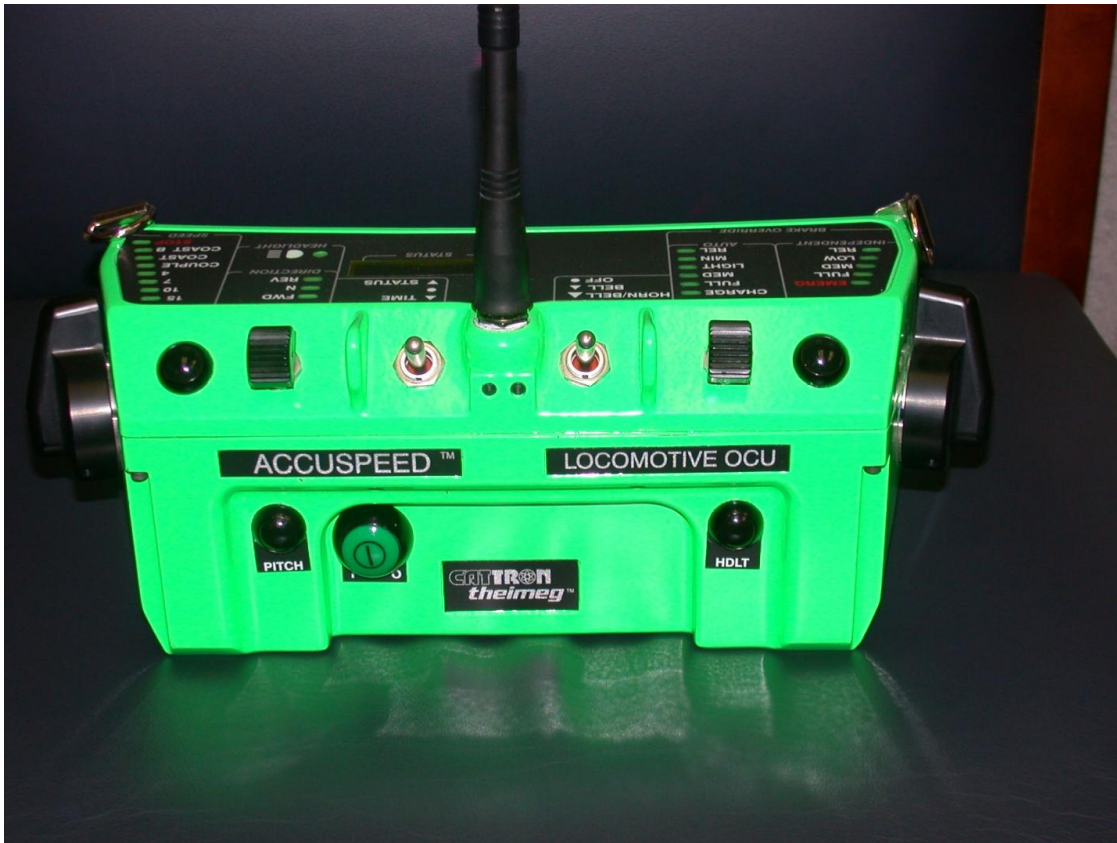
The RCO was using the Cattron OCU shown in figure 2. Cattron tested the recovered unit onsite and again later at the Cattron facilities in Sharon, Pennsylvania. No operational anomalies were found. Onsite testing showed no differences between the simulated recorded operations of the unit from the event recorder when compared with the use of another OCU.

Figure 2. Cattron operating control unit.

The testing determined that the operation of the OCU was consistent with FRA Safety Advisory 2001-01 and that no inadvertent operation of the locomotive could be initiated from the OCU.
