National Transportation Safety Board

Railroad Accident Brief

Accident No.: DCA-09-FR-008
Location: Lake Buena Vista, Florida
Date: July 5, 2009
Time: 2:00 a.m., eastern daylight time¹
Railroad/Property: Walt Disney World Resort
Property Damage: \$24 million
Injuries: 0
Fatalities: 1
Type of Accident: Collision

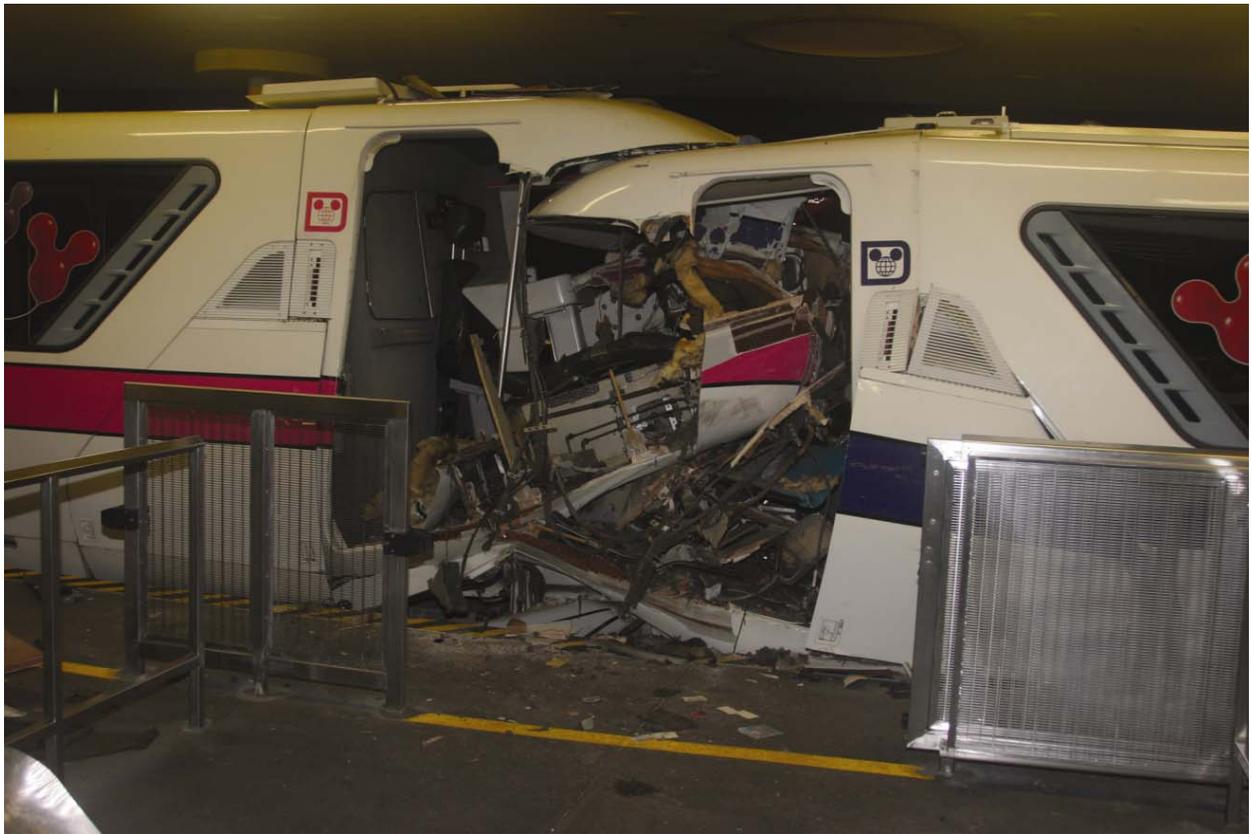
About 2:00 a.m. on Sunday, July 5, 2009, two monorails² collided on a fixed guideway system³ referred to as the Epcot beam⁴ near the Concourse station within Walt Disney World Resort in Lake Buena Vista, Florida. The accident occurred when the Pink monorail backed through an improperly aligned switch-beam⁵ and struck the Purple monorail. An operator and six passengers were on board the Purple monorail at the time of the collision. The operator was fatally injured; the passengers were not injured. The only occupant of the Pink monorail, the operator, was taken to a nearby hospital and treated and released. At the time of the accident, weather conditions were clear with light winds and a temperature of 76° Fahrenheit. One operating cab from each of the monorails was destroyed.⁶ (See figure 1.) Total damages were estimated at \$24 million.

Figure 1. The accident monorails after the collision. The rear operating cab of the Pink monorail (unoccupied at the time of the accident) is on the left, and the front operating cab of the Purple monorail is on the right.

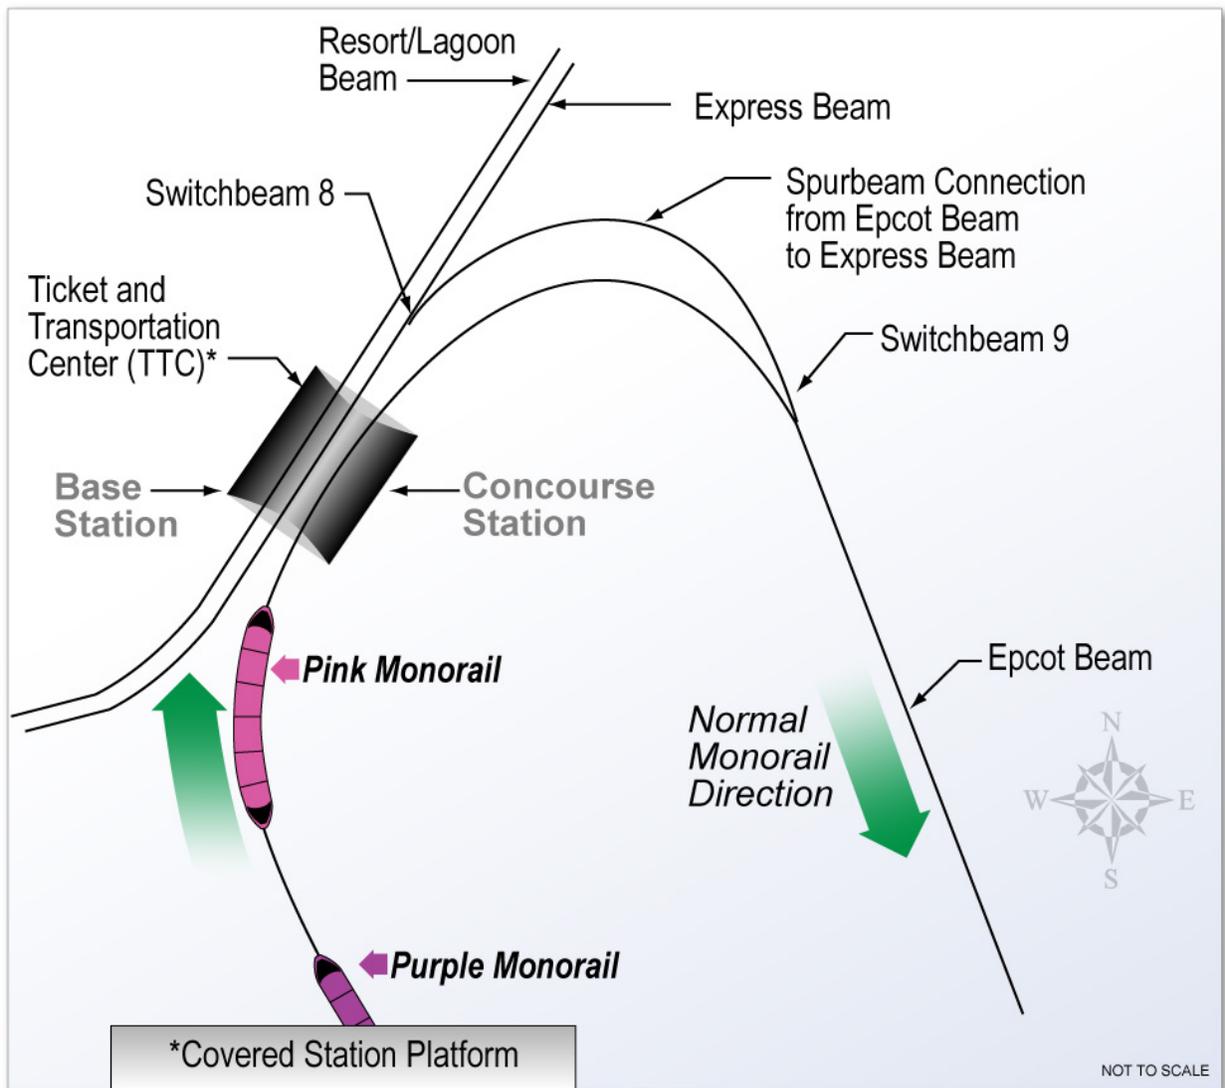
The Epcot beam is located to the south of the Magic Kingdom Park beam system. The Epcot beam is connected to the Magic Kingdom Express beam through a spur-beam. Switch-beams 8 and 9 at either end of the spur-beam⁷ can be repositioned to allow a monorail access from the Epcot beam to the Express beam or vice versa. (See figure 2.)

Figure 2. Junction of the Epcot beam with the Resort/Lagoon beam and the Express beam near the Ticket and Transportation Center. Normal direction of monorail travel on the Epcot beam is indicated by green arrows.

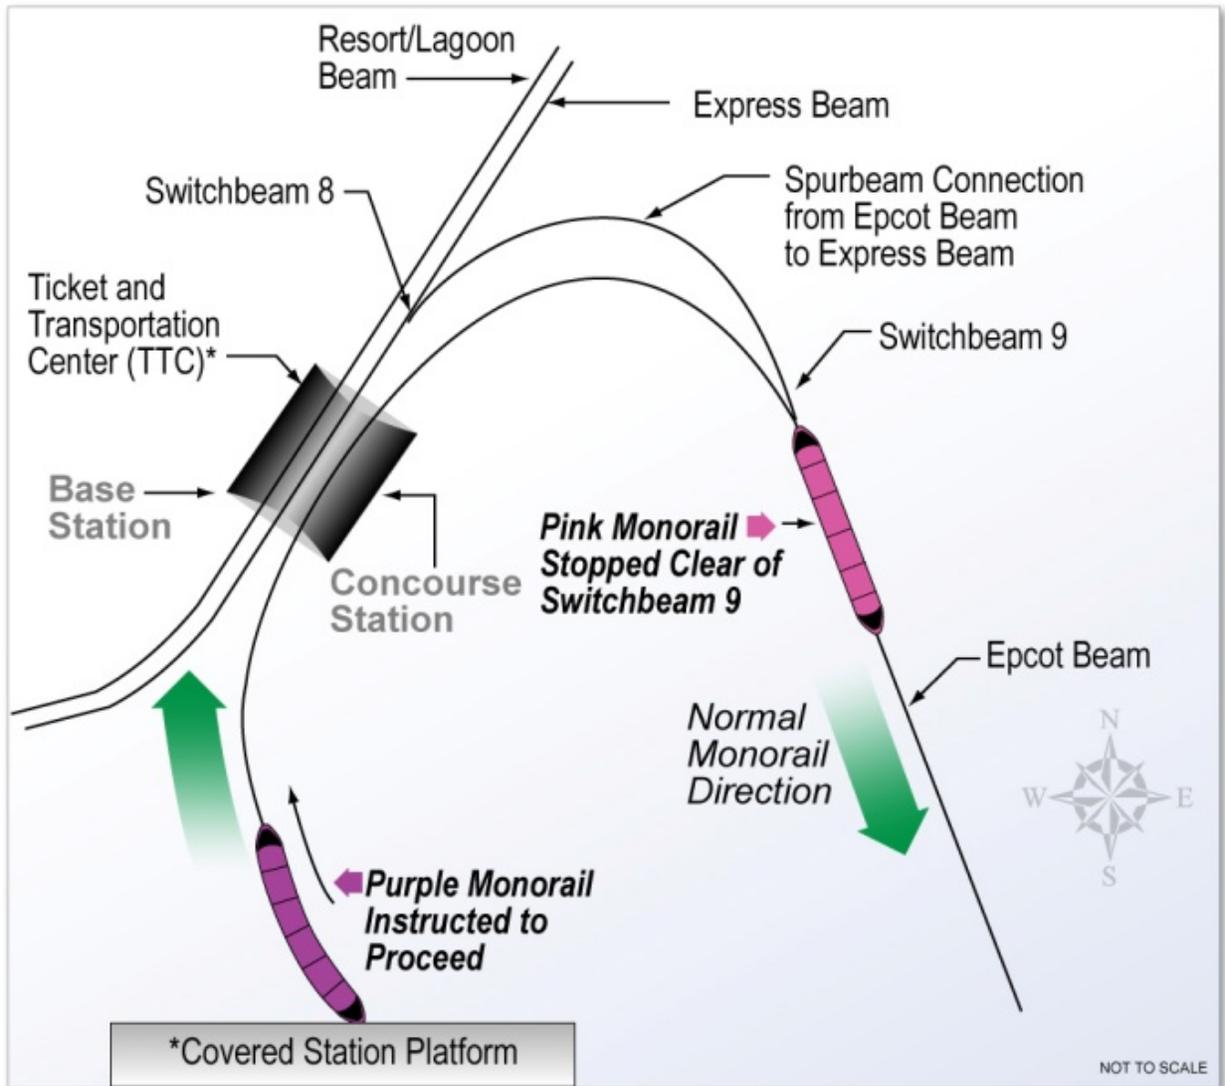
which is accessible via the Express beam. About 1:53 a.m., the monorail central coordinator transmitted the following instruction to the operator of the Pink monorail: “Normal visual to pylon 30,^[8] hold and notify.” This was a routine instruction intended to move the Pink monorail past switch-beam 9 on the Epcot beam so that, after switch-beams 8 and 9 were aligned for the spur-beam, it could back onto the spur-beam and then onto the Express beam for return to the mechanical facility. The operator of the Pink monorail stopped the monorail beyond switch-beam 9. He then notified the central coordinator that he had cleared switch-beam 9 and was awaiting further instructions. (See figure 3.)

Figure 3. The Pink monorail has cleared switch-beam 9 and is awaiting further instructions.

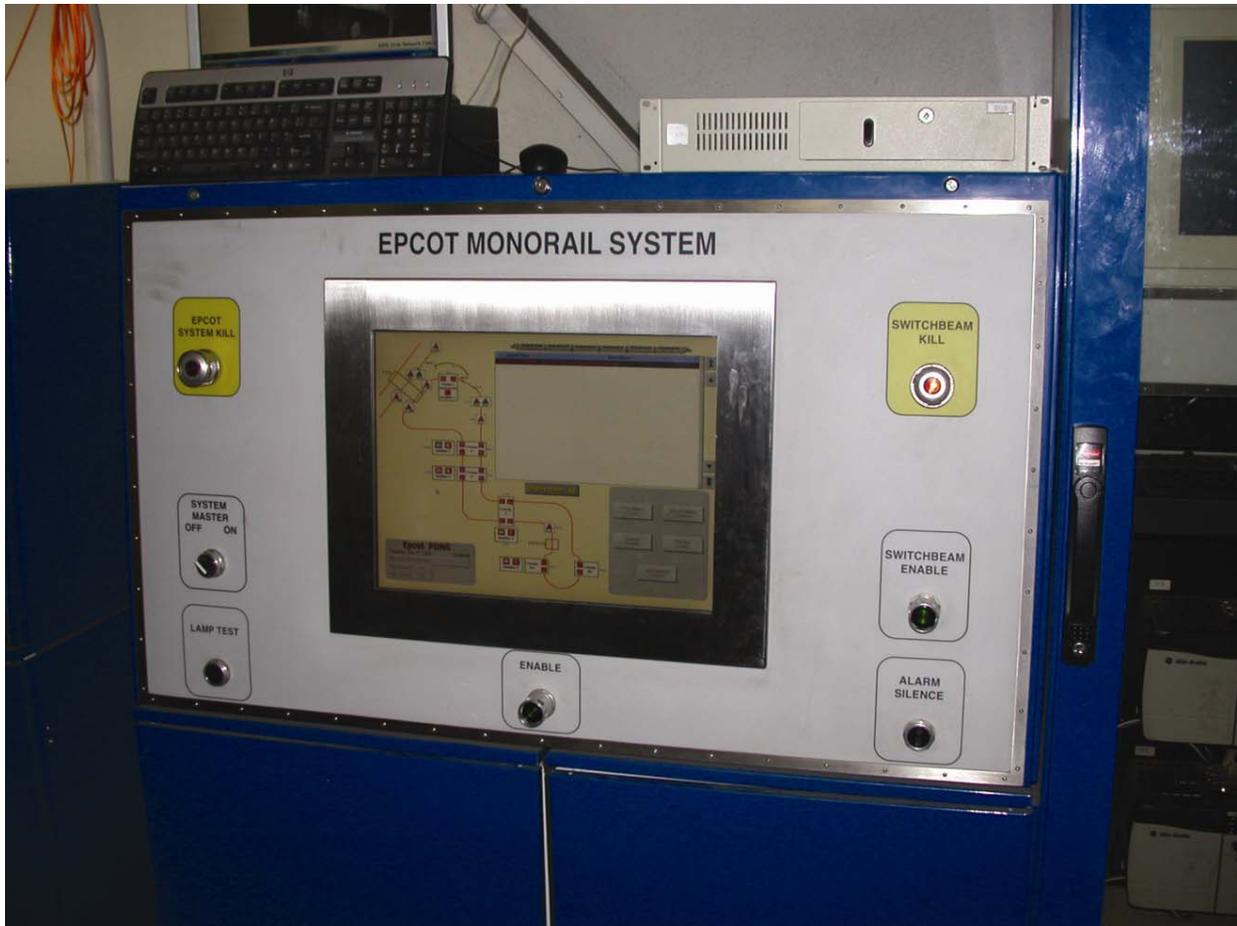
Figure 4. Power Distribution and Monitor System switch panel for controlling switch-beams 8 and 9.

The investigation determined that after cutting power to the beam, the shop panel operator did not immediately initiate the switch-beam realignment. He explained that, “there’s a little bit of time lapse before the switch—you know, it takes time for the switches to move.” About this same time, at 1:55 a.m., the operator of the Silver monorail called the shop panel operator and advised him that the monorail had experienced a left side door alert as it traversed

The shop panel operator told the investigator that when he returned to the switch panel, he thought that he had completed the switch-beam realignment; he restored power to the Epcot beam. At 1:57 a.m., the shop panel operator contacted the central coordinator and said, “Switch-beams 8 and 9 are on the spur-line with power.” The central coordinator confirmed this message and contacted the Pink monorail. He told the operator of the Pink monorail, “Clear in reverse MAPO override^[10] in reverse through 8, through 9, then you’ll be cleared through Base all the way to Grand Floridian,^[11] switch ends.”¹²

The PDMS was operated by the shop panel operator, who had been trained on the job. The operator was familiar with the operations and maintenance manual,¹⁸ which explained the steps for operating the shop panel when moving monorails from the Epcot beam to the Express beam. The procedural steps did not require that the shop panel operator ensure that the switch-beam position had changed after making the request through the switch panel.

In addition to verifying switch beam position and power status via the PDMS display as was required on and prior to July 5, 2009, monorail shop panel operators are required to confirm the position of the switch beams via video camera monitors prior to directing monorail movement across those switch beams.

A second monorail shop panel operator must visually verify the switching process is properly performed by the primary monorail shop panel operator.

The PDMS software has been upgraded to capture additional data related to switch-beam operation.

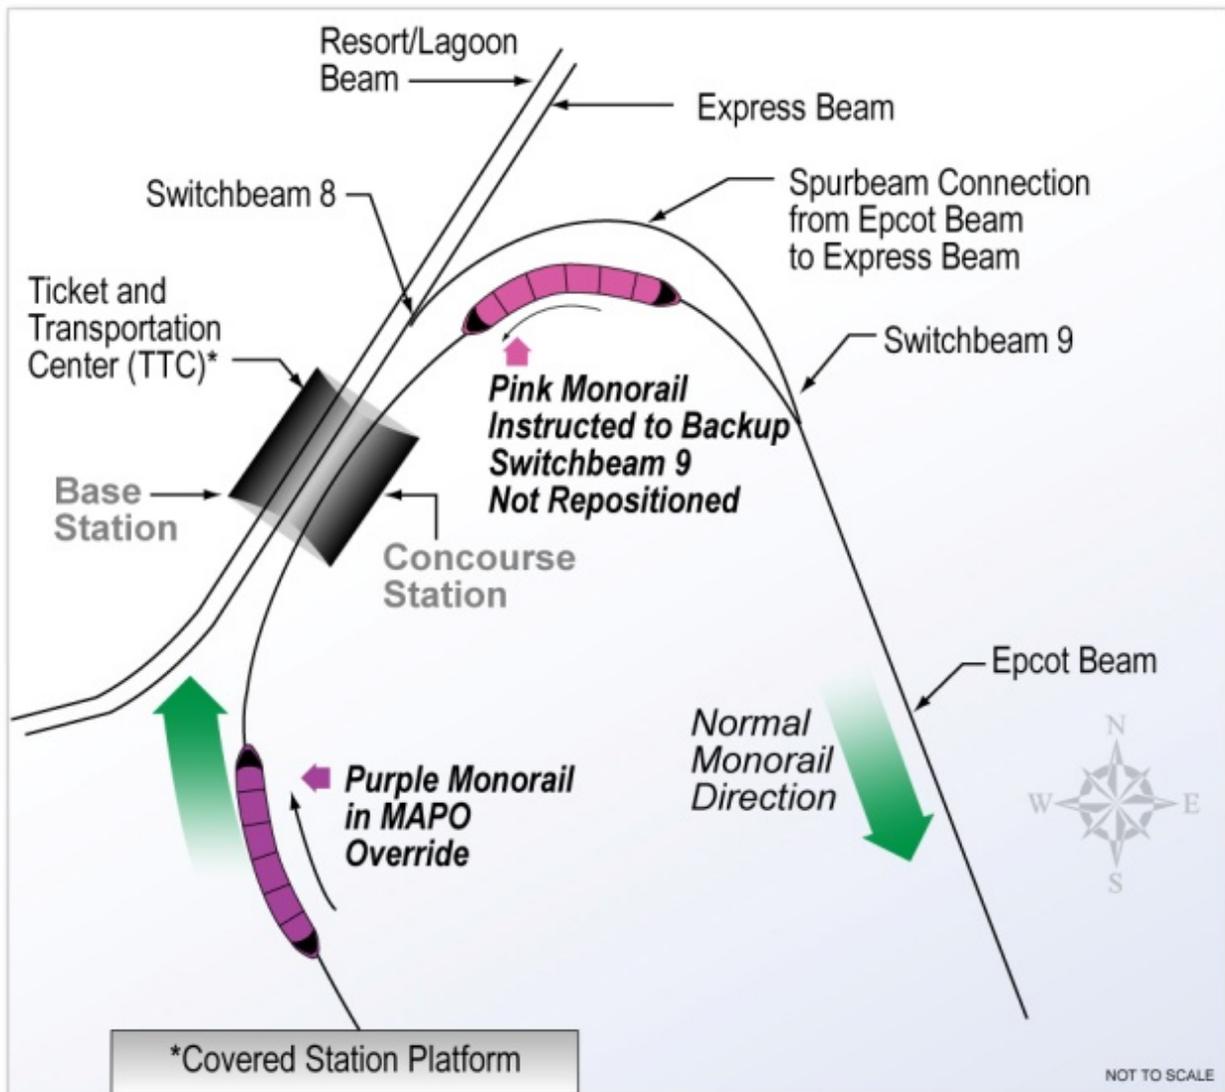
The operator of the Pink monorail began backing up the monorail. However, switch-beams 8 and 9 had not been repositioned. This resulted in the Pink monorail backing up on the Epcot beam, the same beam on which it had just been traveling and the same beam on which the Purple was following.

At 1:59 a.m., the central coordinator gave the operator of the Purple monorail (the monorail following the Pink monorail on the Epcot beam loop) the following instruction: “Normal visual 385, MAPO override into Concourse^[13]....” The MAPO system had to be placed in override to allow the Purple monorail to enter the station while the Pink monorail should have been backing through the spur-beam just beyond the station. (See figure 5.)

Figure 5. The Pink monorail is backing up on the same beam as the incoming Purple monorail, instead of on the spur-beam.

Operating procedures require that monorail drivers be in the forward facing cab when switching from one beam to another (unless a switching procedure must be terminated before completion due to a safety concern, in which case, a driver is permitted to back out of the switch so long as an observer monitors the rearward motion of the monorail).

Monorail drivers are required to visually confirm the correct position of switch-beams prior to switching from one beam to another.

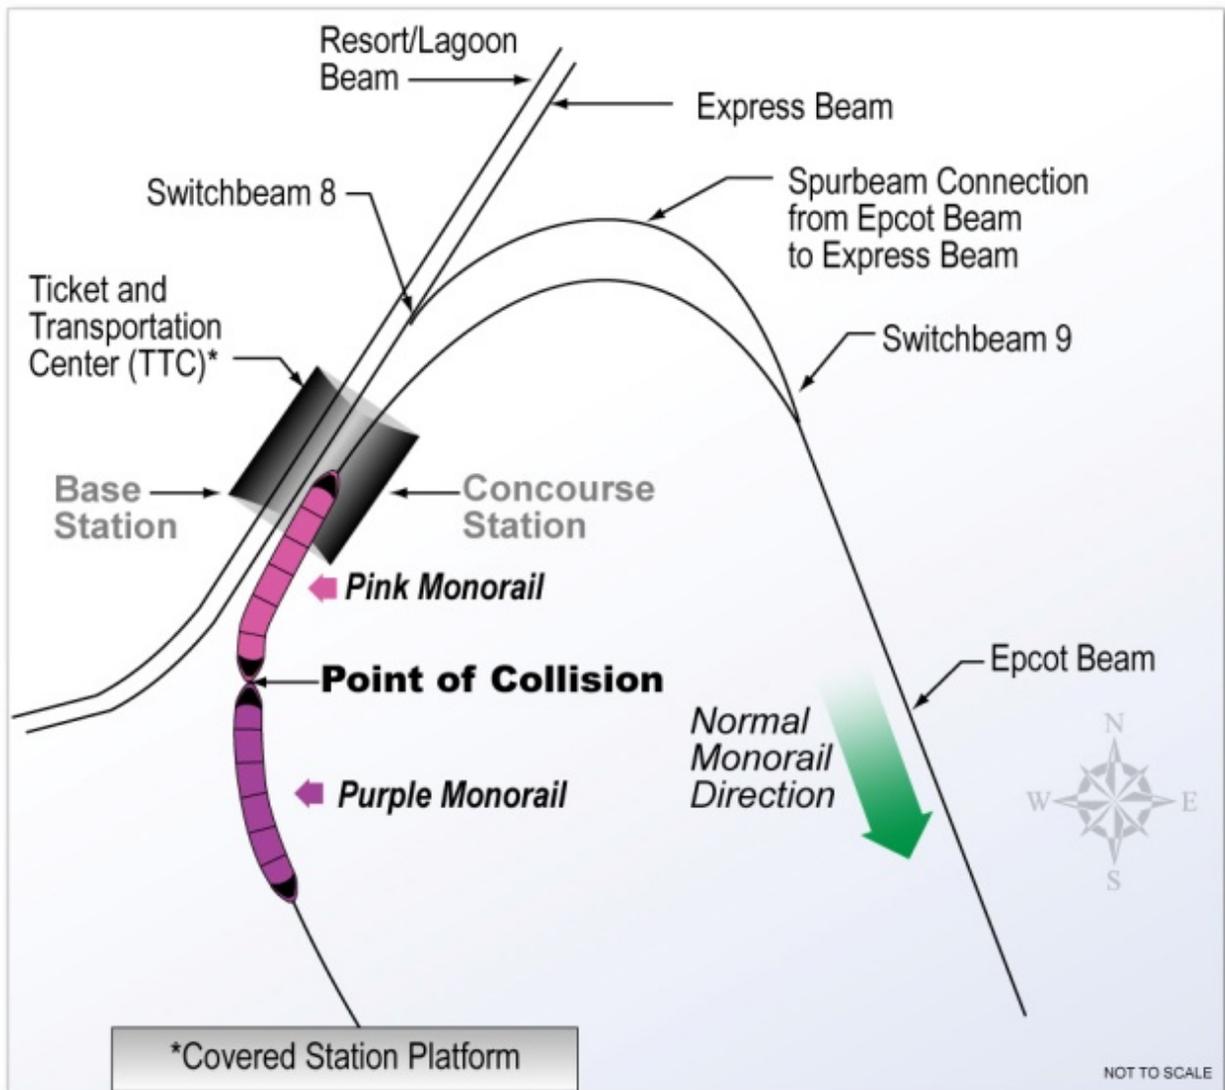
The Purple monorail proceeded toward the Concourse station within the Ticket and Transportation Center. According to the onboard Local Monitoring and Control Unit, which captures and logs data during operations, the operator of the Purple monorail stopped the monorail and placed the controls in reverse, but before the Purple monorail could be moved, it was struck by the Pink monorail (See figure 6.). The occupied operating cab of the Purple monorail was crushed, and the operator was fatally injured.

Figure 6. The unoccupied rear operating cab of the Pink monorail strikes the occupied operating cab of the Purple monorail.

The National Transportation Safety Board determines that the probable cause of the July 5, 2009, collision between two monorails at Walt Disney World Resort in Lake Buena Vista, Florida, was the shop panel operator's failure to properly position switch-beam 9 and the failure of the monorail manager acting as the central coordinator to verify the position of switch-beam 9 before authorizing the reverse movement of the Pink monorail. Contributing to the accident was Walt Disney World Resort's lack of standard operating procedures leading to an unsafe practice when reversing trains on its monorail system.
