National Transportation Safety Board

Railroad Accident Brief

Accident No.: DCA-10-FR-002
Location: Minneapolis, Minnesota
Date: December 29, 2009
Time: 11:22 a.m. central standard time¹
Railroad: BNSF Railway Company
Property Damage: None
Injuries: 0
Fatalities: 1
Type of Accident: Derailment resulting in employee fatality

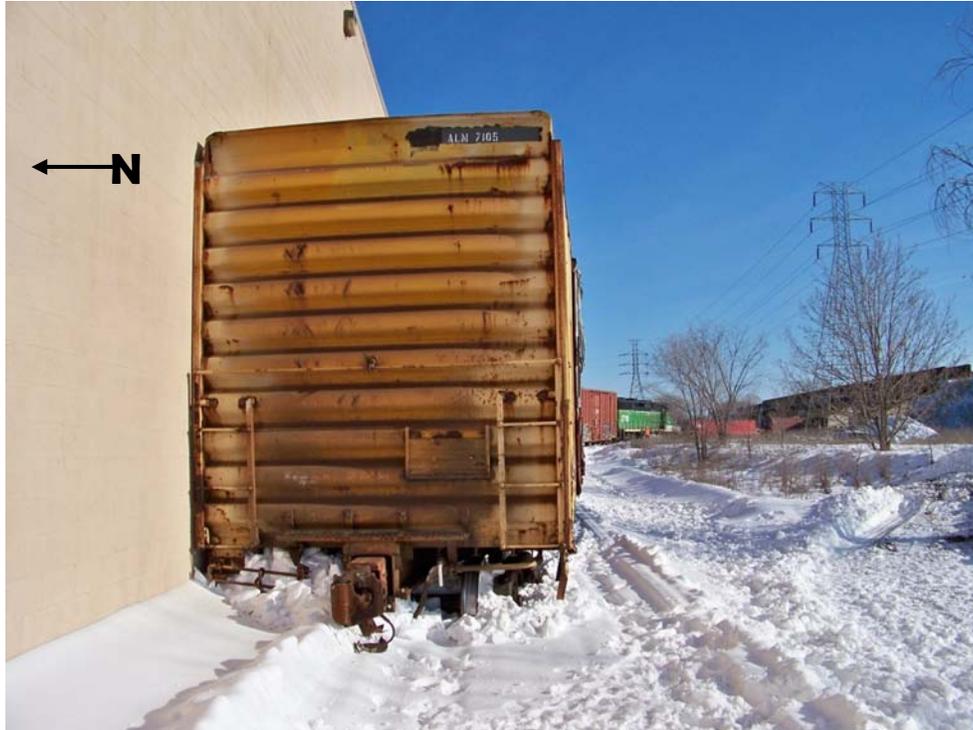
Figure 1. This photograph shows the final position of the boxcar on which the switch helper was riding. The photograph also shows the accumulation of snow.

During the shoving movement, the lead railcar encountered accumulated ice between the gage of the rail where the flange of the wheels ride against the rail. The ice was solid enough to allow the wheels to climb over the top of the rail, lifting the empty boxcar and derailing toward the building. The track inspector said, "...there was ice buildup of approximately 2 inches above the ball [top]..." of the rail. The track inspector said that at the point of derailment, "...we could see the marks where it appeared that the lead set of wheels had climbed."

The National Transportation Safety Board determines that the probable cause of the accident was a buildup of ice and snow that derailed a boxcar on which an employee was riding, crushing the employee between the boxcar and an adjacent building. Contributing to the accident was the decision to ride the boxcar when conditions were not determined to be safe.

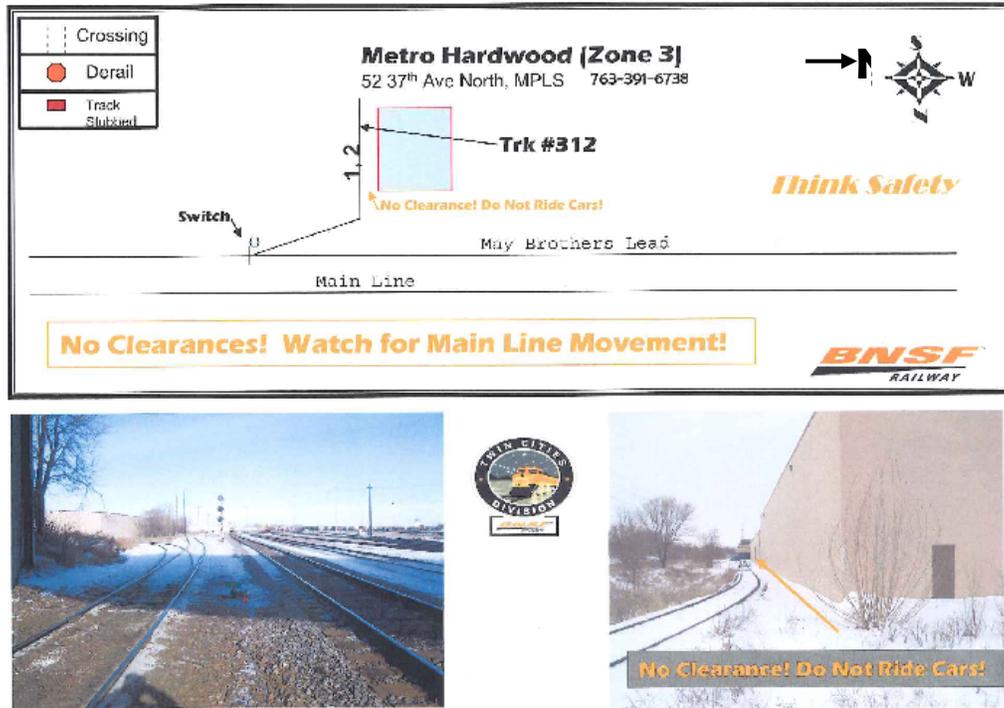
Included in this storybook is a photograph with an arrow that appears to point toward a close clearance location. (See Figure 2.)

Figure 2. “No Clearance” warning for Metro Hardwoods in the BNSF *Northtown Terminal Spotting Profiles and Risk Identification Storybook*, which was in effect at the time of the accident.

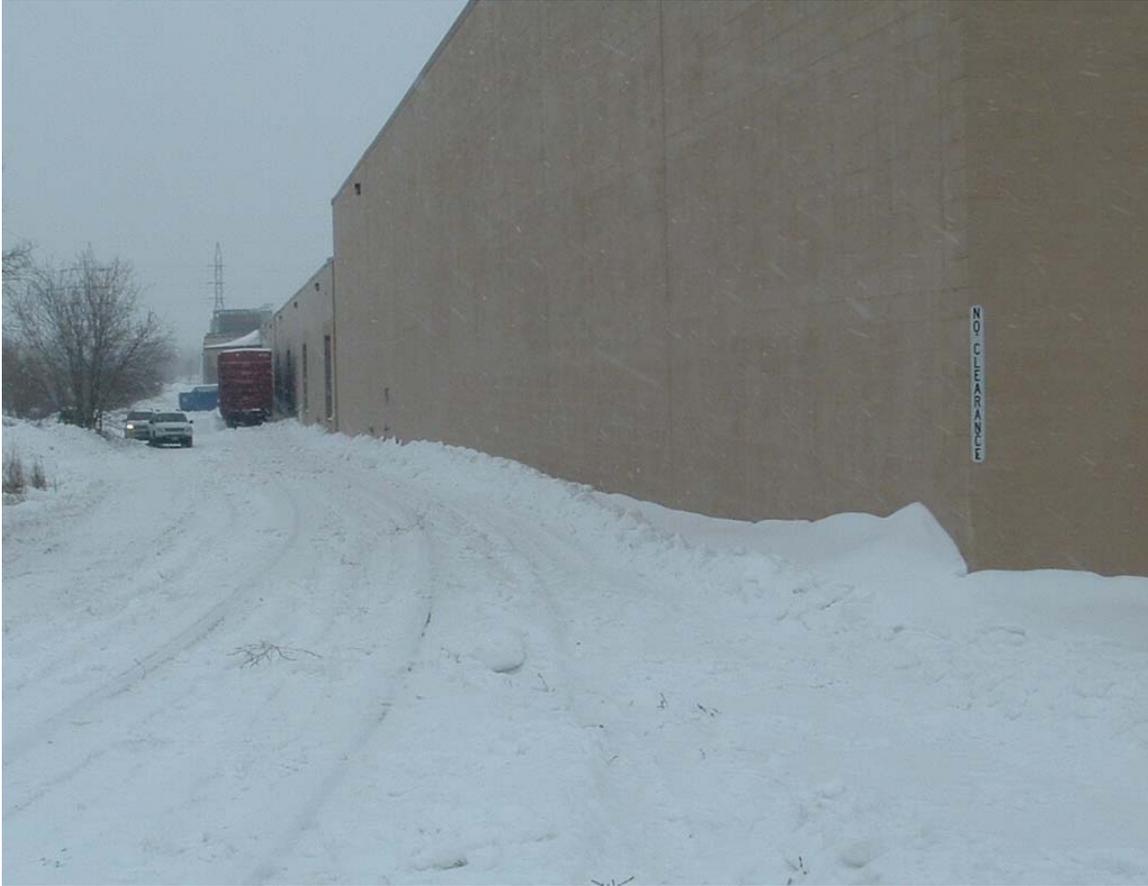
Figure 3. The "No Clearance" sign at Metro Hardwoods.
