# National Transportation Safety Board

## Railroad Accident Brief

**Accident No.:** DCA-07-MR-007  
**Location:** Shepherdsville, Kentucky  
**Date:** January 16, 2007  
**Time:** 8:43 a.m. eastern standard time<sup>1</sup>  
**Railroad:** CSX Transportation  
**Property Damage:** \$22.4 million  
**Injuries:** 52  
**Type of Accident:** Derailment with Hazardous Materials Release

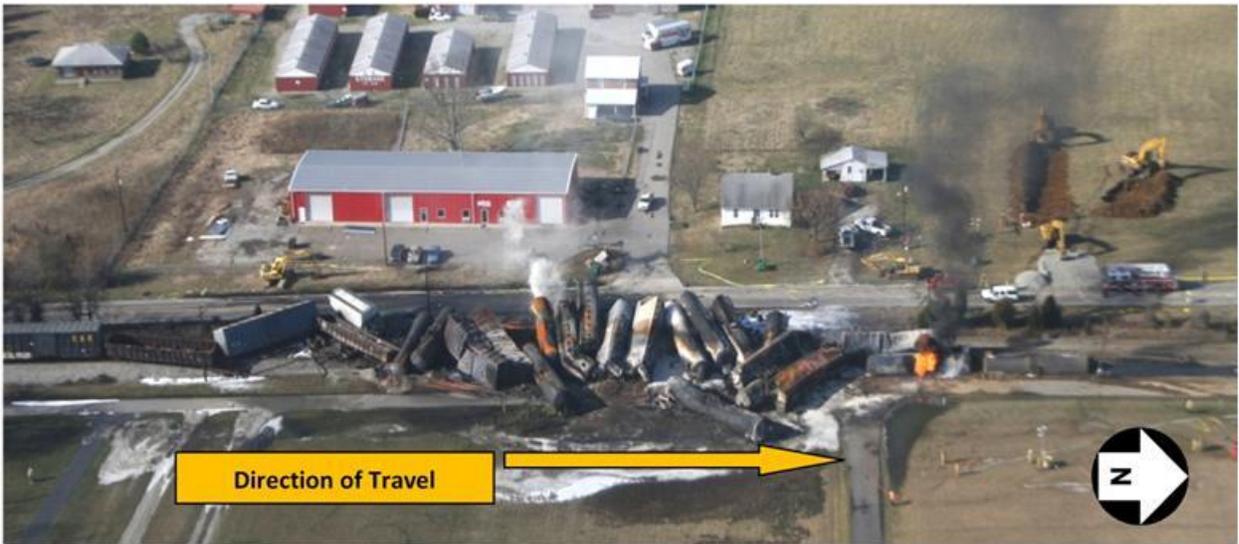
The accident train separated at the 15th car behind the locomotives. The four locomotives and the first 14 cars continued north and came to a stop about 1,632 feet from the derailed cars. Twenty-six cars derailed in the accident, the 15th through the 40th. Twelve of the derailed cars contained hazardous materials. Three tank cars containing flammable liquids breached as a result of the derailment and released full loads of cyclohexane, methyl ethyl ketone, and butadiene, resulting in a large fire. (See figure 1.)

**Figure 1.** Aerial photo of wreckage.

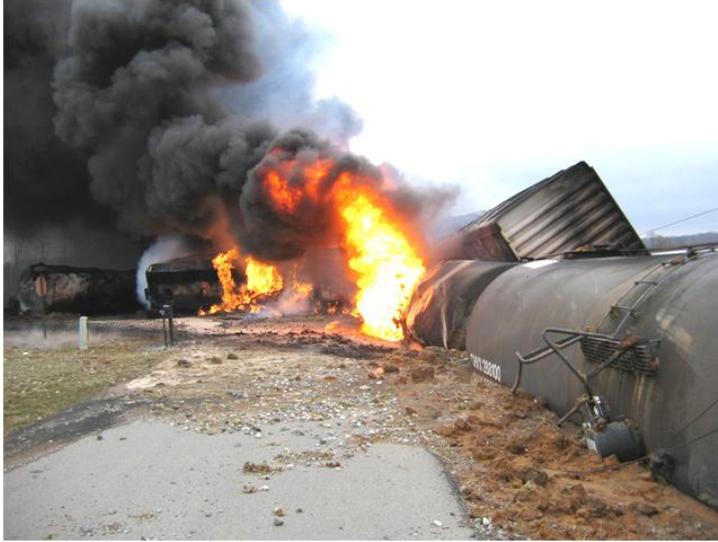
The 16th car, a hazardous materials car, bore into the mud adjacent to the mainline, leaving the top two-thirds of the tank exposed, but it did not breach. However, the 17th car, another hazardous materials car, breached and caught fire. The 18th car derailed upright and came to rest leaning against the 17th car and remained in the right of way. (See figure 2.)

**Figure 2.** Photo showing derailed cars 16, 17, and 18.

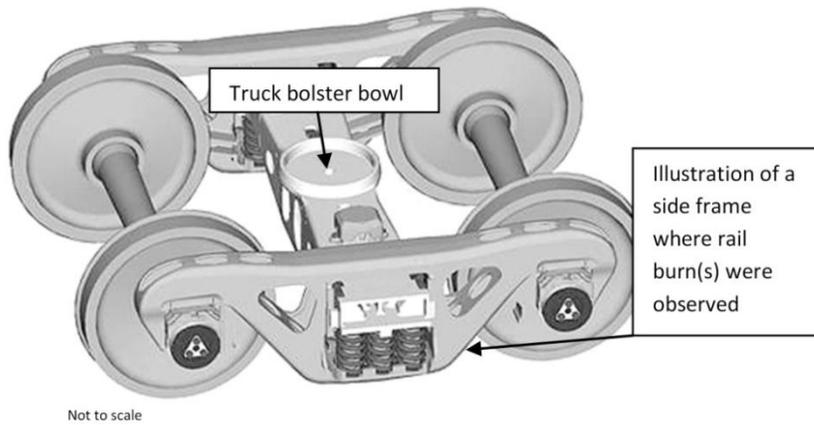
The rail burn was observed on the underside (bottom) of the side frame on the leading (B-end) truck of the 18th car. The trailing (A-end) truck side frame was split as a result of rail burn. The location of rail burns on both trucks was consistent with a northbound movement along the east rail. (See figures 3 and 4.)

**Figure 3.** Illustration of truck assembly with location of rail burn on both trucks on 18th car indicated.

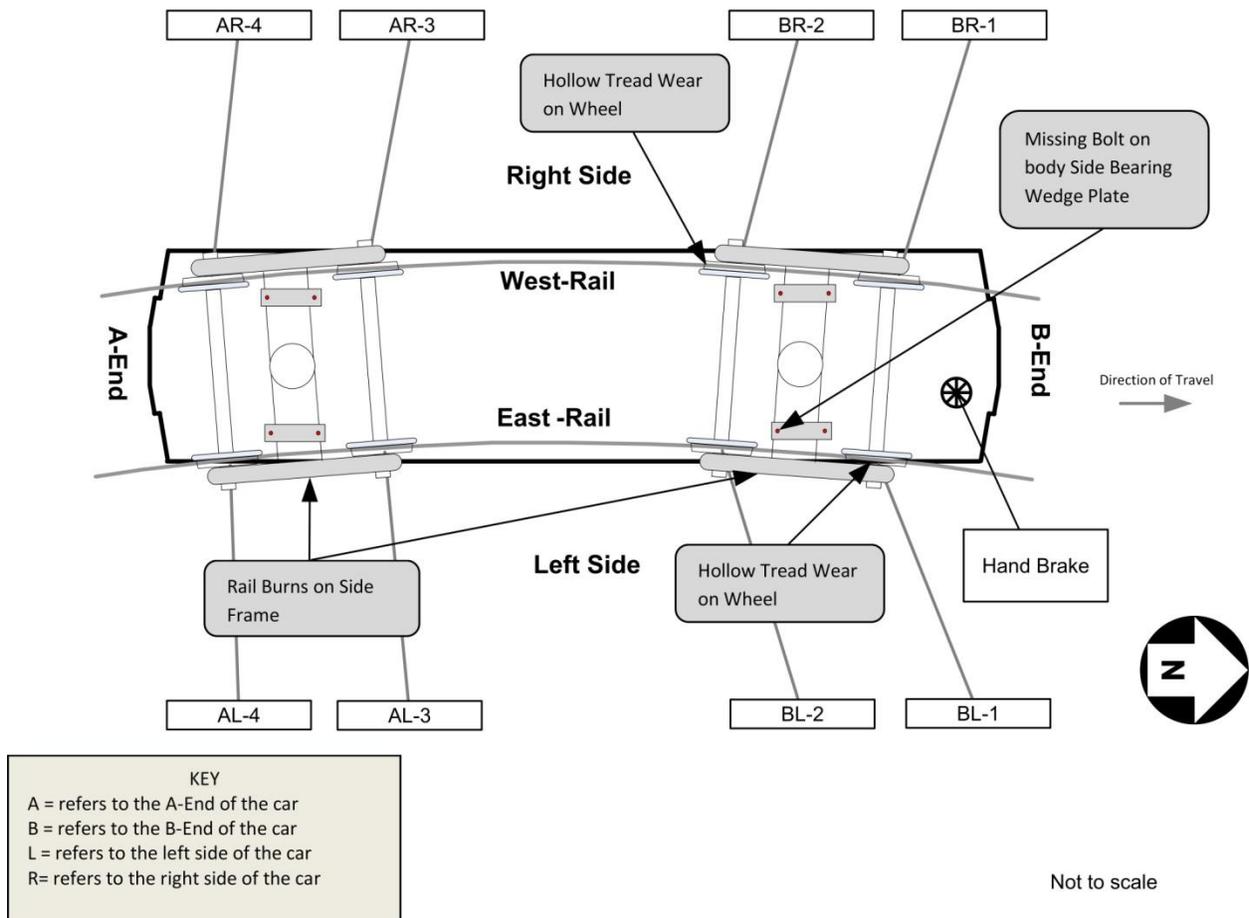
**Figure 4.** Illustration of car AN-5696, 18th car.

Wheels from the 18th car were recovered and examined. The BL-1 wheel exhibited hollow tread wear that exceeded Association of American Railroads (AAR) condemning limits. (See figure 4.) Hollow tread wear is defined as the vertical difference between the outside wheel radius and the midpoint of the tread as seen in figure 5. Title 49 CFR Part 215 contains no criteria for hollow tread wear.

One of two B-end body side bearing plate attachment bolts was found broken on the left side of the 18th car. (Refer to figure 4.) The broken bolt allowed the partially attached body side bearing wedge plate to rotate inward toward the center of the car. The bearing surface of the B-end left side wedge plate was heavily worn and damaged from contact with the side bearing roller. Side bearing clearance is specified by AAR rules<sup>6</sup> and must be maintained between a minimum of 3/16 inch and a maximum of 5/16 inch.

The B-end body side bearing plate attachment bolt found broken on the left side of the B-end of the 18th car allowed the partially attached body side bearing wedge plate to rotate inward toward the center of the car. The bearing surface of the B-end left side wedge plate was heavily worn and damaged from prior contact with the side bearing roller, strongly suggesting the condition was preexisting.

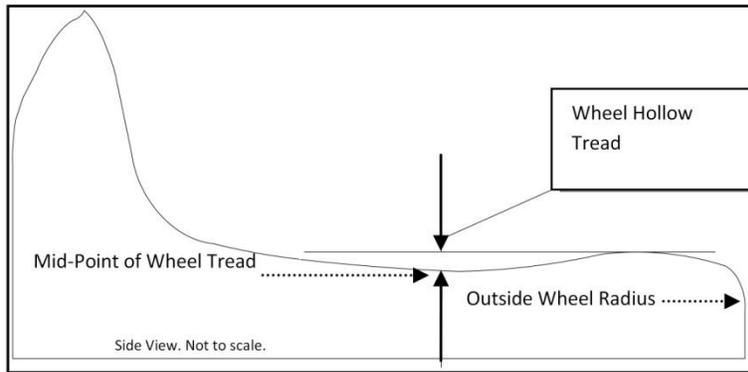
**Figure 5.** Illustration of hollow worn wheel profile.

Wheels recovered from the B-end truck of the 18th car were examined. The BL-1 wheel exhibited hollow tread wear that exceeded AAR condemning limits. The BL-1 wheel exhibited thin flange width and high vertical flange nearing the AAR condemning limits. The BR-2 wheel was also found to have hollow tread but did not exceed the AAR condemning limit.

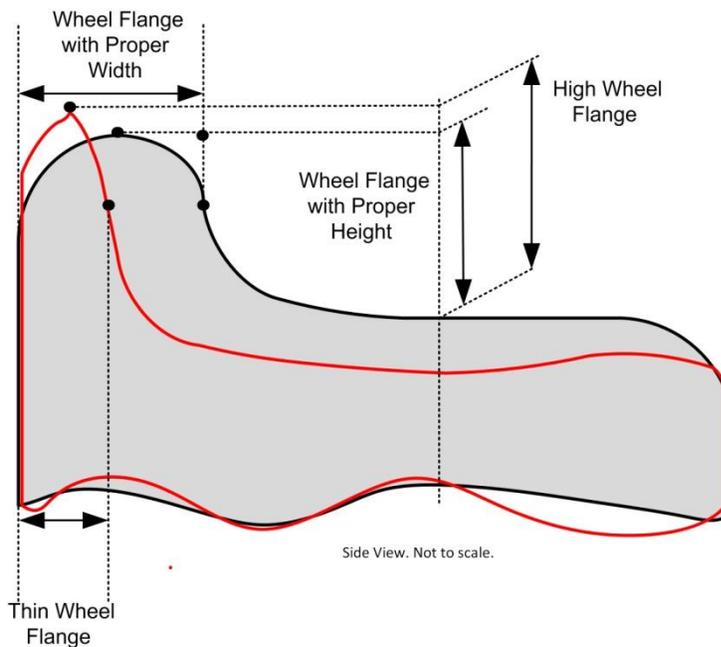
The BL-1 wheel also exhibited thin wheel flange width and high vertical flange nearing the AAR condemning limits. An example of a thin wheel flange and high wheel flange profile is illustrated against an unworn wheel profile in figure 6. The BR-2 wheel was also found to have hollow tread, but it did not exceed the AAR condemning limit. Title 49 CFR, Part 215 contains condemning criteria for thin wheel flanges, and the BL-1 flange was within the allowable limits.

**Figure 6.** Illustration of a thin flange wheel profile shown with an unworn profile.

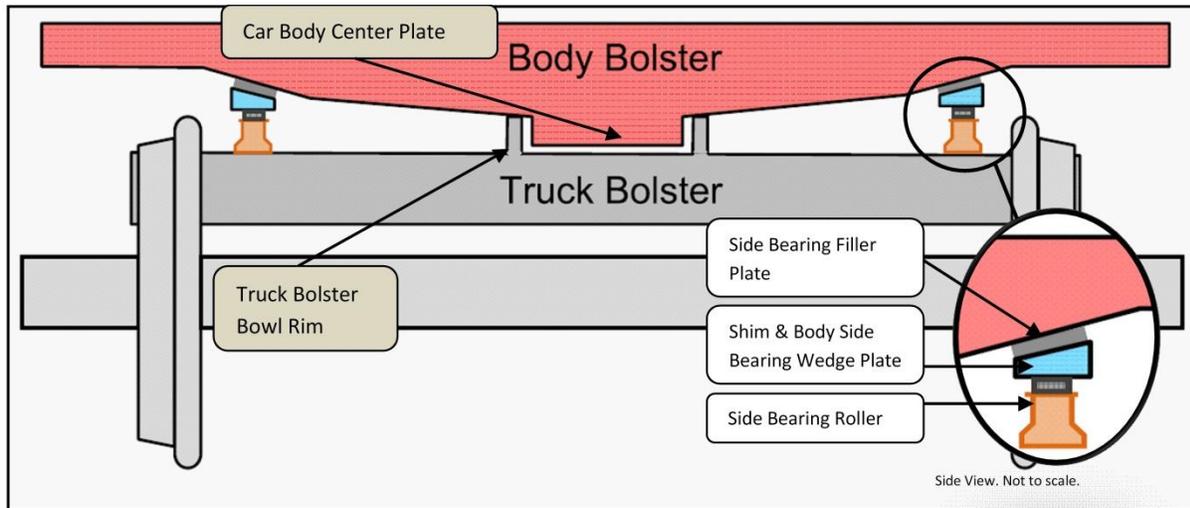
Inspection of the B-end truck assembly from the 18th car revealed engagement wear patterns on the truck bolster bowl rim. (See figure 7.<sup>5</sup>) The engagement wear patterns matched the carbody center plate wear patterns. AAR rules require a clearance of 1 1/16 inch be maintained. Postaccident wreckage of the B-end truck assembly precluded obtaining any clearance measurements during the on-scene portion of the accident.

**Figure 7.** Side view of car-body and truck connection.

The B-end truck assembly revealed engagement wear patterns on the truck bolster bowl rim. The engagement matched the engagement patterns on the B-end car-body center plate of the 18th car. Investigators determined this undesirable engagement could directly affect the steering performance of the B-end truck assembly.
