National Transportation Safety Board

Railroad Accident Brief

Accident No.: DCA-10-FR-005
Location: Miami, Florida
Date: July 20, 2010
Time: 5:39 p.m. eastern daylight time¹
Railroad: Miami-Dade Transit Metromover
Property Damage: \$406,691
Fatalities: 0
Injuries: 16 minor
Type of Accident: Collision between two Metromover cars

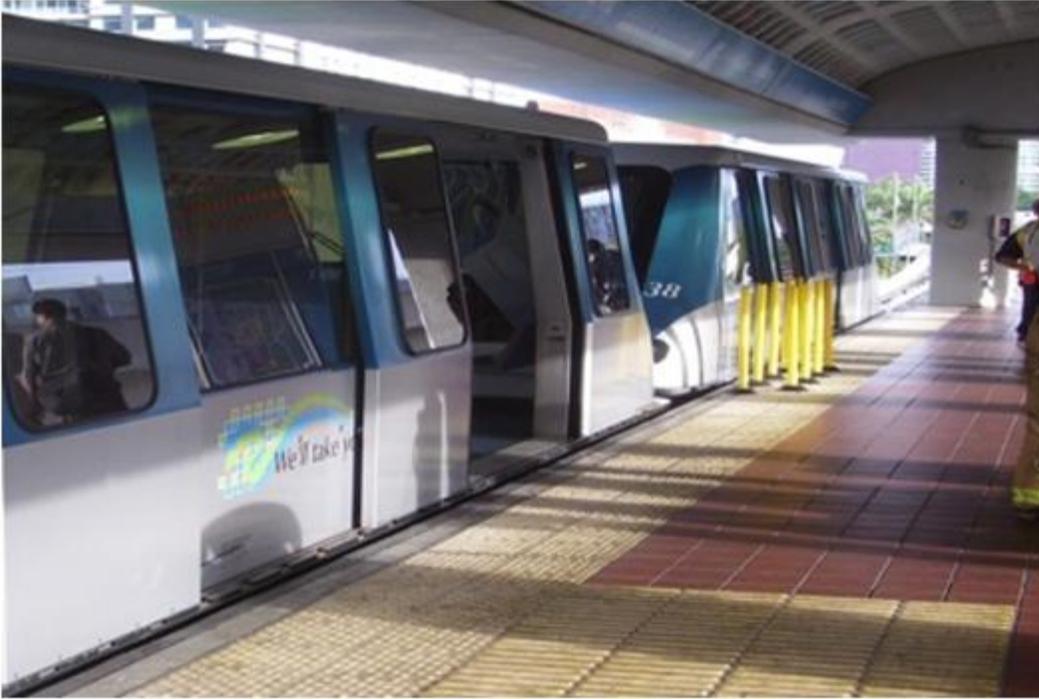
Figure 2. Photograph of Metromover No. 32 (lower left/foreground) and Metromover No. 38 (upper right/ background) at Brickell Station following the accident.

At 5:39 p.m., Metromover No. 38 entered Brickell Station, where it collided with the trailing end of standing Metromover No. 32. The doors on both trains opened, and the passengers exited the APMs. The collision damaged the couplers of both Metromovers; however, the car bodies of the Metromovers were not damaged.

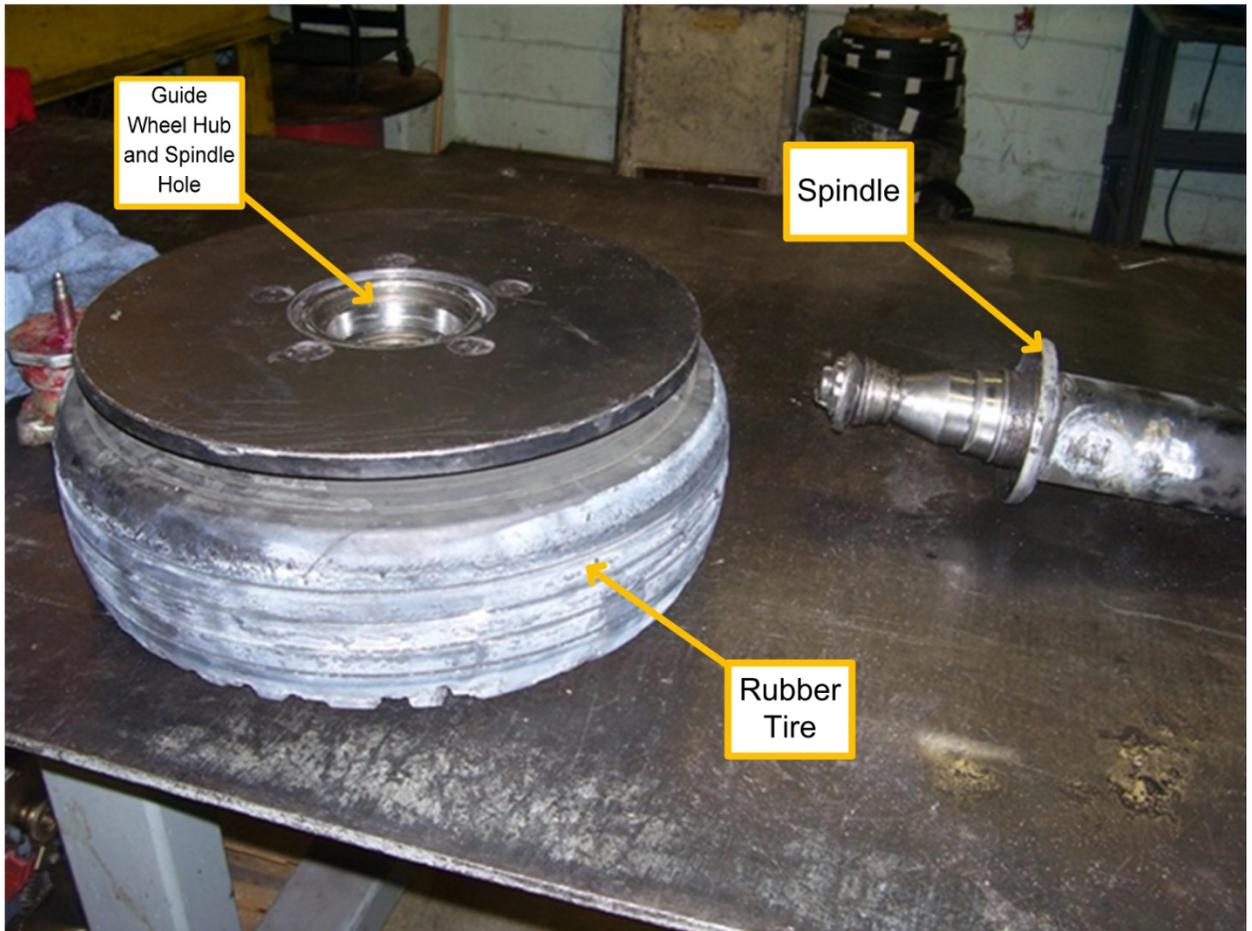
The guide wheel hub and tire, along with some internal components, were recovered from the right-of-way near Knight Center Station, on the downtown loop. The guide wheel hub and tire were intact but damaged (see figure 3).

Figure 3. Photograph of the guide wheel of Metromover No. 35.

The spindle hole of the guide wheel hub had increased due to excessive wear, which allowed the guide wheel hub and tire to separate from the Metromover. Additionally, the guide wheel spindle bearing failed. Upon inspection, no lubrication was found in the spindle bearing or in the spindle hole. Further inspection revealed a fracture around the entire circumference of the guide wheel hub. The fracture surface did not show signs of abrasion. Independent laboratory testing confirmed that the hub material did not meet specifications.

This guide wheel hub failure is consistent with that of another guide wheel hub that failed on another MDT Metromover in April 2010, which was discovered during a daily inspection. Subsequent to the July 20, 2010, accident, Bombardier disclosed that the hub that had failed in April 2010 had been subjected to outside laboratory examination and also did not meet Bombardier specifications.

- MDT no longer uses two-piece hubs on the Metromover vehicle guide wheel assemblies. According to MDT, all Metromovers have been equipped with guide wheel assemblies that have a one-piece hub design. After cars have been in service for a minimum of 5 hours, MDT technicians take daily temperature readings of the guide wheel hub bearings to detect overheating.
