National Transportation Safety Board

Railroad Accident Brief

Accident No.: DCA-12-FR-003
Location: Amarillo, Texas
Date: January 9, 2012
Time: 11:09 a.m. central standard time
Railroad: BNSF Railway
Property Damage: \$150
Injuries: 0
Fatalities: 1
Type of Accident: Employee struck by moving equipment

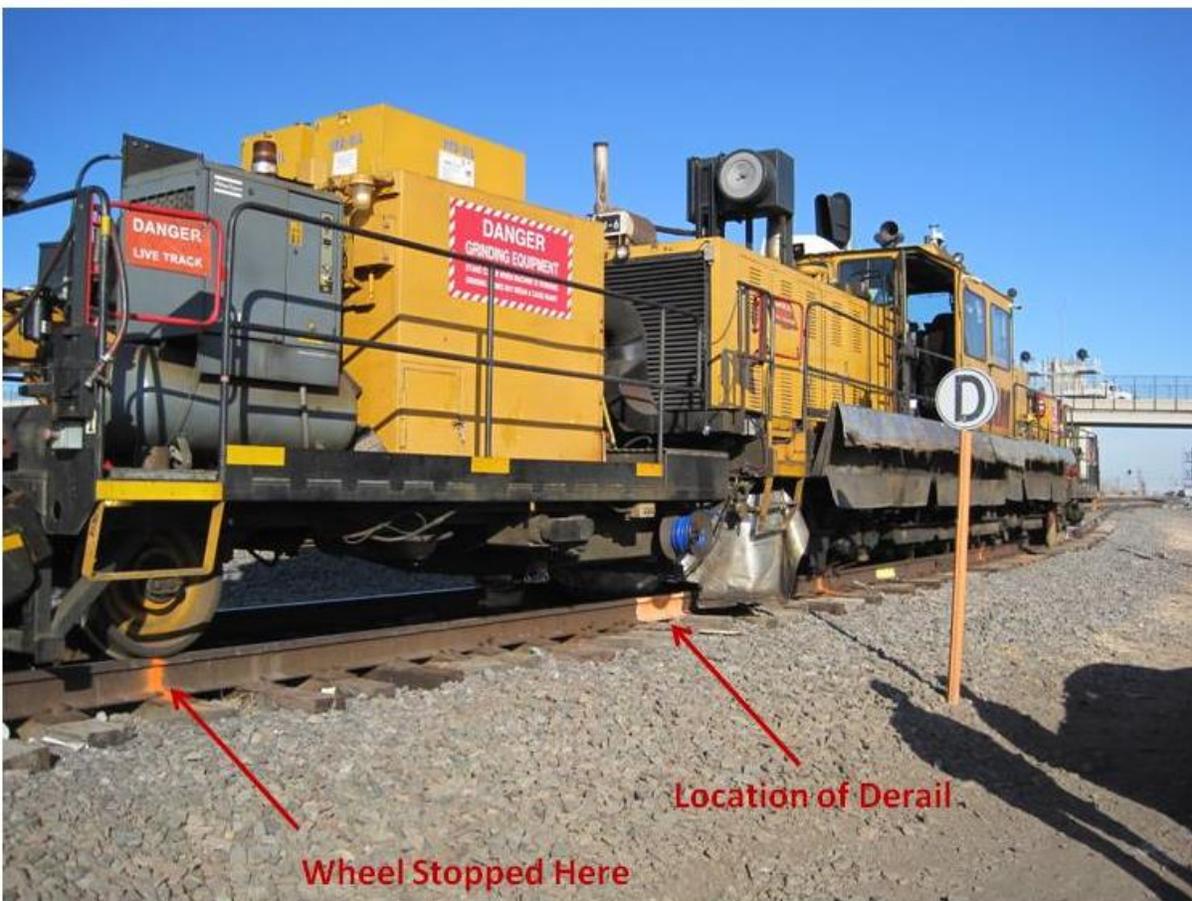
Figure 1. Side view of the Loram J6 rail grinding machine.

- Fixed position color travel cameras at either end of the machine. The travel camera field of view (FOV) will overlap the sequence camera FOV. An additional monitor was installed at the operator console dedicated to the travel cameras.
- An "Alert" horn button tied into the machine travel horn circuit in series with the units mounted at the four-corner ladders.
- A "Machine Stop" button for use by the point person. (Tests have shown 100-foot stopping distance at 10 mph and 12 feet at 3 mph.)

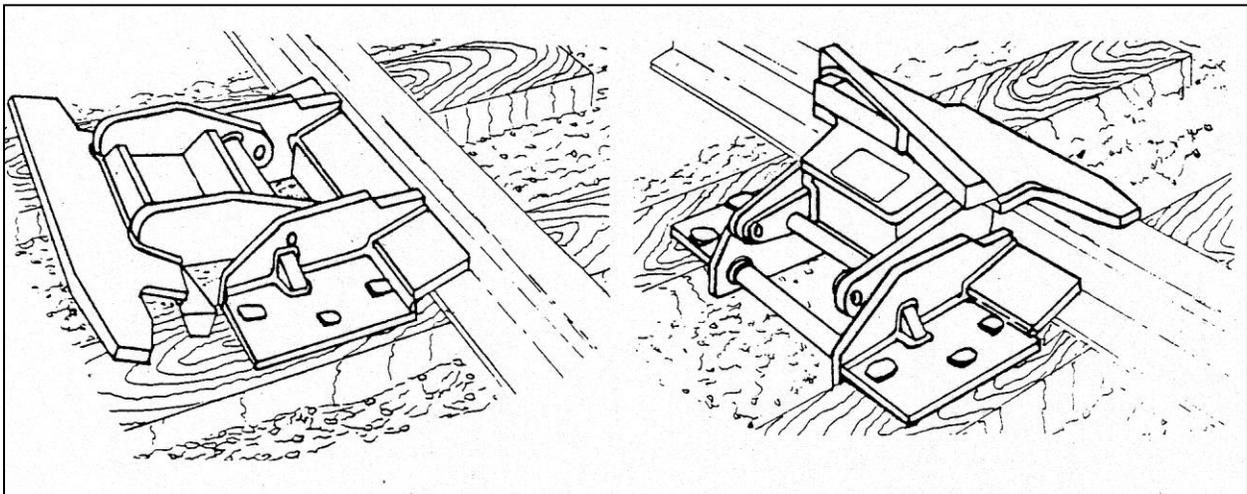
Figure 2. Hinged derail: Left: Off the rail, Right: On the rail.

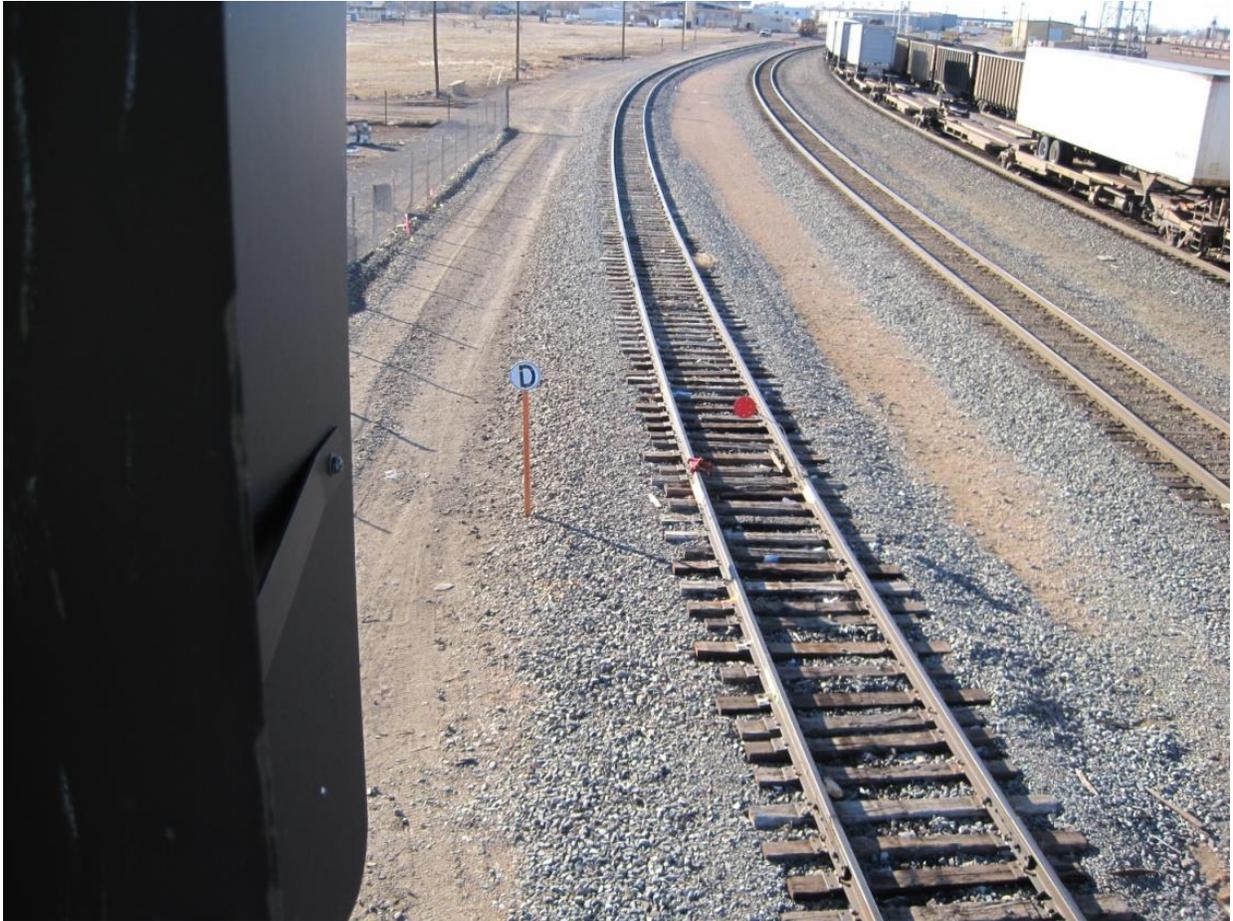
Figure 3. Overhead view facing west of track No. 1805 with derail opposite signpost D.

After the equipment stopped,⁸ the welding foreman restored the derail to the derailing “on” position and secured the derail with its lock. He then walked to the control cab to tell the machine operator he had noticed a hydraulic leak as the grinding machine passed him. The welding foreman, the machine operator, and the Loram laborer evaluated the leak and determined they needed to move the equipment back into the yard to make the necessary repairs, because the leak was too severe to continue to the work location. The operator told investigators that he and the welding foreman decided that the derail would have to be removed to allow for the reverse movement. The operator also said that he and the welding foreman had walked together to the cab of the grinding machine, and then he had climbed into the cab. The operator said that shortly after he entered the cab, the welding foreman gave him a hand signal to make a westbound (that is, a reverse) movement.
