# National Transportation Safety Board

## Railroad Accident Brief

**Accident No.:** DCA-13-FR-001  
**Location:** Niles, Michigan  
**Date:** October 21, 2012  
**Time:** 10:10 a.m. eastern daylight time<sup>1</sup>  
**Train:** Amtrak (National Railroad Passenger Corporation) train 350  
**Property Damage:** \$400,000  
**Fatalities:** 0  
**Injuries:** 13  
**Type of Accident:** Derailment

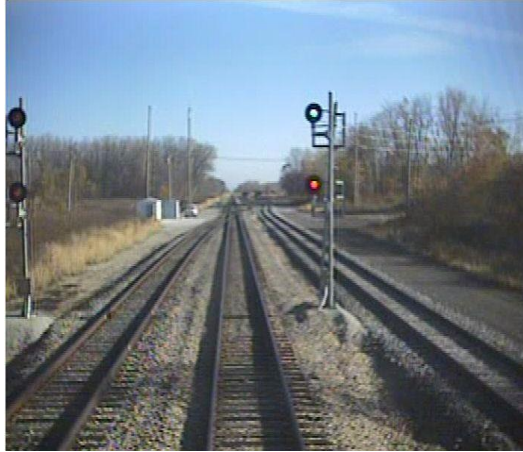
**Figure 1.** Train 350 outward-facing video screen shot showing clear signal at CP 190.

The outward-facing video recorder on board the locomotive was downloaded and reviewed. The video indicated that Amtrak 350 was operating on a clear signal as it was approaching CP 190. The video also showed that CP 190 switch #2 was aligned reverse (toward the yard).

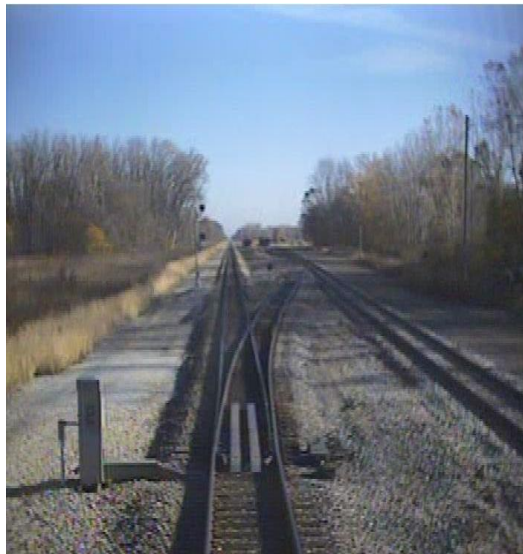
**Figure 2.** Train 350 outward-facing video screen shot showing reversed switch #2 at CP 190.

The inspection of the wayside equipment found all signal units and cases secured with no evidence of vandalism. Inspection and tests of the #2 power-operated switch machine determined the switch point detector was latched out.<sup>12</sup> The switch point detector latched out when the train director attempted to align the switch to the reverse position for the track maintenance crew earlier on the day of the derailment. With the switch machine point detector latched out, the train director received an out-of-correspondence indication for that switch.

The National Transportation Safety Board determines that the probable cause of the accident was the unauthorized use of a jumper wire that provided a false proceed signal with a mainline switch lined to Niles Yard. The use of the jumper wire was inconsistent with Amtrak procedures for using jumper wires to override signal and train control safety-critical circuits. Contributing to the accident was the inadequate oversight by Amtrak management to ensure proper jumper wire safeguards were employed.
