National Transportation Safety Board

Railroad Accident Brief

Accident No.: DCA-12-FR-004
Location: Madison, Illinois
Date: February 28, 2012
Time: 11:57 a.m. central standard time¹
Railroad: Amtrak (National Railroad Passenger Corporation)
Vehicle: 2007 Pontiac Grand Prix four-door sedan
Property Damage: \$3,794
Fatalities: 1
Injuries: None
Type of Accident: Highway-rail grade crossing collision

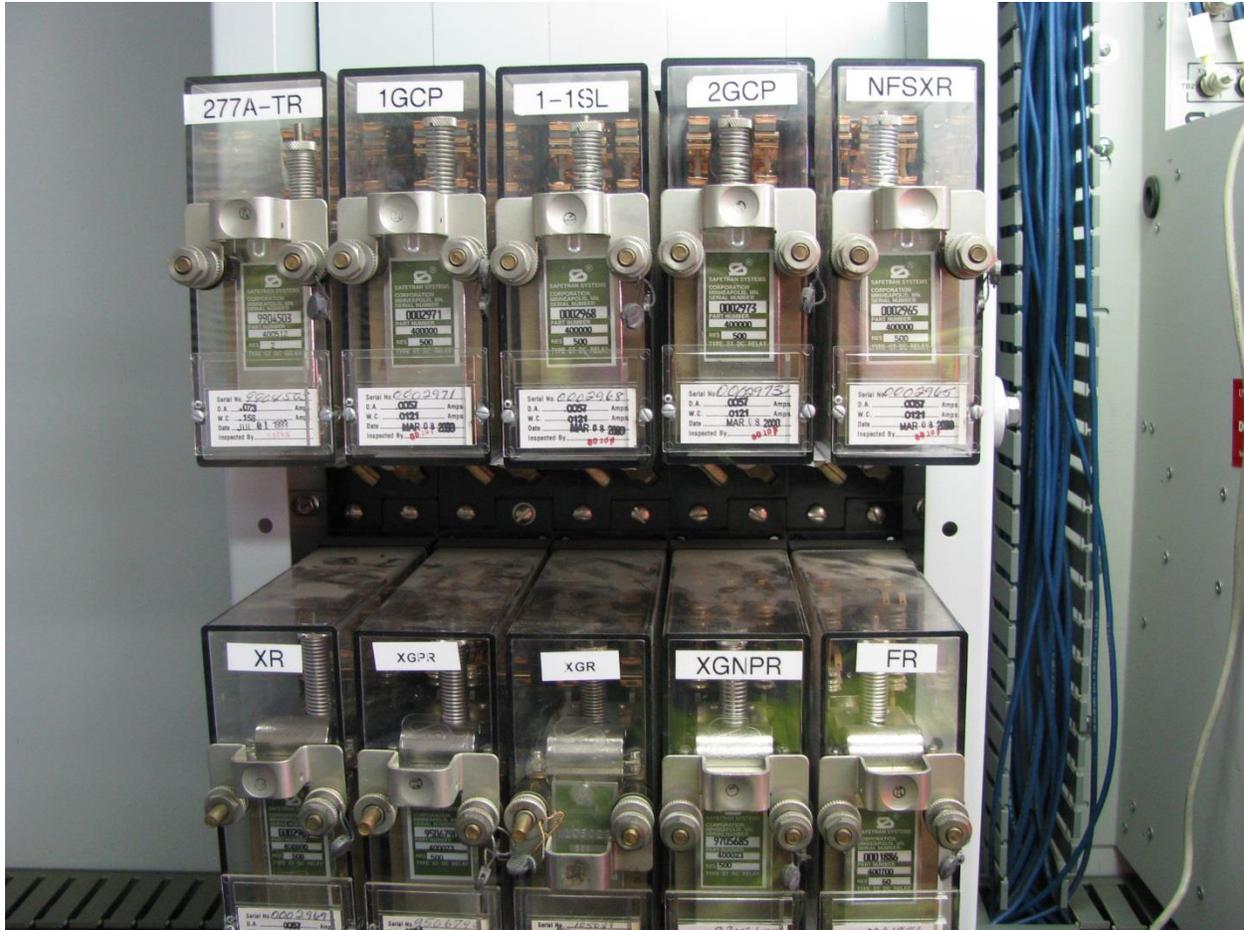
Field inspection and visual examination of the relays (see figure 2) used by the crossing warning system determined that three relays (1GCP, 2GCP, and NFSXR) exhibited damage on two of the contacts (12 and 13). NTSB investigators took custody of the three damaged relays and one undamaged relay and submitted them to the NTSB Materials Laboratory for further examination.

The NTSB Materials Laboratory examination identified metallic splatter and thermal-related discoloration on the armature of the three relays. The plastic cases for the relays had consistent sooting¹⁵ patterns on the case walls nearest to the damaged contacts. The three relays also exhibited arc damage on the contacts. The remaining relay contacts showed signs of thermal damage in the form of discolored and sooted areas around the tip of the contact, as well as discoloration of the support springs. There was also evidence of slight surface wear on the undamaged contacts.

The NTSB Materials Laboratory determined that the presence of splatter, discoloration, and sooting was indicative of an electrical arcing event. The evidence of material transfer on the rear left contact for relay 2GCP was also indicative of an electrical arcing event where the contacts were closed during the event. Laboratory staff could not determine if the contact surfaces had been fused at the time of the accident.

Figure 2. Relay rack in UP signal bungalow at Bissell Street crossing

The NTSB Materials Laboratory was unable to determine whether the arcing damage on the contacts of the three relays was preexisting damage or the result of using a jumper wire. Although the technician and the inspector told NTSB investigators that they did not use a jumper wire, the following additional investigative information collectively indicates that either the technician or the inspector likely used a jumper wire to falsely energize the relay, thereby disabling the Bissell Street crossing warning system:
