National Transportation Safety Board

Railroad Accident Brief

Angels Flight Railway Derailment

Accident No.:	DCA13FR011
Location:	Los Angeles, California
Date:	September 5, 2013
Time:	11:30 a.m. pacific daylight time
Railroad:	Angels Flight Railway Foundation
Property Damage:	\$6,000
Injuries:	None
Fatalities:	None
Type of Accident:	Derailment

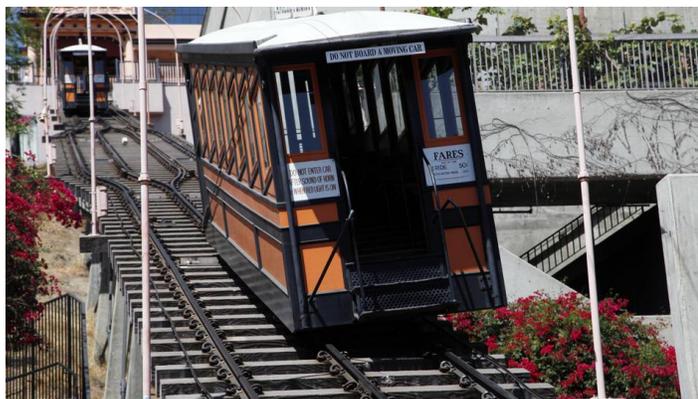
On September 5, 2013, about 11:30 a.m. pacific daylight time, an Angels Flight Railway (Angels Flight) car that was moving down the incline derailed near the middle of the guideway.¹ One passenger was on board the derailed car, and five passengers were on board the stalled car that had been moving up the incline. The temperature was 93°F, and the weather was clear. No passengers were injured.

When the operator of the Angels Flight cars recognized that a car had stopped on the incline, he initiated a command to return each car to its respective destination gate. The operator told an NTSB investigator that he was unaware of the derailment. Both cars moved about 100 feet and stopped; neither car reached a gate. Then, the operator reversed the direction of the cars in an attempt to reposition each car at its starting gate. The derailed car moved uphill and stopped. At this time, the operator recognized that the car had derailed. (See figure 1.)

Figure 1. Derailed Angels Flight car.

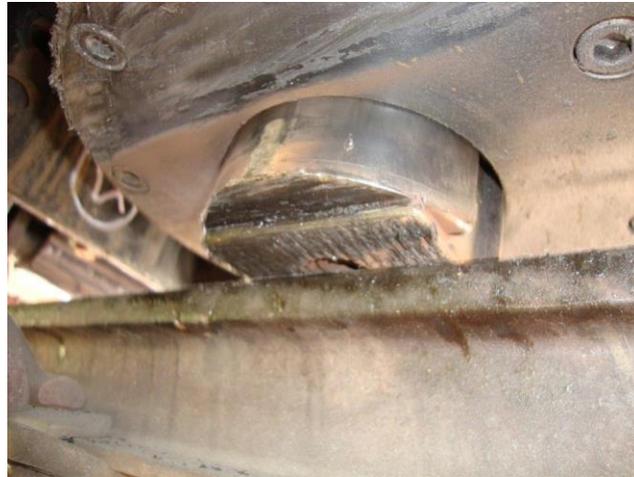
Angels Flight reopened on March 15, 2010. At that time, a safety redesign had been implemented: a track brake was mounted on each car. Electrical power to the track brake system was provided from a third-rail parallel to the guideway, and a set of batteries was installed on each car to provide backup power. Electrical grounding for the track brake system was provided by a car-mounted wire brush that contacted a wheel. The track brakes were designed to be tested only when the cars were stopped. (See figure 2.)

Figure 2. Track brake ram head in contact with the rail head.

During the postaccident investigation it was apparent that the existing track brakes were not an efficient method of redundant braking. The ram heads on both cars that contact their respective rails showed evidence of prolonged wear. According to the brake design engineer, this situation should not have occurred since the track brake should have only deployed in a static mode during routine testing and dynamically during an actual emergency. Angels Flight managers repeatedly stated they were unaware that track brakes had been deployed prior to the September 5, 2013, accident.

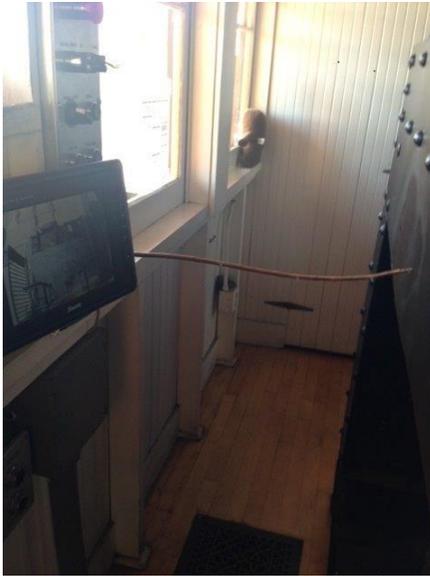
Angels Flight personnel said that the cars had experienced undesired stops for some time. When these undesired stops occurred, the operator was required to depress and hold the start (that is, the run) button on the control panel. This action allowed the operator to move the cars in a manual operation. Typically, each car was moved by operator to its destination gate. The frequency of the undesired stops had increased over time. During the days prior to the accident, the stops could occur multiple times on a single trip. The operators used a small stick (that is, a branch from a nearby tree) to constantly depress the start button. (See figures 3 and 4.) The operator said that he was using the stick at the time of the derailment. The operator also said that Angels Flight management was aware of the stick, which could be readily seen in the station house controls.

When the operator saw the cars stop because of the derailment, he mistakenly believed it was just another undesired stop. Consequently, he started to manually move each car to its destination gate. The operator was able to move the cars until the force on the rope surpassed the threshold of the drive-system limiting switch. With the stick wedged in place, the safety systems were negated.

Figure 3. Wedged tree limb.

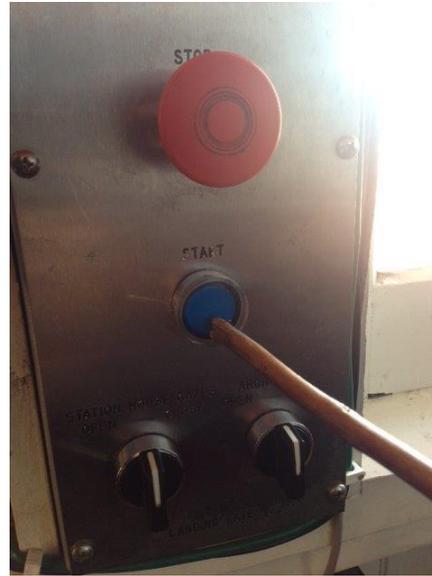
Figure 4. Start button with wedged tree limb.
