National Transportation Safety Board

Railroad Accident Brief

Union Pacific Railroad Employee Fatality

Accident No.:	DCA13FR012
Location:	Mathis, Texas
Date:	September 4, 2013
Time:	4:15 p.m. central daylight time ¹
Railroad:	Union Pacific Railroad
Property Damage:	None
Injuries:	1
Fatalities:	1
Type of Accident:	Employee fatality

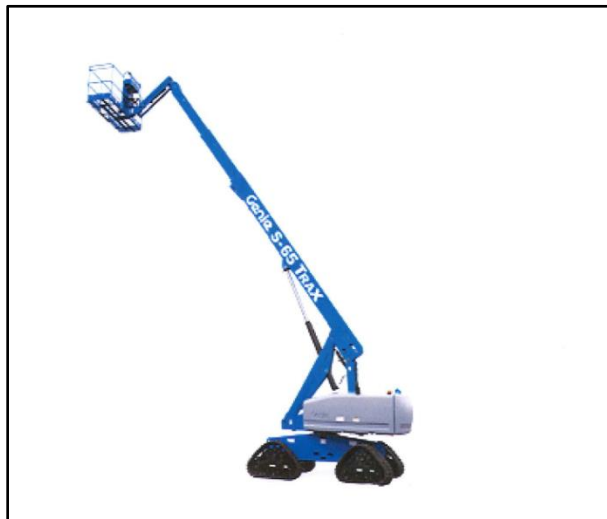
Figure 1. Exemplar S-60 Trax aerial lift vehicle.

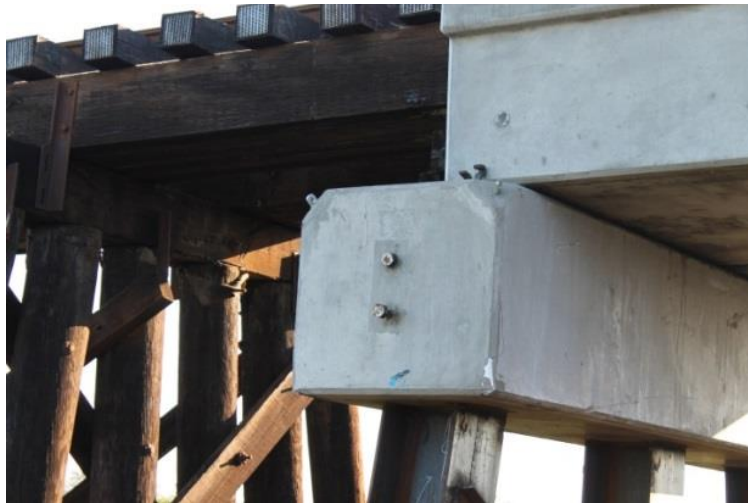
While a UP welder was repairing a railroad bridge from the lift bucket of an S-60 Trax aerial lift vehicle, the lift bucket became stuck on two cap bolts in a concrete girder. (See Figure 2.) After several attempts, he was unable to free the lift bucket. Two UP welders, who were working directly above the welder, saw that the lift bucket was stuck. To offer assistance, one of these welders unhooked his fall-arrest system and climbed from the bridge into the lift bucket. This welder did not re-secure himself to the fall-arrest system once he was in the lift bucket.

Figure 2. Cap bolts that restricted the movement of the aerial lift bucket.

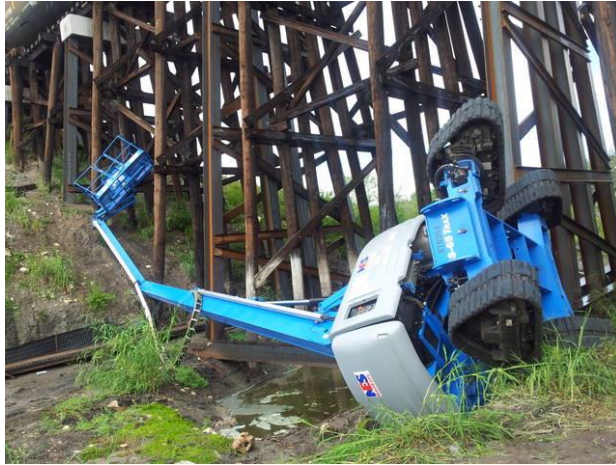
After about 5 minutes of operating the controls of the lift, the unsecured welder freed the bucket. Upon being freed, the lift bucket suddenly dropped about 3 feet, and then it sprung upward. As a result of this sudden movement, the unsecured welder was ejected from the lift bucket; he fell about 30 feet to the ground. He was transported to the Corpus Christi Memorial Hospital in Corpus Christi, Texas. He had a dislocated hip, a broken leg, and a collapsed lung. As the lift fell to the ground, it hit several bridge supports. (See Figure 3.) The welder, who was in the bucket when it struck the ground, was killed.

Figure 3. The overturned S-60 Trax aerial lift vehicle.

The National Transportation Safety Board determines that the probable cause of the accident was the welders’ attempt to free the snagged aerial lift bucket from within the bucket, in lieu of evacuating the bucket and using the ground controls.
