National Transportation Safety Board

Railroad Accident Brief

Collision between Two Freight Trains, Barton County, Missouri, July 21, 2012

Accident No.:	DCA12FR007
Location:	Barton County, Missouri
Date:	July 21, 2012
Time:	3:30 p.m. central daylight time
Trains:	Kansas City Southern Railway Company train QSHKC20 and BNSF Railway train EMHSEBM088
Railroads:	Kansas City Southern Railway Company and BNSF Railway
Property Damage:	\$7.75 million
Injuries:	2
Fatalities:	0
Type of Accident:	Side Collision

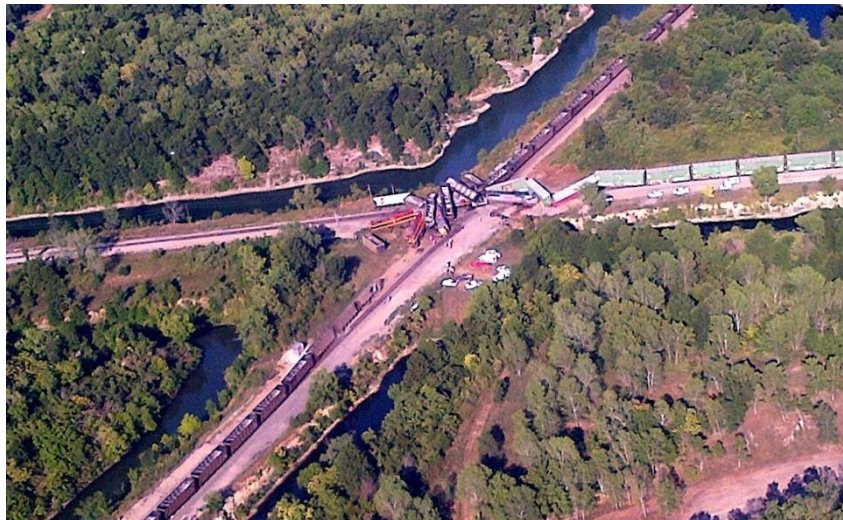
On July 21, 2012, about 3:30 p.m. central daylight time, Kansas City Southern Railway Company (KCS) freight train QSHKC20 collided with the side of BNSF Railway (BNSF) freight train EMHSEBM088 at a railroad crossing near Arcadia, Kansas.^{1,2} Figure 1 shows the accident site.

Figure 1. The accident site.

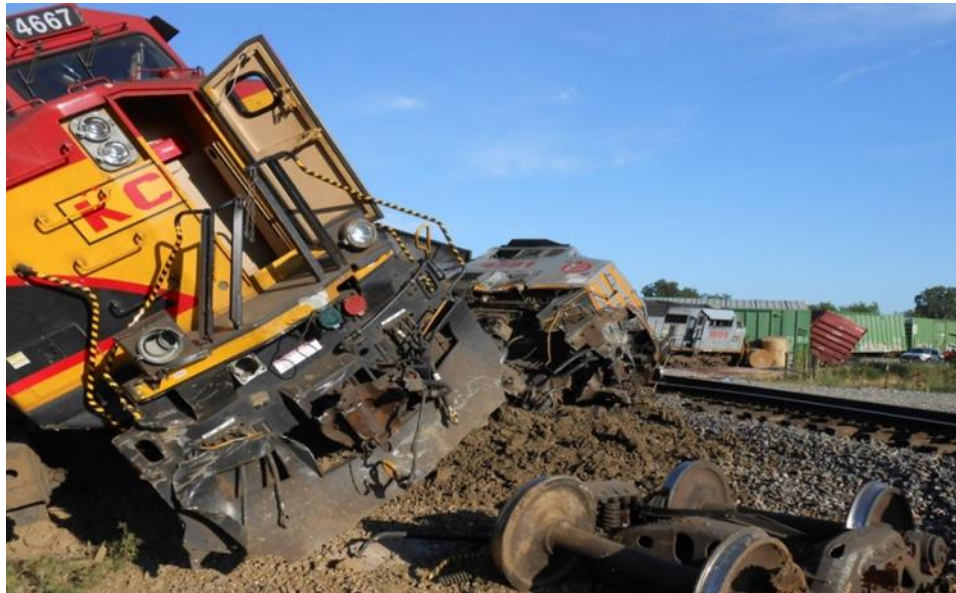
At the time of the collision, the BNSF train was traveling about 35 mph and the KCS train was traveling about 31 mph. The temperature at the time of the accident was 92°F and the weather was clear. Figure 2 shows the wreckage.

Figure 2. The accident wreckage.

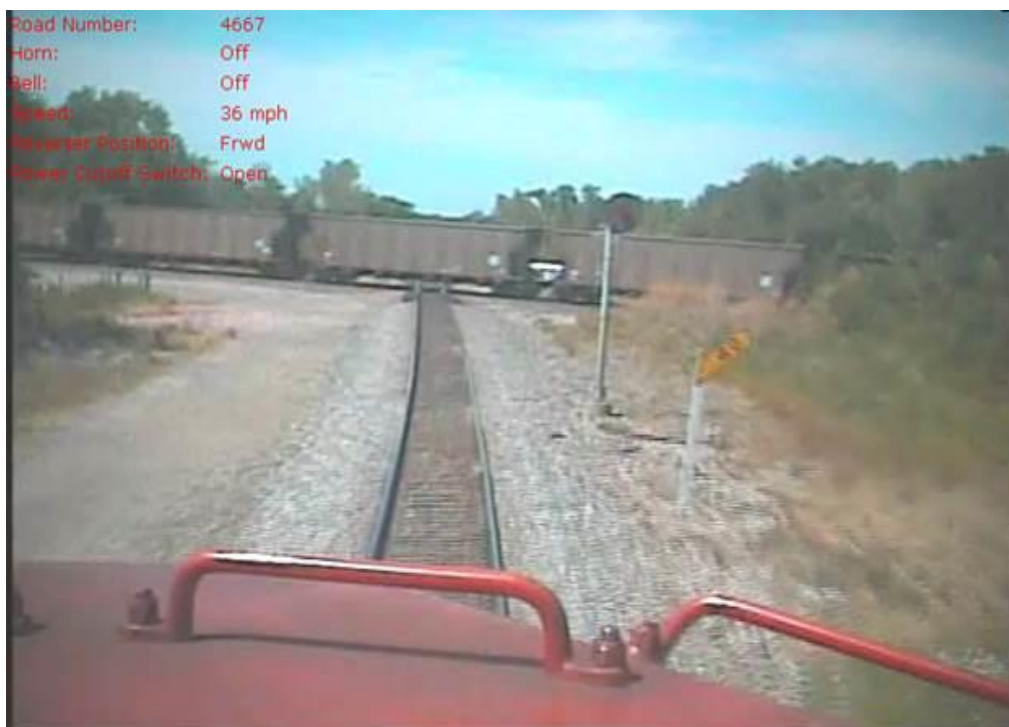
About one-half mile farther north, the crew of the KCS train saw that the signal controlling movement over the railroad crossing displayed a red (stop) signal aspect. Immediately after recognizing the red signal, the KCS train crew saw the BNSF train pass through the railroad crossing and the KCS engineer placed the train air brakes into an emergency air brake application. Both KCS crewmembers exited the lead locomotive control cab and jumped from the train prior to the collision, receiving minor injuries. Figure 3 shows the view from the forward-facing video camera of the KCS train immediately prior to impact.

Figure 3. View from forward-facing video camera of KCS train.

NTSB investigators determined that the KCS train was traveling about 42 mph when the emergency air brake application was made, and collided with the BNSF train at a speed of 31 mph.
