# National Transportation Safety Board

## Railroad Accident Brief

### Norfolk Southern Railway Company Train Derailment and Hazardous Materials Release

<b>Accident No.:</b>	DCA12MR006
<b>Location:</b>	Columbus, Ohio
<b>Date:</b>	July 11, 2012
<b>Time:</b>	2:03 a.m. eastern daylight time
<b>Railroad:</b>	Norfolk Southern Railway Company
<b>Property Damage:</b>	\$1.2 million
<b>Injuries:</b>	1
<b>Fatalities:</b>	0
<b>Type of Accident:</b>	Train derailment (hazardous materials release)

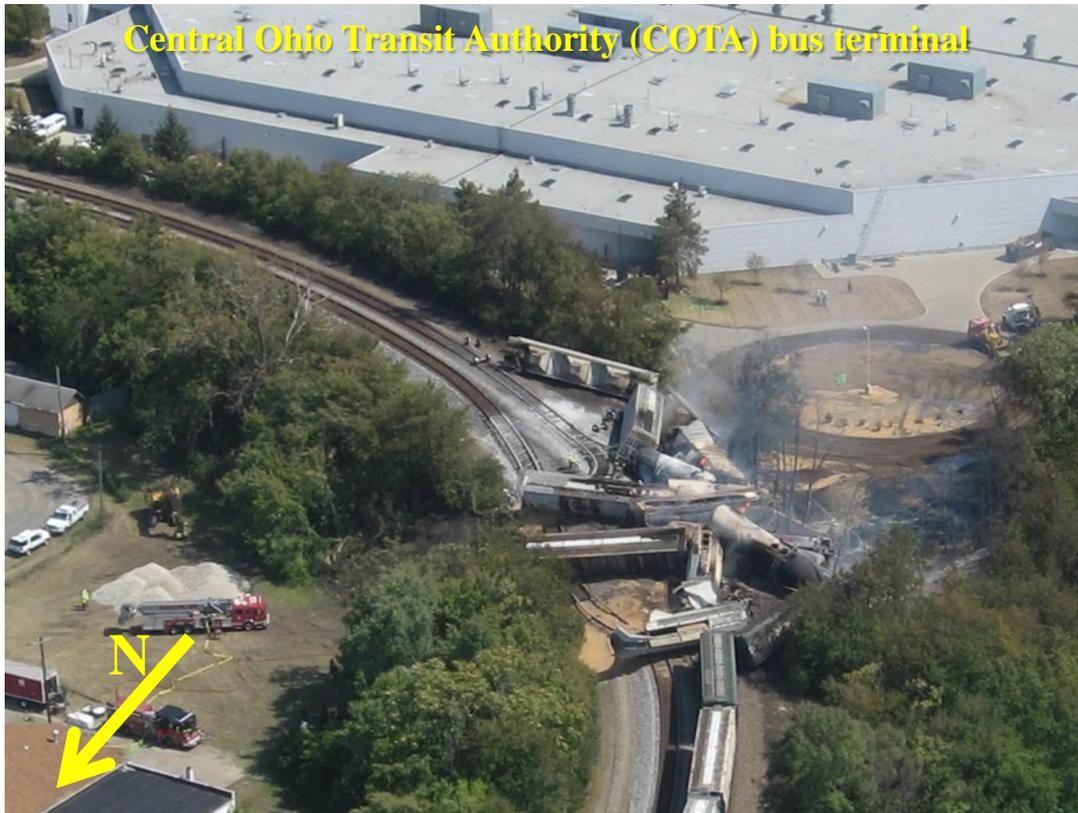
car fueled a large pool fire. The two other tank cars that were carrying denatured ethanol were engulfed in the pool fire and split open. Witnesses observed multiple energetic fire eruptions when these two tank cars ruptured. (See figure 1 for an overview of the accident scene.)

**Figure 1.** Aerial photograph of the derailment. (Photo by Columbus Police Department)

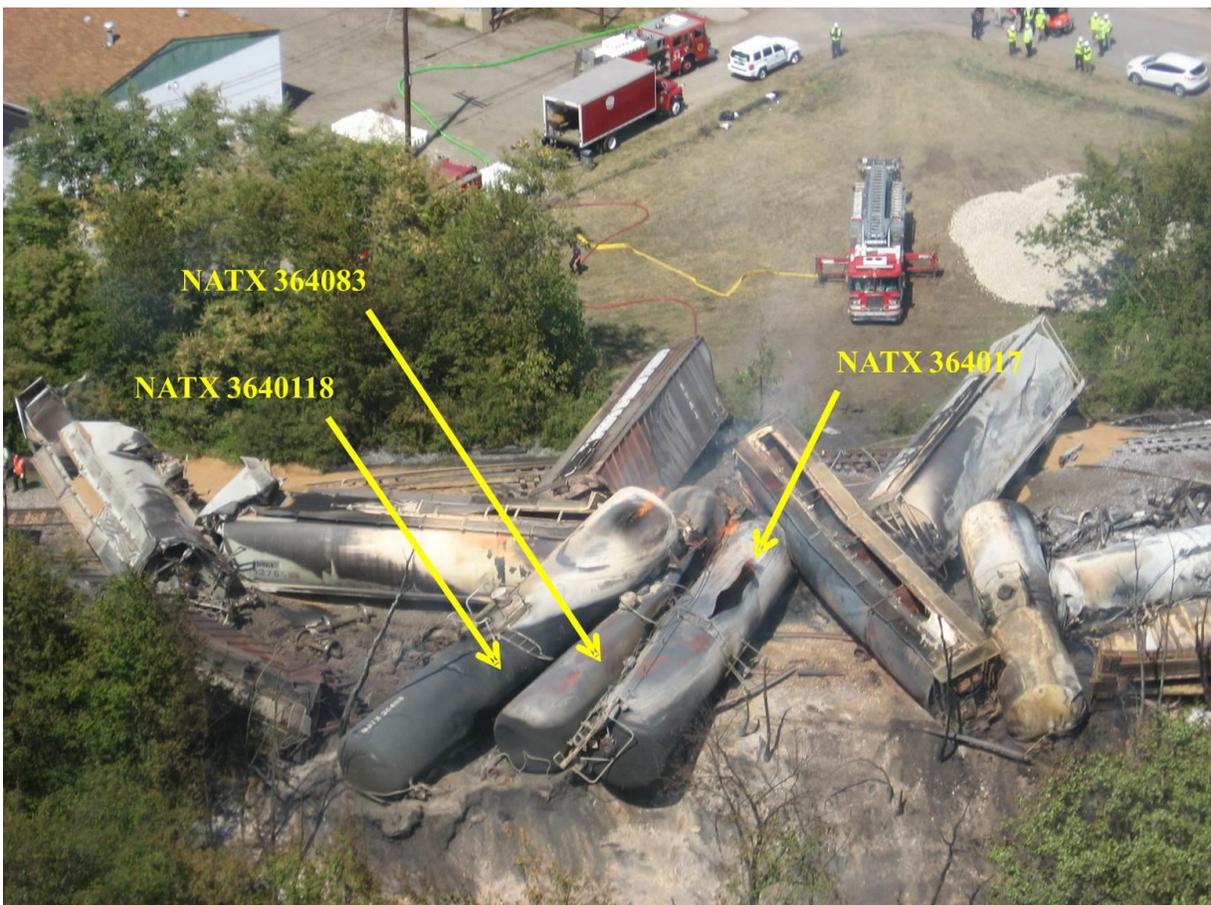
The locomotives and the first two cars in the train did not derail. The third car derailed one axle. The 4th through the 19th cars derailed and overturned. Tank cars 12 through 14, which were general service specification (DOT-111A-100W1 [DOT-111]) tank cars, contained denatured ethanol. These three tank cars were identified as NATX 364017, NATX 364083, and NATX 364118. Tank car NATX 364083 was breached during the derailment, and its cargo caught on fire. The other two tank cars, NATX 364017 and NATX 364118, eventually experienced thermal tears resulting from exposure to the pool fire that resulted from the breach of tank car NATX 364083. (See figure 3.)

**Figure 3.** Derailed tank cars exhibiting breach and thermal tears. (Photo by Columbus Police Department)

Inspection of tank car NATX 364083 indicated that it was punctured by a coupler or an object on an adjacent tank car. Tank car NATX 364118 exhibited a tear in the top longitudinal weld metal of a shell ring, and tank car NATX 364017 exhibited a longitudinal tear through three shell rings. The NTSB Materials Laboratory found that the tank wall thickness of NATX 364118 in the area of the longitudinal fracture was reduced and contained an outward bulge deformation consistent with release of internal pressure. Investigators found no evidence of a preexisting crack on the fracture faces of the tank car, and the welds showed no evidence of anomalies (such as weld defects).
