# National Transportation Safety Board

## Railroad Accident Brief

### Metro-North Railroad Derailment

| <b>Accident No.:</b> | DCA13FR009 |

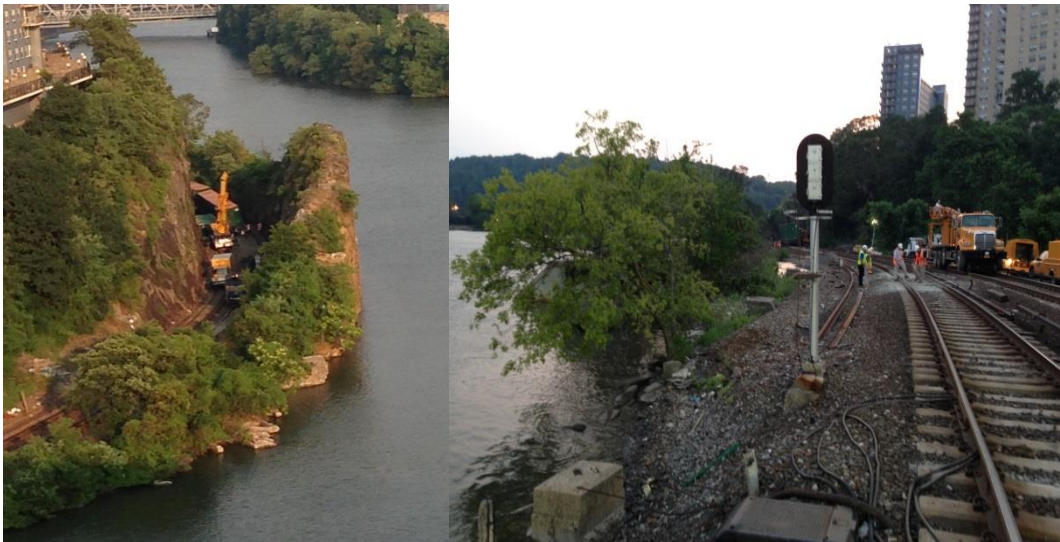
The CSX engineer said he immediately applied the full service air brake and shortly thereafter the train went into emergency braking. He said that he immediately made an emergency radio transmission. Upon making a walking inspection, the conductor determined that the 11th through the 20th cars had derailed on main track 2 and that derailed equipment was blocking main track 1. (See figure 1.)

**Figure 1. Derailed cars in cut (left). Point of derailment area (right).**

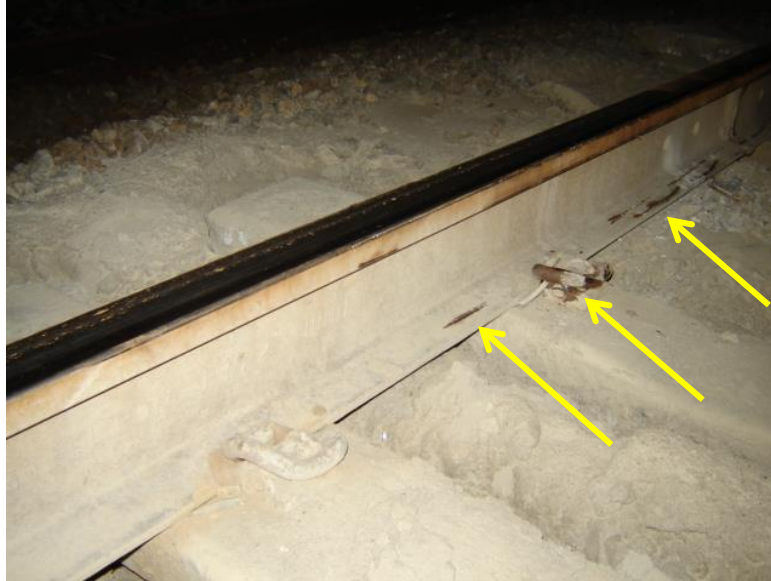
The POD was determined by a wheel flange mark on the inside base of the west (low) rail at MP 9.99 (72 feet 10 1/4 inches north of CP 10). (See figures 2 and 3.)

**Figure 2. Marks on gage side of base of low rail at point of derailment highlighted by arrows.**

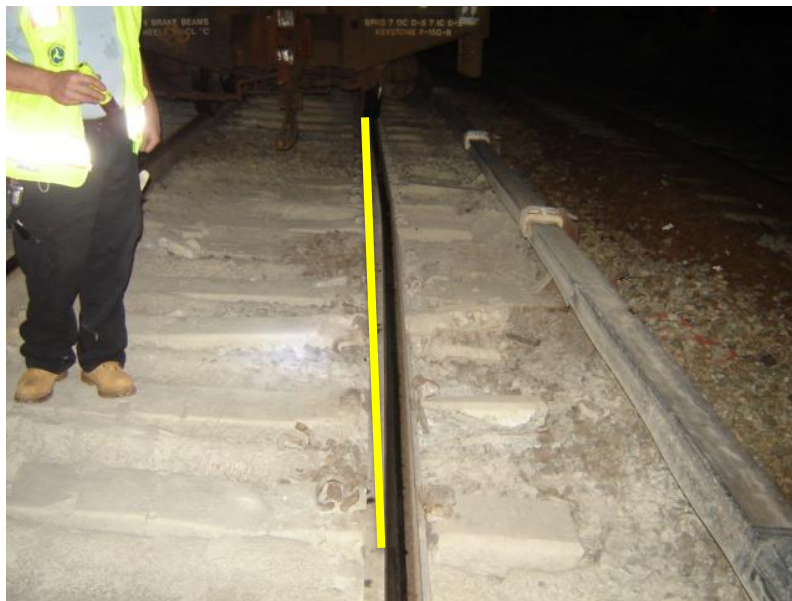
**Figure 3. Point of derailment showing a slight outward bow as compared with the straight yellow line.**

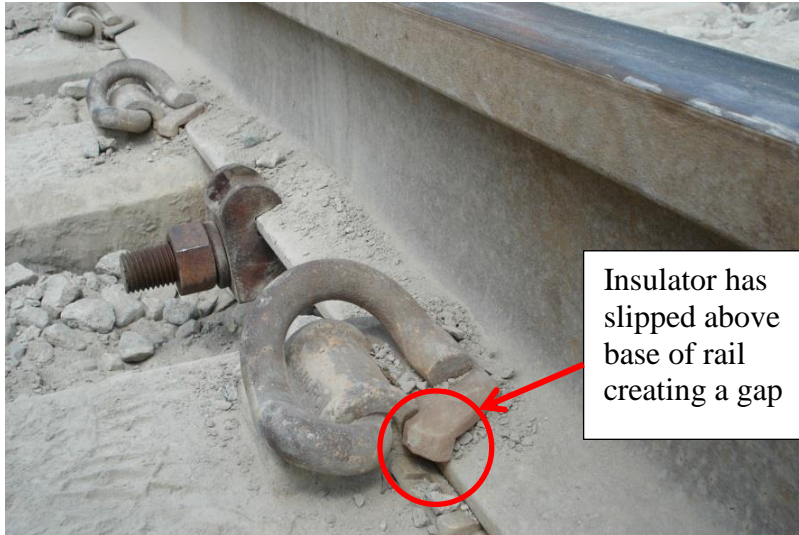
In the vicinity of the POD, investigators noted that the clip insulators on the field side of the rail had slipped out of place, so they were incorrectly positioned above the base of the rail on a number of ties. With the bottom of the insulator above the rail base, a gap is created allowing the rail to move further outward and thereby widening the gage by approximately 5/16 inch.

**Figure 6. Insulator between Pandrol clip and rail base. Note that bottom portion of the insulator in the image in the foreground has slipped above base of rail on field side creating a gap.**

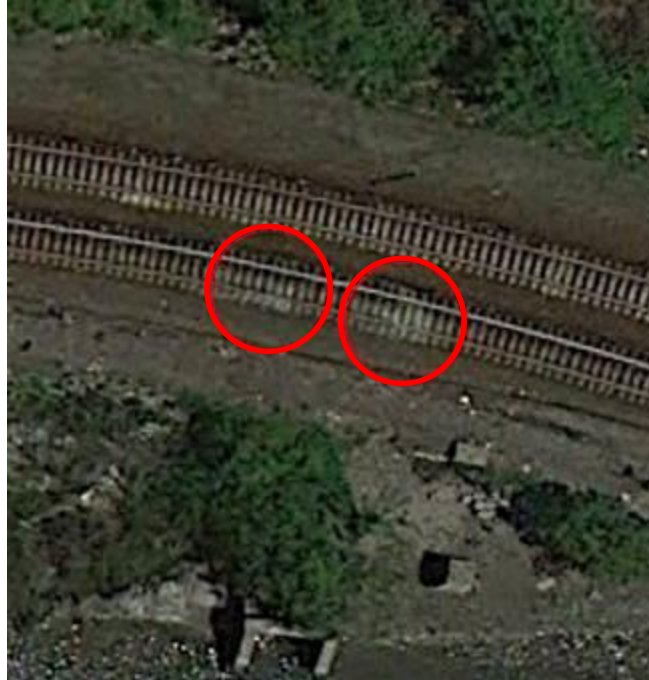
Soil intrusion into the ballast (fouled ballast) was noted in the derailment area.<sup>8</sup> Fouled ballast occurs when inadequate drainage results in a buildup of water in the track substructure. Hydraulic action (“pumping”) during train movements over the area results in fine soil particles rising to the surface and contaminating the ballast. In addition, the movement of the ties in the ballast can cause abrasion of the ties. The gray powdery substance that was observed throughout the track structure in the POD area appeared to be from concrete tie abrasion. Over time, pumping and fouled ballast conditions worsen and provide less structural support to the ties and track.

Satellite images from June 2010 (3 years before the derailment) showed the fouled ballast at the point of derailment, indicating fouled ballast at the POD was not a recent phenomenon.<sup>9</sup>

Figure 7. 2010 Satellite image showing fouled ballast at the POD (that is, the white areas inside red circles).

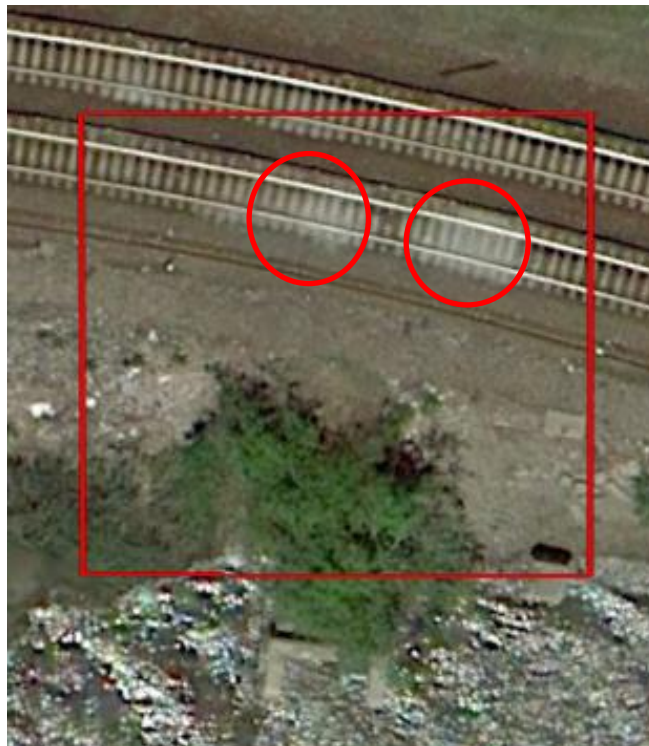
Figure 8. 2011 Satellite image showing fouled ballast at POD.

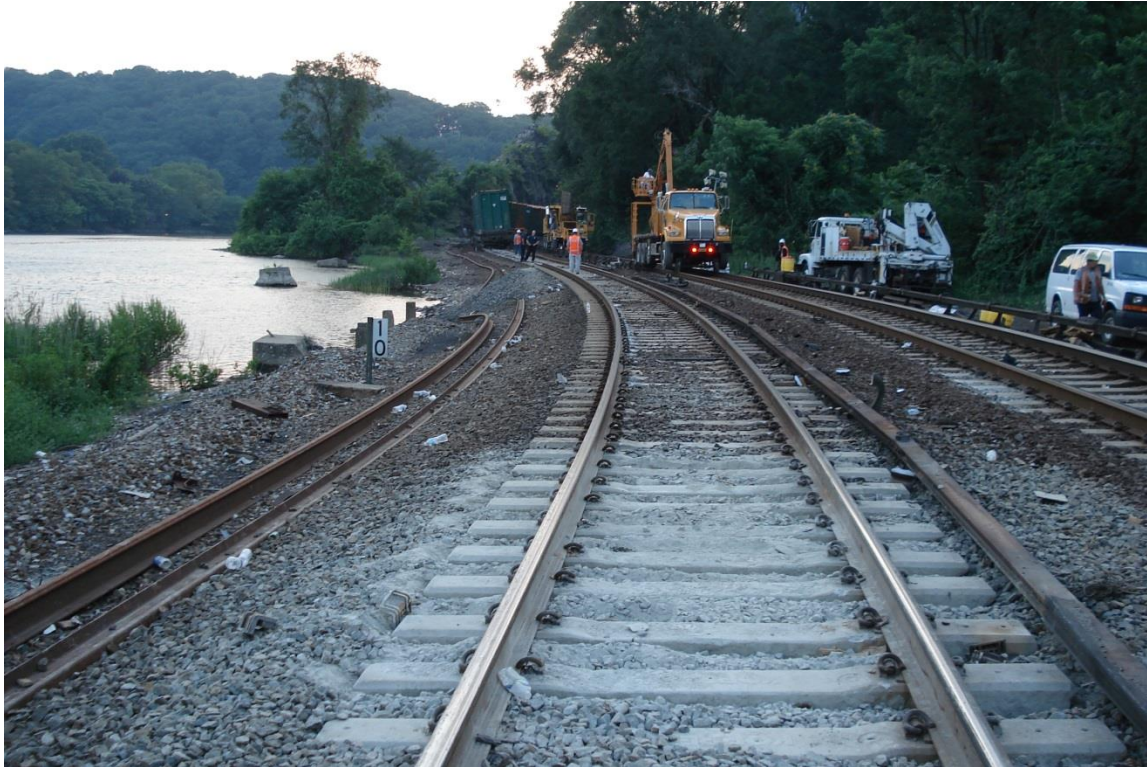
A similar image about 1 year later shows the POD fouled ballast more clearly.<sup>10</sup>

**Figure 9: Close up of fouled ballast in POD area.**

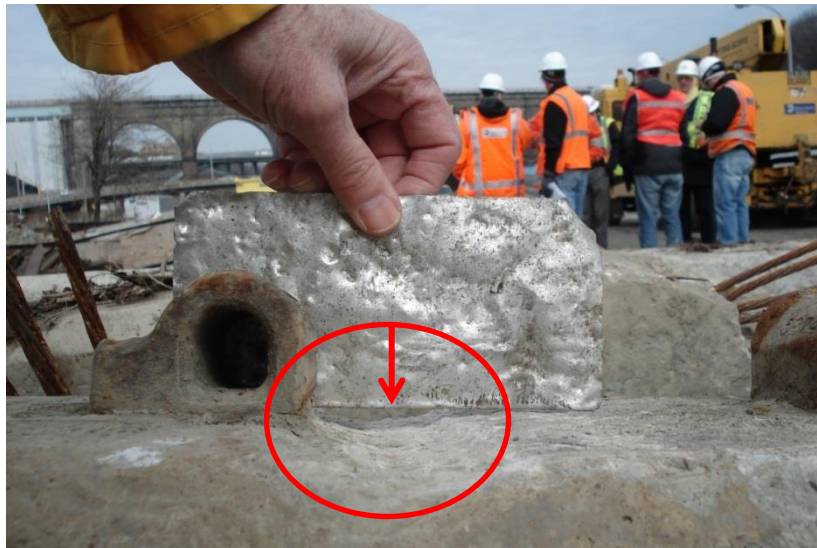
Track panels from the derailment site were preserved and later disassembled at Metro-North High Bridge Yard. Wear in the rail seat area was noted on many of these ties along with a worn trough on the field side of the rail seat. (See figure 10.) This wear was indicative of the rail canting outward.

**Figure 10. Groove worn into field side of rail seat.**

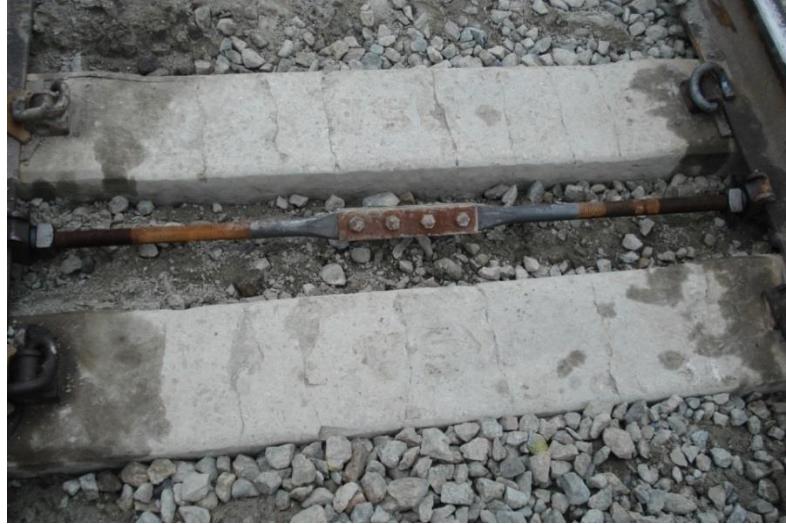
Center cracking was evident on a number of ties. (See figure 11.) Center cracking on concrete ties is an indication that the ties are center bound, meaning that there is inadequate support at the ends of the ties and that they can flex or bow under loads. When ties bow, the track gage increases because the rails cant outward.

**Figure 11. Cracks at centers of ties at POD. (Gage rod was installed after the derailment.)**

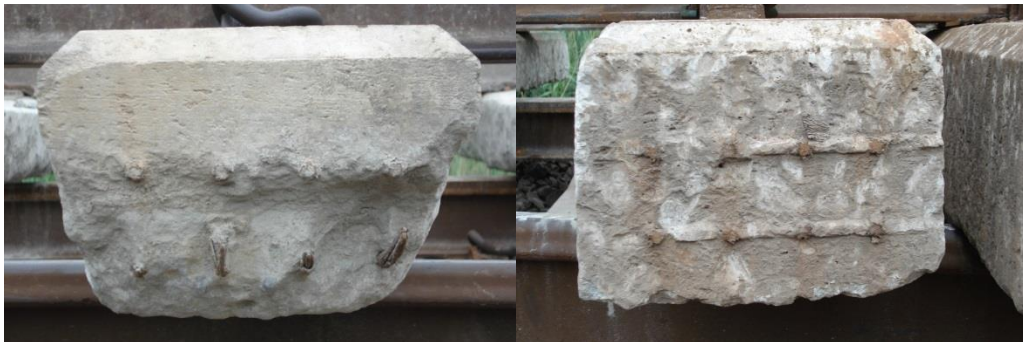
The cross section of the ties was reduced by abrasion on the bottom of the ties, and the reduced cross section was more pronounced at the ends of ties at the inside of the curve. Steel tensioning strands were exposed on the ends of many ties. (See figure 12.) More pronounced loss of cross section at the ends of ties indicates more movement and abrasion against the ballast and is another indication of less support at the ends of ties than in the center.

**Figure 12. Tie from POD area (left) with reduced cross section and exposed tension strands and unused exemplar tie (right).**
