National Transportation Safety Board

Railroad Accident Brief

Metro-North Railroad Employee Fatality

Accident No.:	DCA14FR006
Location:	Manhattan, New York
Date:	March 10, 2014
Time:	12:55 am eastern daylight time
Railroad:	Metro-North Railroad
Property Damage:	N/A
Injuries:	0
Fatalities:	1
Type of Accident:	Employee Fatality

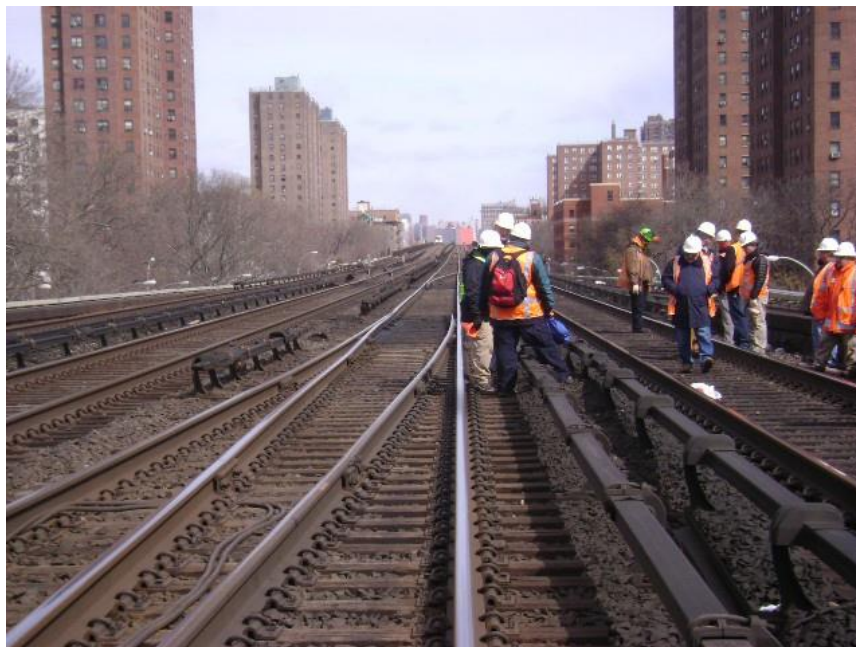
On March 10, 2014, at 12:55 a.m. eastern daylight time, a Metro-North Railroad (Metro-North) electrician was fatally struck by northbound train No. 897 near milepost 3.2 at Control Point 3 (CP 3) interlocking in Manhattan, New York. Three employees were attempting to re-energize tracks that had been out of service for maintenance. Two of the workers cleared the approaching train, but the third worker was struck by the train.

Figure 1. Accident site.

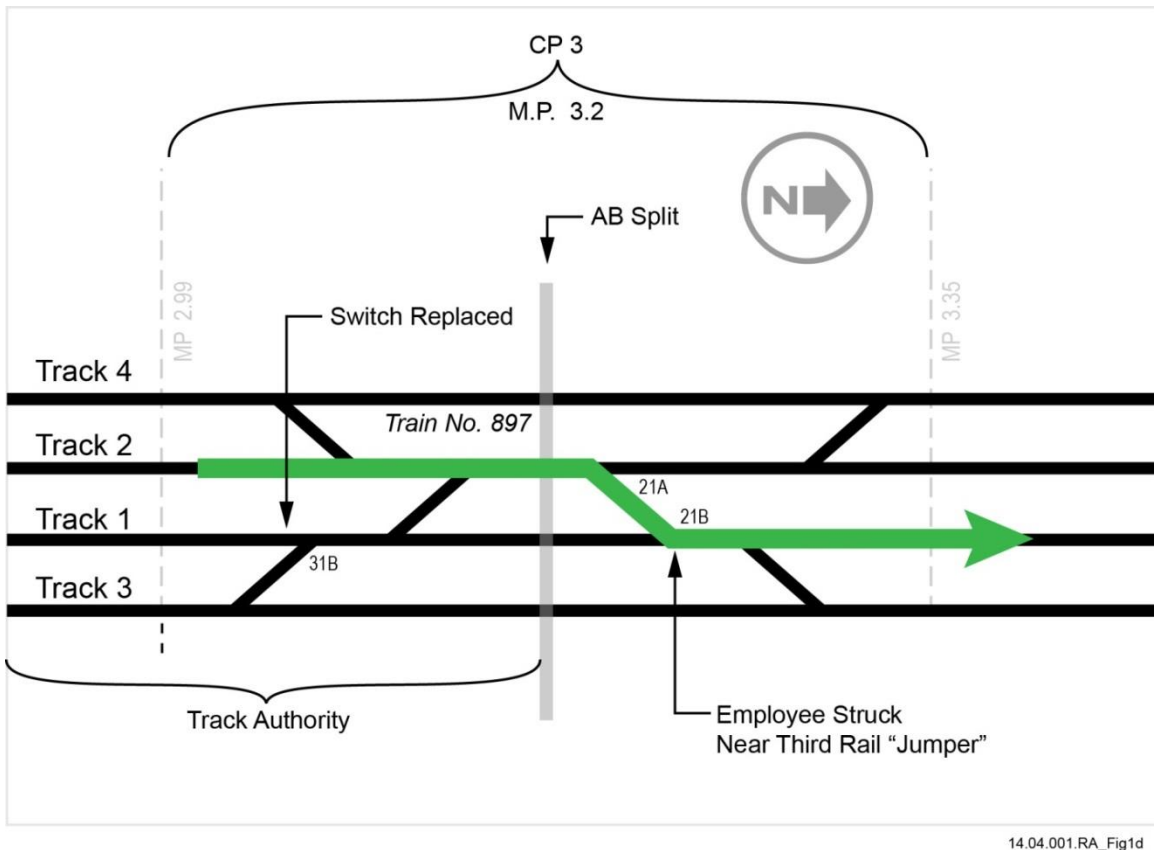
Figure 2. Diagram of CP 3 interlocking segments.

The AB Split was near the middle of the interlocking. (See figure 2.) The AB Split separated the signal system (but not the third rail) within the interlocking.⁴ Using the AB Split as a limit for the on-track protection allowed the rail traffic controller (RTC) to block/lock switches at one end of the interlocking but still use the switches at the other end on the same track for train

movements. Before starting the track work, the third rail was de-energized for track 1 within the CP 3 interlocking. This removed the power from track 1 through the interlocking and up to the 21B switch at the north end of the interlocking. The AB Split had no effect on the third rail. (See figure 2.) Using the AB Split as a limit of authority was normal practice for the signal and track department. However, during interviews with the NTSB, the electricians said they were less familiar with the location and use of the AB Split.

Although the authority ended at the AB Split, the power department supervisor stated that he believed the authority extended to the 21B switch (north of the AB Split) because of his knowledge that the third rail power would be de-energized within the CP 3 on track 1 to the 21B switch.

Metro-North also issued the following prohibition on the use of the AB Split as a working limit when obtaining on-track protection:

The use of an “A/B Split” or “B/C Split” as a “Working Limit” is not to be granted in the application of roadway worker protection within an interlocking for all Crafts other than qualified Signal Department Employees.⁵

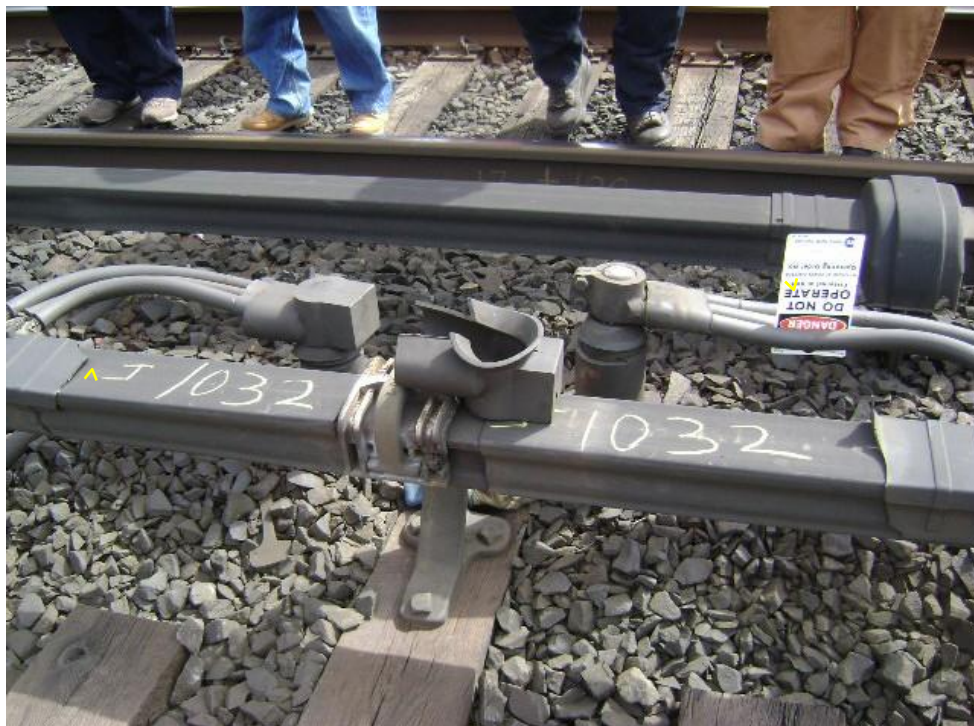
The power department foreman and two electricians went to close the jumper adjacent to the 21B switch, which was outside the authority limits that were established Friday night by the assistant track supervisor.

Figure 3. Jumper inserted in receptacle and considered “closed.”

The power department foreman and the two electricians had finished connecting the jumper and were removing an out-of-service tag when the train arrived. The two surviving employees said that they were not alarmed at first by the arrival of the train because they believed they had protection on track 1. As the train came closer (and the operator blew the horn) they realized the train was coming through the crossover and entering the track where they were standing. The workers yelled to each other and jumped toward track 3.
