# National Transportation Safety Board

## Railroad Accident Brief

### Collision of BNSF Railway Company and Union Pacific Railroad Trains Near Keithville, Louisiana

<b>Accident No.:</b>	DCA14FR003
<b>Location:</b>	Keithville, Louisiana
<b>Date:</b>	December 30, 2013
<b>Time:</b>	6:37 a.m. central standard time
<b>Train:</b>	BNSF train CMNRNAJ 23 and UP train MPBSR 30
<b>Railroads:</b>	BNSF Railway Company and Union Pacific Railroad
<b>Property Damage:</b>	\$7.8 million
<b>Injuries:</b>	4
<b>Fatalities:</b>	0
<b>Type of Accident:</b>	Head-on Collision

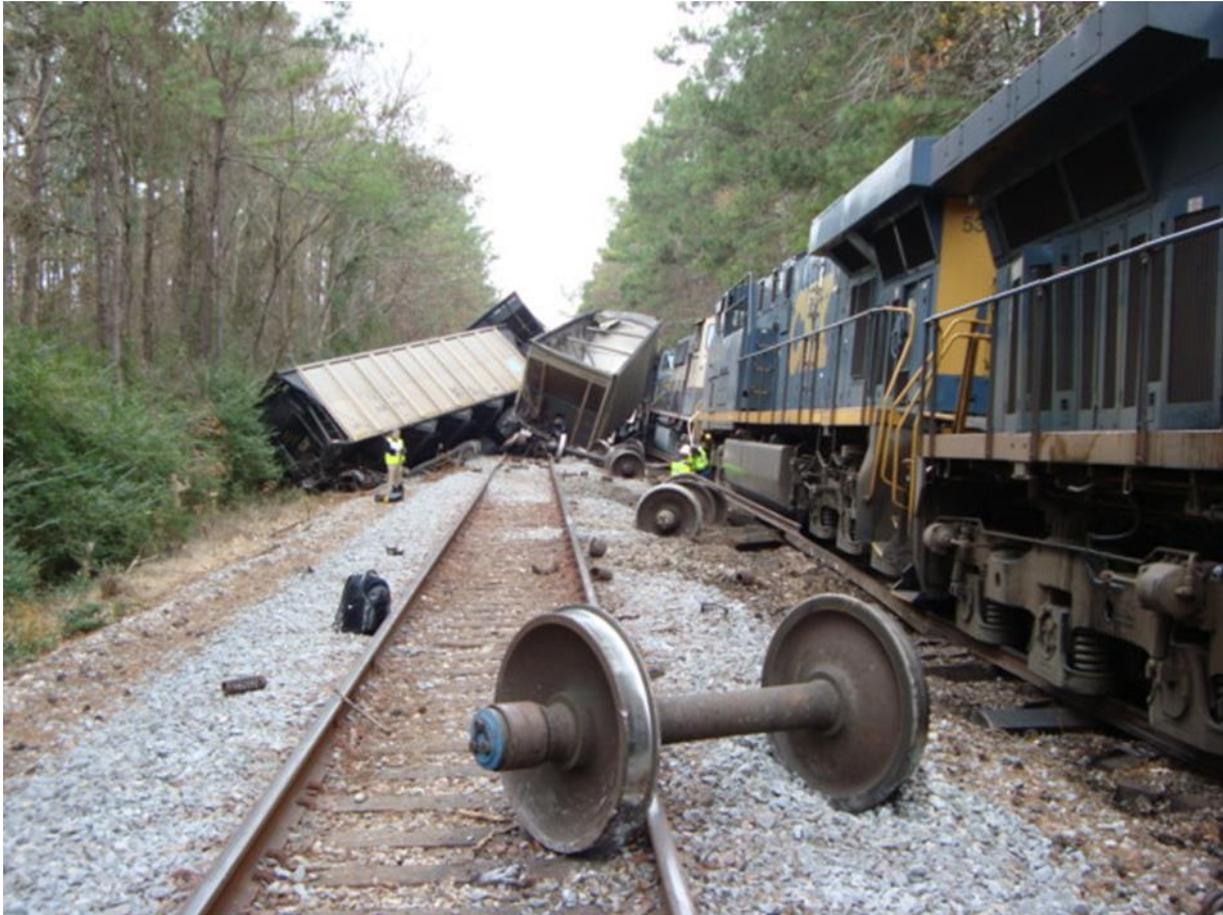
**Figure 1.** Derailment scene.

The event recorder data from one of the UP locomotives indicated the train was traveling about 48 mph when an emergency application of the train brakes was initiated. The train's speed was about 34 mph at the time of impact.
