National Transportation Safety Board

Railroad Accident Brief

Bay Area Rapid Transit Train 963

Struck Roadway Workers

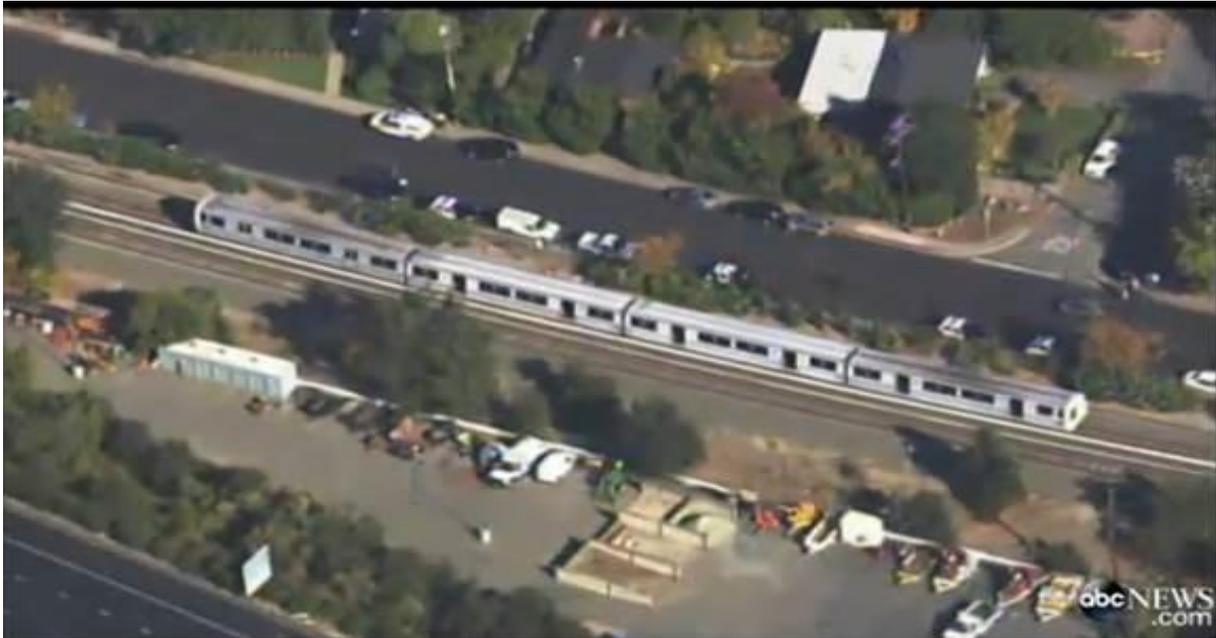
Figure 1: Accident scene. (Photo by ABC News)
