National Transportation Safety Board

Railroad Accident Brief

Collision of Union Pacific Railroad Freight Train MSIDV 16 with Standing Railroad Cars in Hays, Kansas

Accident No.: DCA13FR008

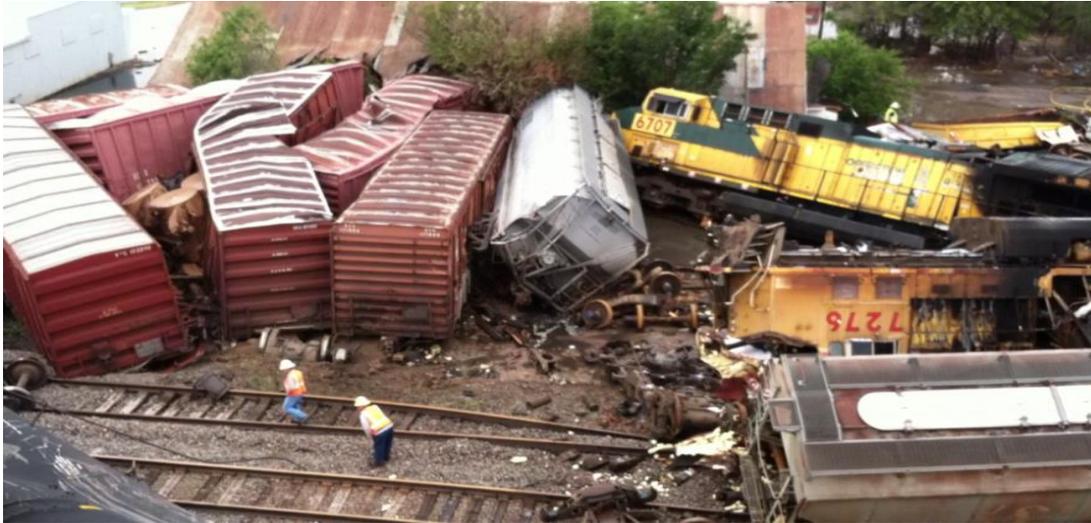
On July 16, 2013, at about 1:20 a.m., central daylight time, westbound Union Pacific Railroad (UP) freight train MSIDV 16 unexpectedly encountered a hand-operated main track switch at MP 288 in the reverse position diverting the train from the main track onto two adjacent tracks at the Sharon Springs subdivision in Hays, Kansas.^{1,2} The switch was not equipped with technology to warn oncoming trains that it was in the reverse position. At the time of the accident, the train was traveling in nonsignaled track warrant territory at a timetable speed of 49 mph. The lead locomotive collided with standing cars on the spur track. (See figure 1.) Diesel fuel leaked from the ruptured locomotive fuel tanks, ignited, and burned. The three crewmembers were injured. Damage was estimated by the UP to be \$1.4 million.

Figure 1. Train wreckage. (Photo by Union Pacific.)

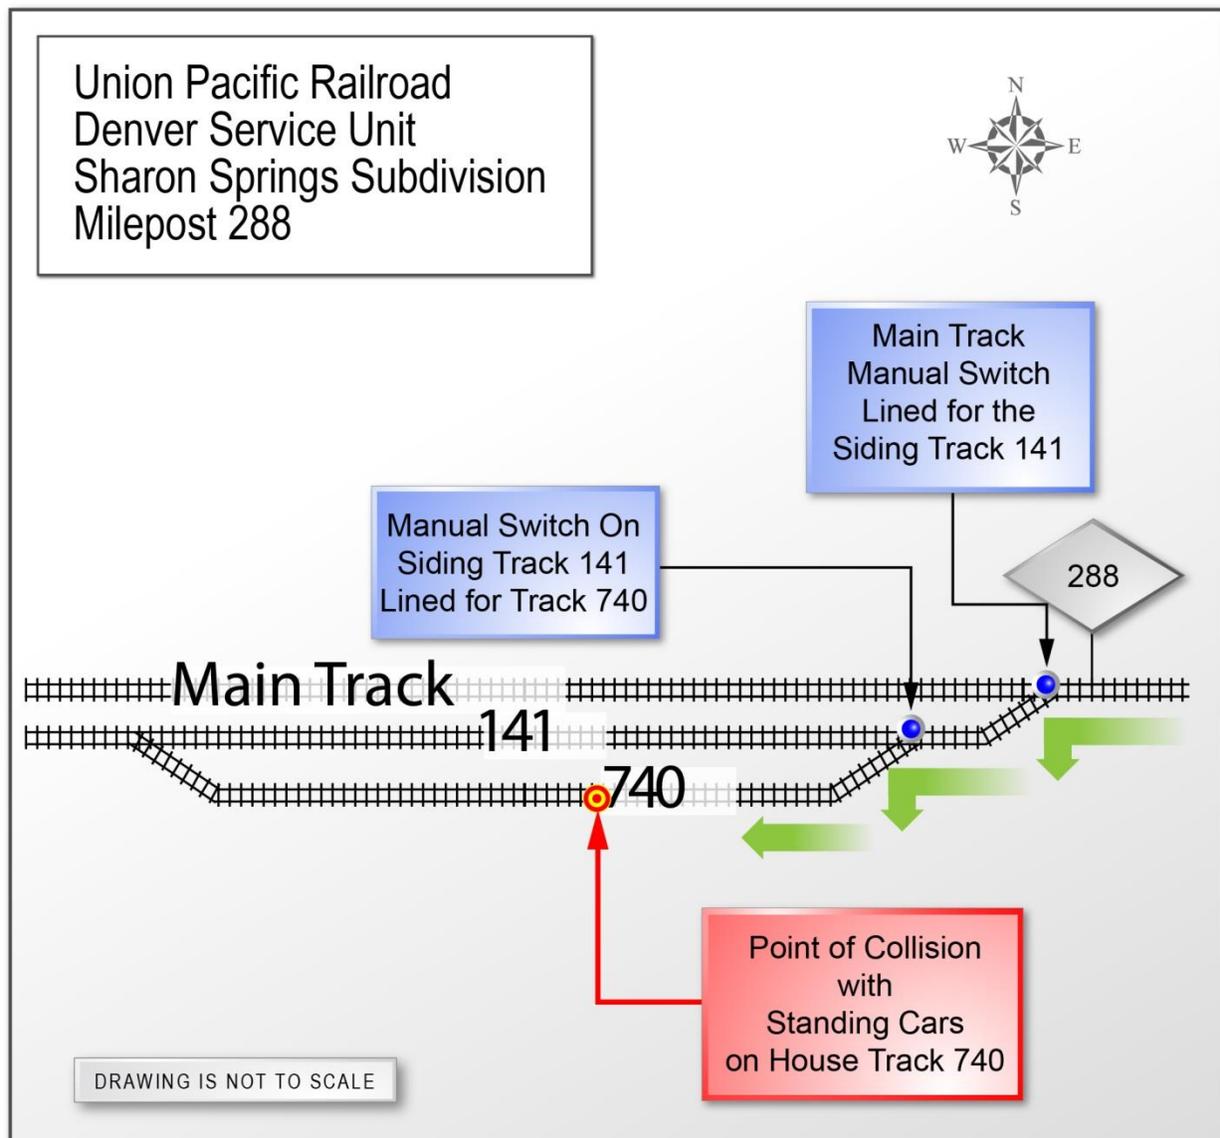
The brakeman proceeded to line the main track switch so the train could move off the main track and enter onto track 141. (See figure 2.) He then walked west to a derail on the siding track.³ He lined the derail off of the rail and made a radio call to the engineer advising him to move the train onto the siding track. As the train entered the siding track, the brakeman returned east toward the main track switch while continuing to watch to the west so he could tell the engineer when the train had cleared past the derail. When the brakeman reached the first switch he stopped. He was standing at the switch that connected siding track 141 with spur track 740, not the main track switch. Spur track 740 contained parked rail cars. The train cleared the derail and the brakeman called the engineer and told him the train was in the clear. He then changed the position of the switch where he was standing and inadvertently lined the switch for track 141 to track 740, rather than realigning the intended main track switch.

brakeman's radio call and the conductor, in turn, called the dispatcher to report the main track switch returned to the normal position and to release track warrant authority for the main track.⁴ However, the conductor's report to the dispatcher was incorrect because the brakeman had incorrectly lined the switch from track 141 to track 740, instead of lining the main track switch to the normal position.

Figure 2. Track layout at accident site.

NTSB investigators observed the accident site at the same time of night with similar visibility conditions as the night of the accident. The main track switch was not visible from the track 740 switch without direct illumination from a lantern or other light source. If the brakeman for train LDG89 15 had shined his lantern toward the switch target as he was lining the track, it would have been visible.

The National Transportation Safety Board determines that the probable cause of the accident was the failure of the brakeman of train LDG89 15 to return a main track switch to the normal position after the crew had secured the train on a siding track. Contributing to the accident was the inability of the crew of train MSIDV 16 to determine the position of the main track switch in nonsignaled territory.
