National Transportation Safety Board

Railroad Accident Brief

Derailment of WMATA Metrorail Train in Interlocking Falls Church, Virginia

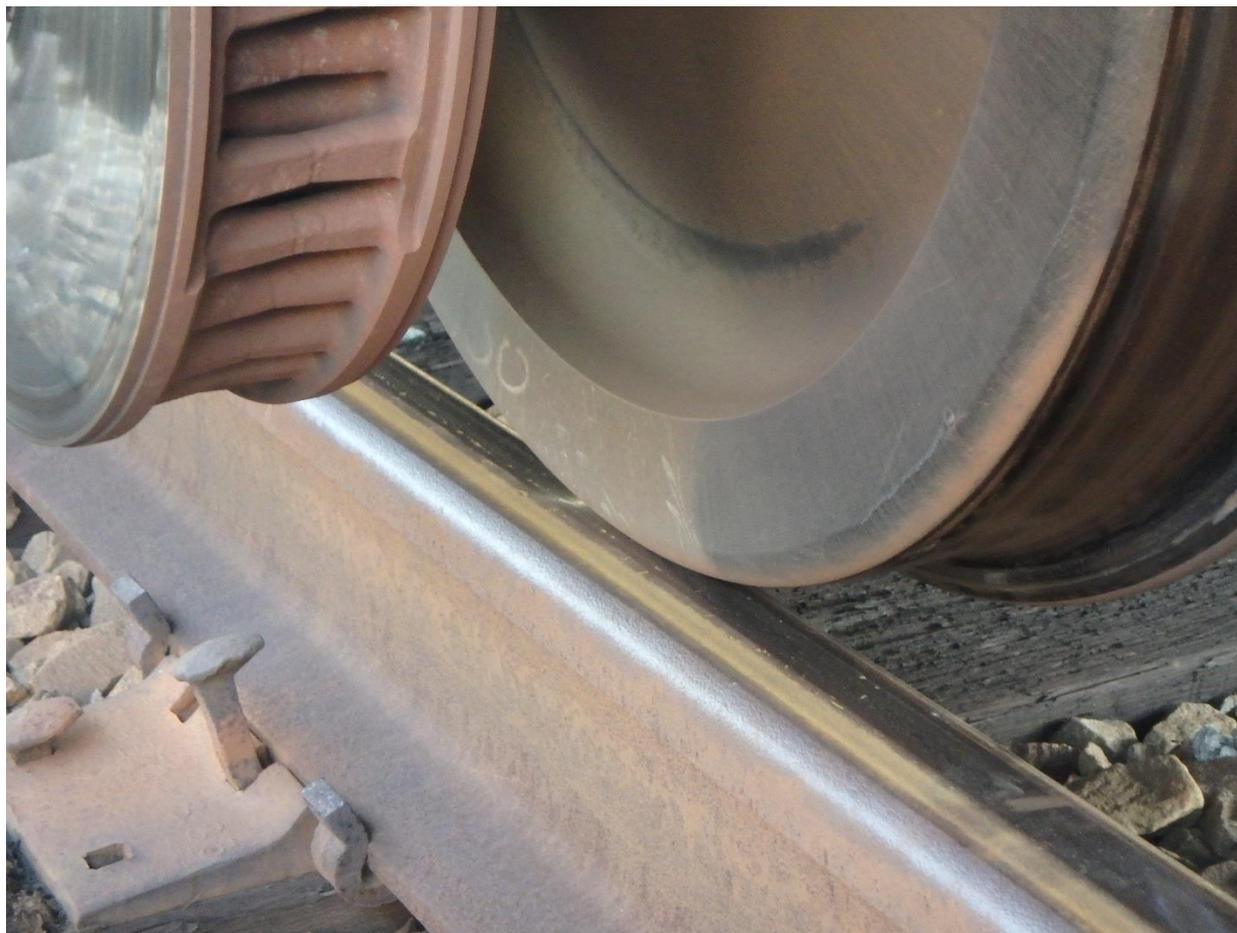
measurement of 59 inches.⁸ When track gage is too wide, the proper wheel-rail interface cannot be maintained and derailment is likely. (See figure 1.)

Figure 1. Equipment wheel misalignment and rail head discoloration.

The area where the train derailed should have been easily identified by WMATA and FTA as an area of concern because discoloration on the running surface of the north rail was visible, indicating that the wheels of the passenger vehicles were not properly aligned with the running rails. (See figures 1 and 2.)

The National Transportation Safety Board determines that the probable cause of this accident was a wide track gage condition resulting from the sustained use of deteriorating wooden crossties due to Washington Metropolitan Area Transit Authority's ineffective inspection and maintenance practices and inadequate safety oversight.

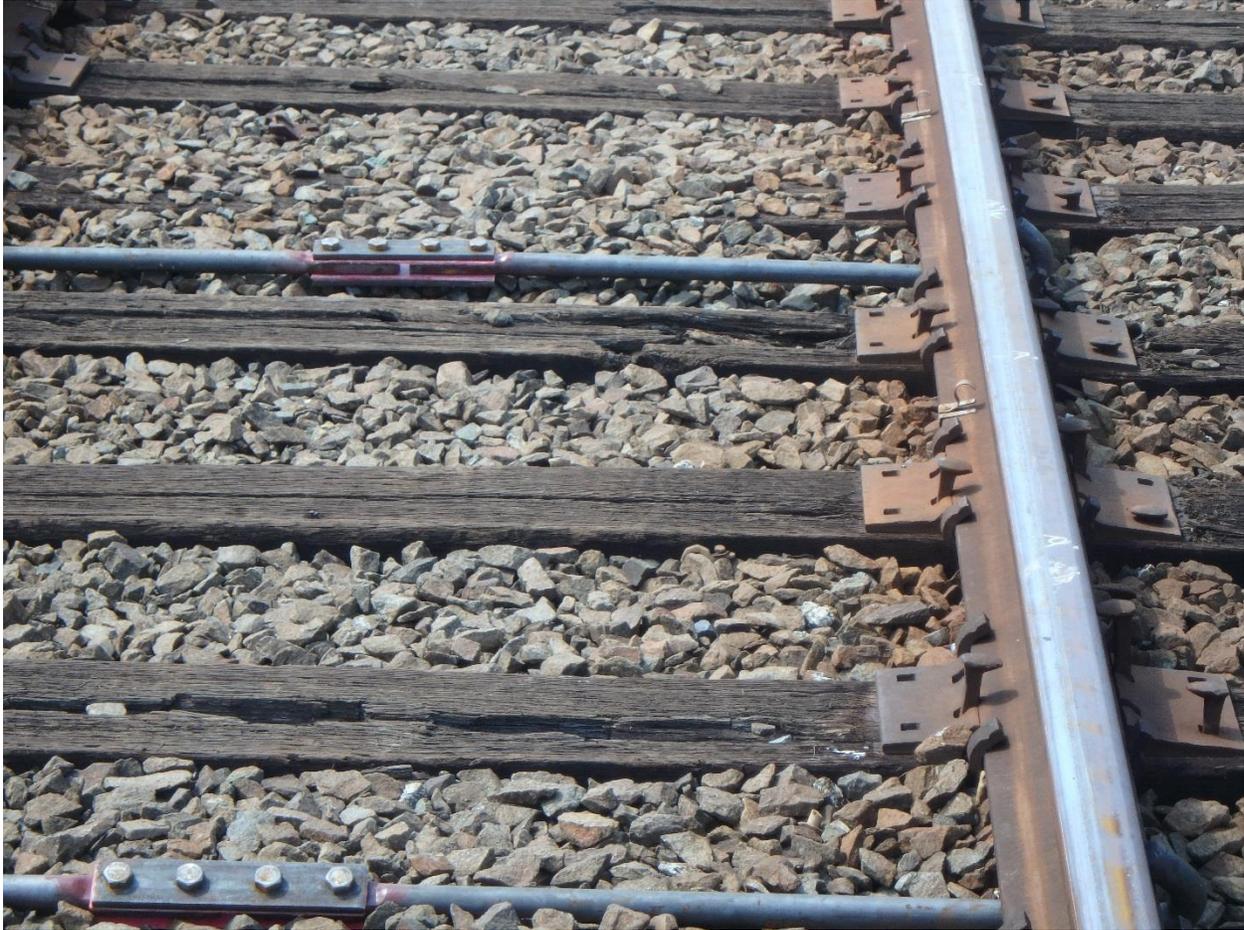
There were 18 crossties in 40 feet of track near the POD. Of those, 16 were not in compliance with WMATA standards or FRA track safety standards, resulting in about 400 inches of unsupported rail. The deteriorated crosstie condition allowed for a total dynamic track gage

Figure 2. Deteriorated cross-ties at accident location. The gage rods were added postaccident.

Also, the lateral movement of the tie plate in relation to the cross-tie was noted throughout the derailment area. Investigators observed a static track gage measurement of 58-1/4 inches, with an additional lateral movement of 3/4 inch, totaling 59 inches of dynamic track gage.⁹
