National Transportation Safety Board

Railroad Accident Brief

National Passenger Railroad Corporation (Amtrak) Passenger Train 55 Collision with Rocks and Subsequent Derailment on the New England Central Railroad Northfield, Vermont

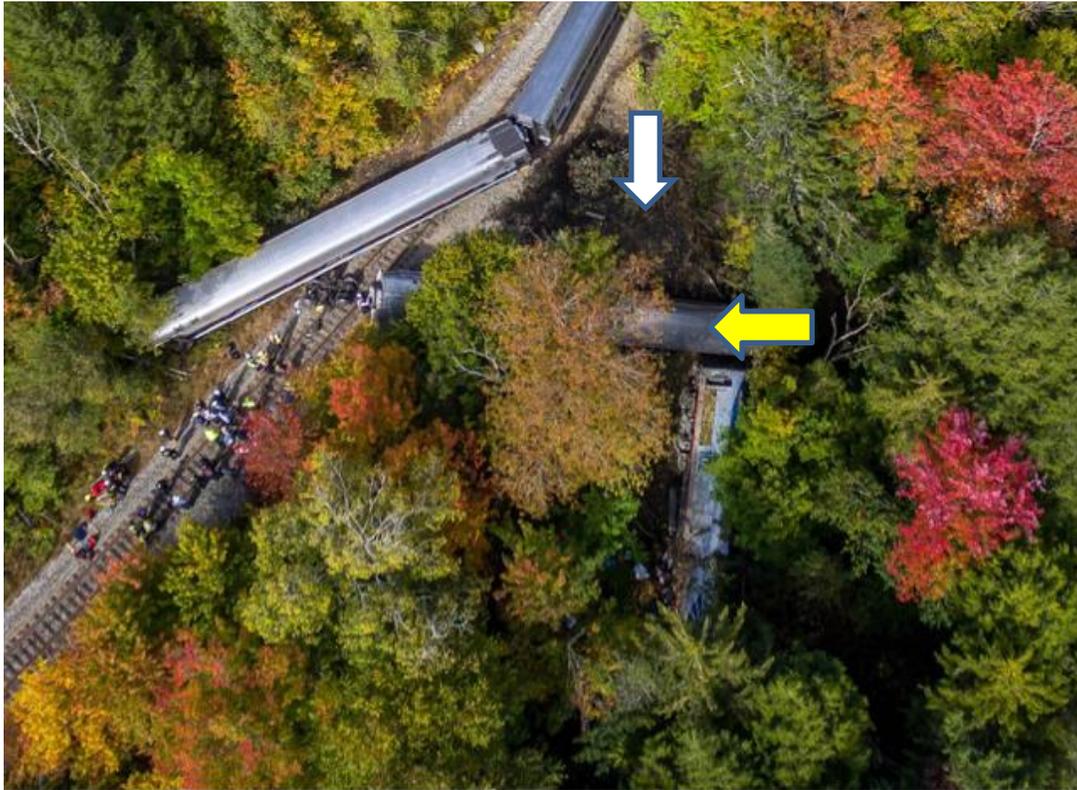
Figure 1. View of derailment (white arrow points to the coach car; yellow arrow points to the locomotive.)

figure 2.) The collision with the rocks caused the locomotive and the first coach car to derail over a steep embankment to the southeast. The locomotive and coach car traveled about 310 feet beyond the point of derailment and about 85 feet down the embankment from the main track.

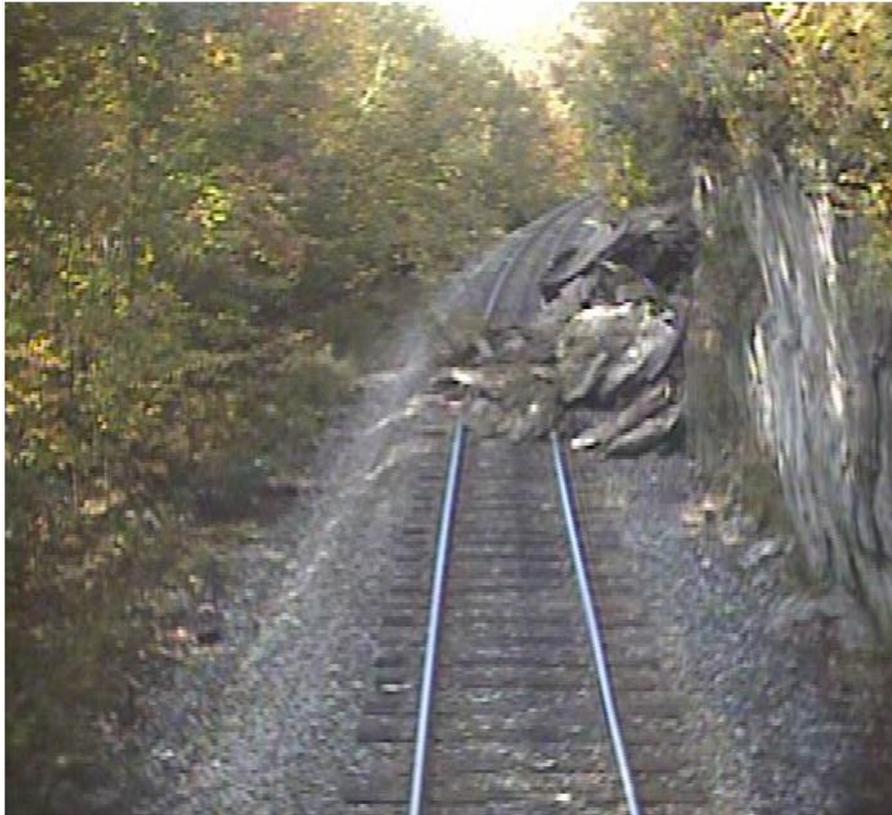
At 10:21 a.m., the train dispatcher provided the assistant conductor with a track warrant that authorized the train to continue southbound between MP 68 and 19. One minute later, as the train traversed a curve, the engineer observed an obstruction ahead on the track and initiated an emergency-brake application. The locomotive struck a large rock pile that was on the tracks. (See

Figure 2. A photo from digital forward-facing video recorder on locomotive.

The National Transportation Safety Board determines that the probable cause of the accident was the collision of the train with debris from a rock slide that fouled the track.
