# National Transportation Safety Board

## Railroad Accident Brief

### Collision of Two Arkansas & Missouri Railroad Trains Brentwood, Arkansas

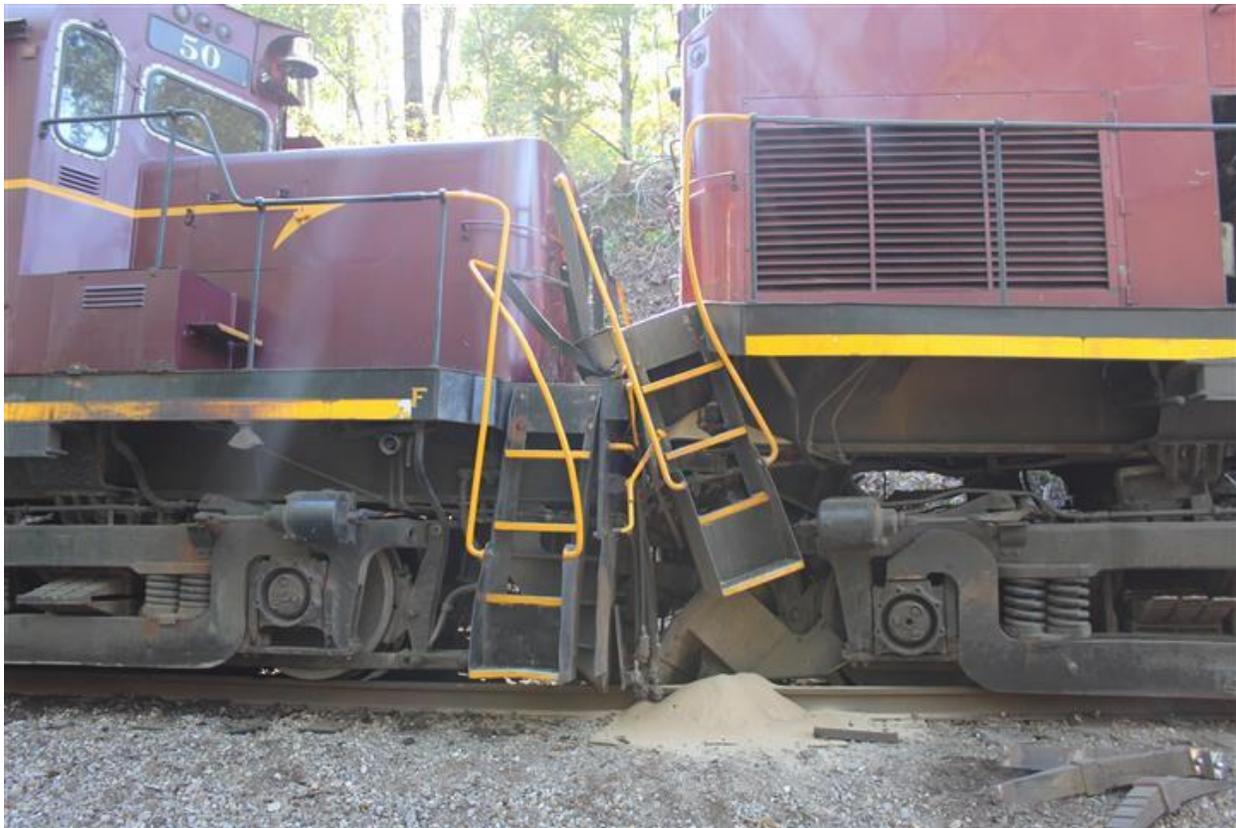
About 46 minutes after it left Winslow, the work train, moving at 24 mph, struck the excursion train locomotive head on. Event recorder data show that just before the collision the independent air brakes of the work train locomotive were fully applied when the locomotive was about 230 feet from the excursion train. However, the work train could not stop in 230 feet, and it struck the excursion train. (See figure 2.)

**Figure 2.** Locomotives of work train (left) and excursion train (right) after collision.

The collision caused the lead trucks of both locomotives to derail and all four cars of the excursion train to separate from the locomotive. The passenger cars rolled about 67 feet north. The train line air brake hose connections also pulled apart when the cars separated from the locomotive. The air brake control valves on the passenger cars sensed the rapid reduction of train line pressure, triggering an emergency brake application that stopped the movement of the cars.

The work train locomotive was moving at about 24 mph when it struck the stopped excursion train locomotive. The excursion train was about 375 feet long, and it weighed 400 tons. During the head-on collision, the stopped southbound excursion train was pushed to the north about 10 feet, and the leading truck of the locomotive derailed. The accident damaged the

excursion train locomotive's rear plate, end sill, and rear truck assembly, and it damaged the work train's end sill and front plate.
