National Transportation Safety Board

Railroad Accident Brief

BNSF Railway Unit Ethanol Train Derailment

Lesterville, South Dakota

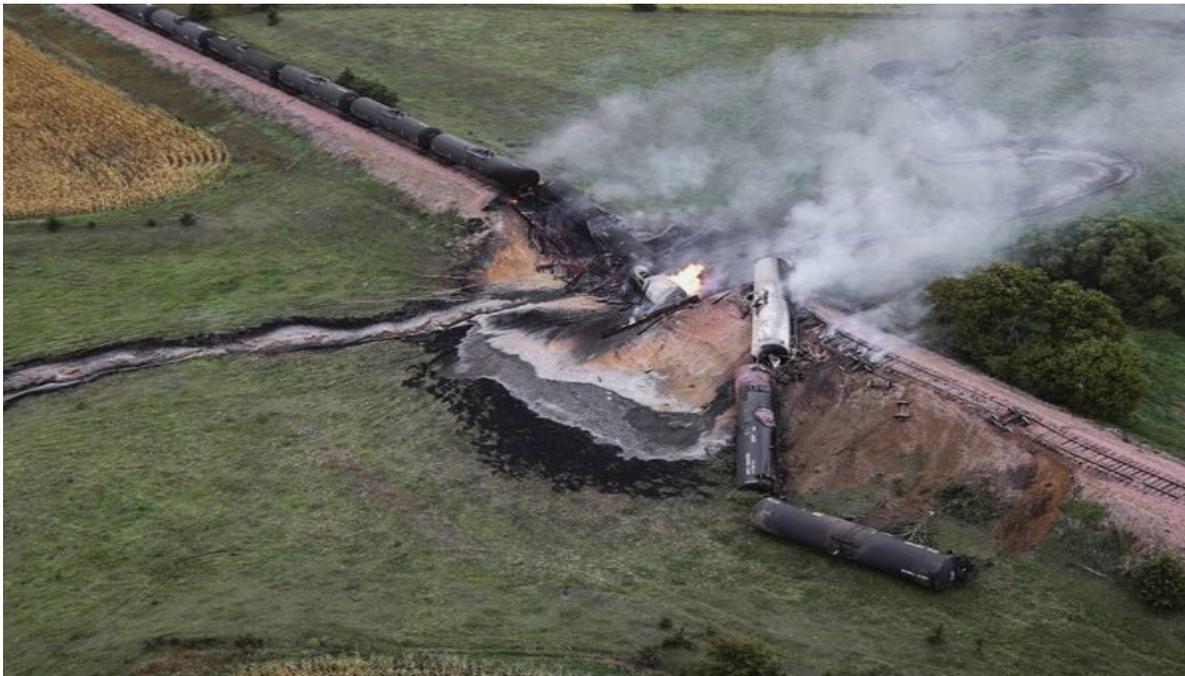
On September 19, 2015, about 6:18 a.m., central daylight time, BNSF Railway Company (BNSF) unit ethanol train GMNXDPK717, with 3 locomotives, 96 loaded tank cars, and 2 hopper cars filled with sand, derailed at a small bridge at milepost (MP) 597.7 near Lesterville, South Dakota.¹ Seven cars (tank car 2 through tank car 8 from the head end of the train) derailed. Two of the derailed cars breached and released 49,743 gallons of denatured fuel ethanol (ethanol) that caught fire. A third car leaked ethanol from its bottom outlet valve. There were no injuries and no evacuation. The estimated damage was \$1.1 million.

Figure 1. The accident site. (Photograph provided by BNSF.)

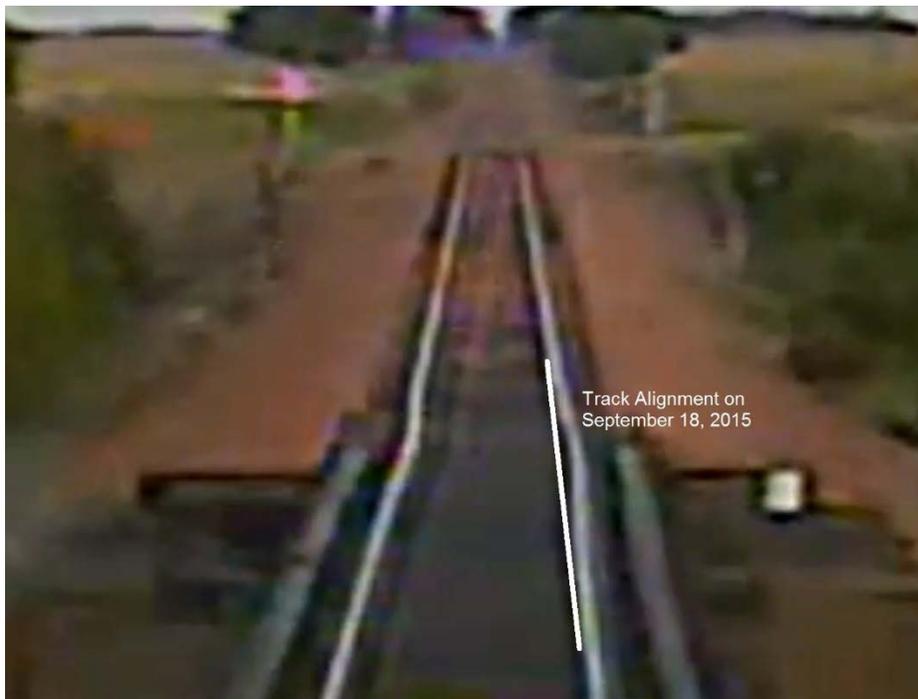
The POD at MP 597.7 was just east of the bridge. A forward-facing video from BNSF 5135, a train that traversed this section of track the day before this accident, showed misalignment of the track at the eastern end of the bridge.⁷ (See figure 2.) Further, the audio track on this video captured an obvious “clunking” sound when the engine traversed this location.

Figure 2. Still photograph from a forward-facing video from the day before the accident. (Photograph provided by BNSF.)

The POD was about 10 feet east of the east-end bridge abutment on the right-hand rail in the direction of the train’s movement. This location corresponded with the image noted from the previous day’s forward-facing video.

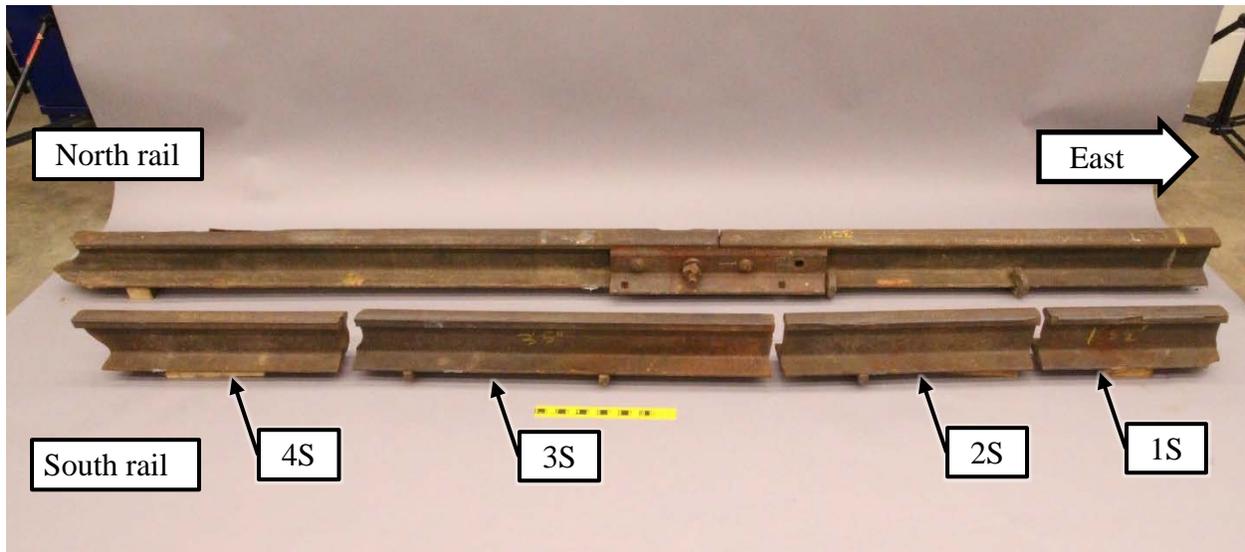
The derailment shattered the rail into many pieces. Investigators gathered the rail and reassembled the track at the derailment site. Pieces of broken rail from the east end of the bridge were sent to the NTSB materials laboratory in Washington, DC, for examination. (See figure 3.)

Figure 3. Recovered right-hand rail just east of the bridge.

The laboratory examination of the break between rail pieces 3S and 2S showed wear marks where the mating fracture faces had been moving up and down against each other. Therefore, the rail broke before the accident train derailed.

The rail at the POD showed signs of wheel wear against the inside head (top) of the rail. In tangent (straight) track, the wheel flange generally does not touch the inside of the rail head and the wheels of the cars center themselves on the top of the rail head.⁹ The wear patterns on the rail indicated the tightening of the gage, which would have applied lateral pressure to the rail by the wheels of passing trains.

The gage tightened at the POD and the track was unstable, which required repair. However, by designating the track as Class 1, BNSF was able to defer maintenance on the track. These issues, along with lateral pressure on the rail from the tight gage and the poor track structural support, increased the likelihood of rail failure.

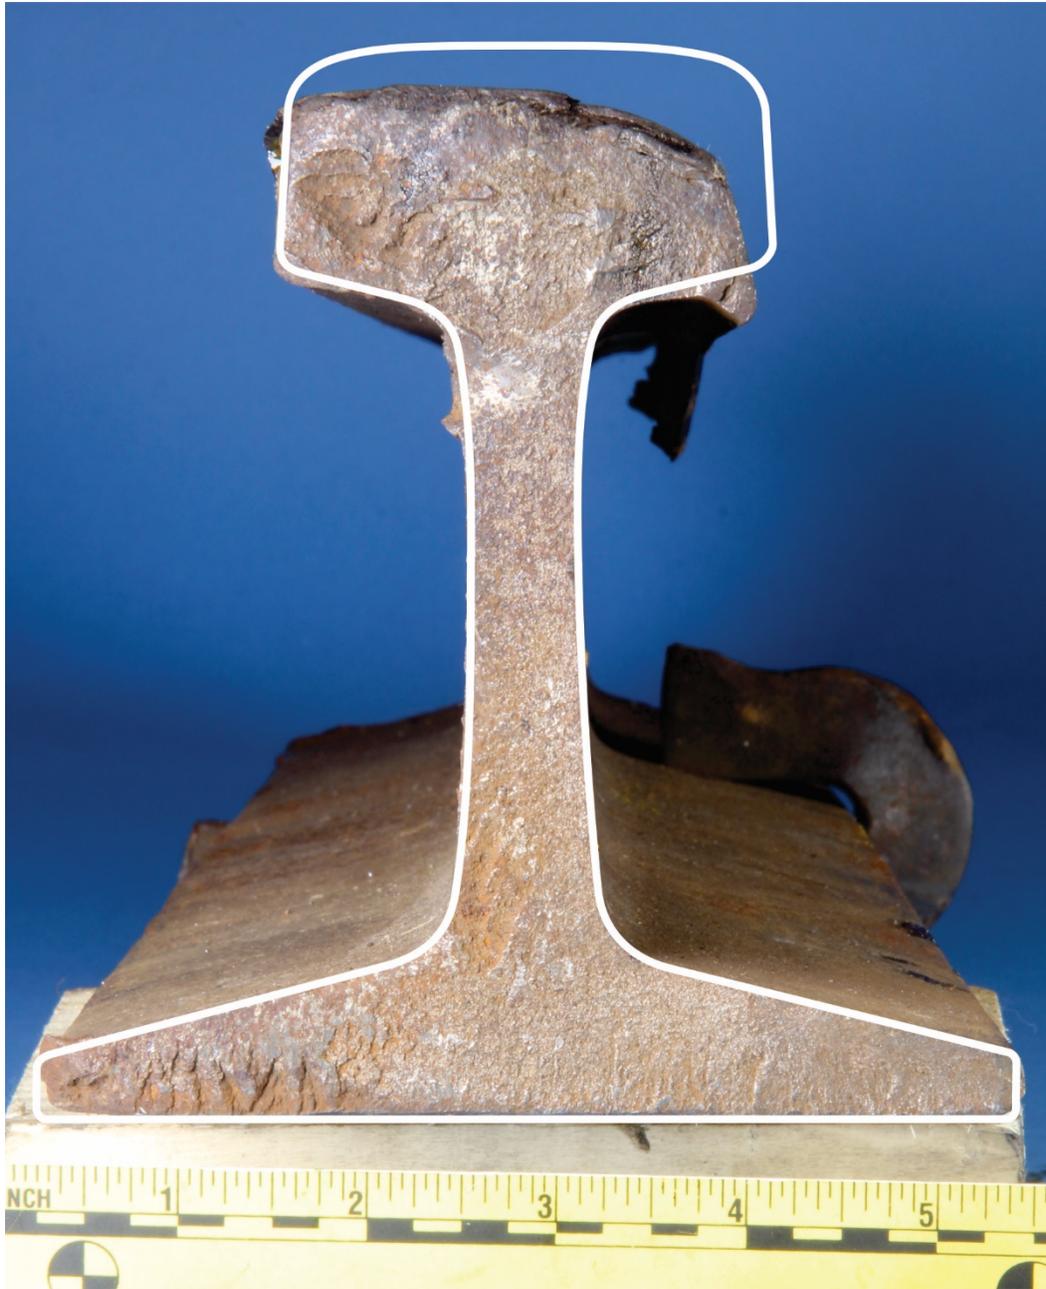
BNSF track standard wear limits for rail heads were based on the specified weight of the rail and allowed more wear for heavier rail.¹⁹ All rail that weighed less than 119 pounds had a 0.5-inch vertical wear limit.²⁰ In the case of a 90-pound rail, such as the one shown in figure 4, 0.5-inch of vertical wear would reduce the rail head to the extent where it may not be able to support the weight of a modern tonnage train and could increase the possibility that the rail would fail.²¹ Although the wear on the accident rail had not reached the level for replacement for 90-pound rail by the BNSF wear limit, NTSB investigators considered the wear in the accident rail to be excessive because the remaining head area in the worn 90-pound rail was less than the remaining head area in heavier rail at the wear limits listed in the BNSF track standard.

Figure 4. Excessive rail head wear on a 90-pound rail from the Aberdeen Subdivision.

Modern high-strength steel rail is harder than the century-old rail used on this track and wears down at a lower rate. The hardness of the rail at the POD was about 30 percent lower than the minimum acceptable value for today's rails. Older rail is susceptible to head checks, spalls, and other rolling contact fatigue damage; deformed rail head flow; and increased wear rates.²⁴ The rail segments recovered at the scene of the accident showed evidence of rolling contact fatigue.
