**National Transportation Safety Board**  
**Railroad Accident Brief**  
**Collision of Two Union Pacific Railroad Freight Trains**  
**Texarkana, Texas**

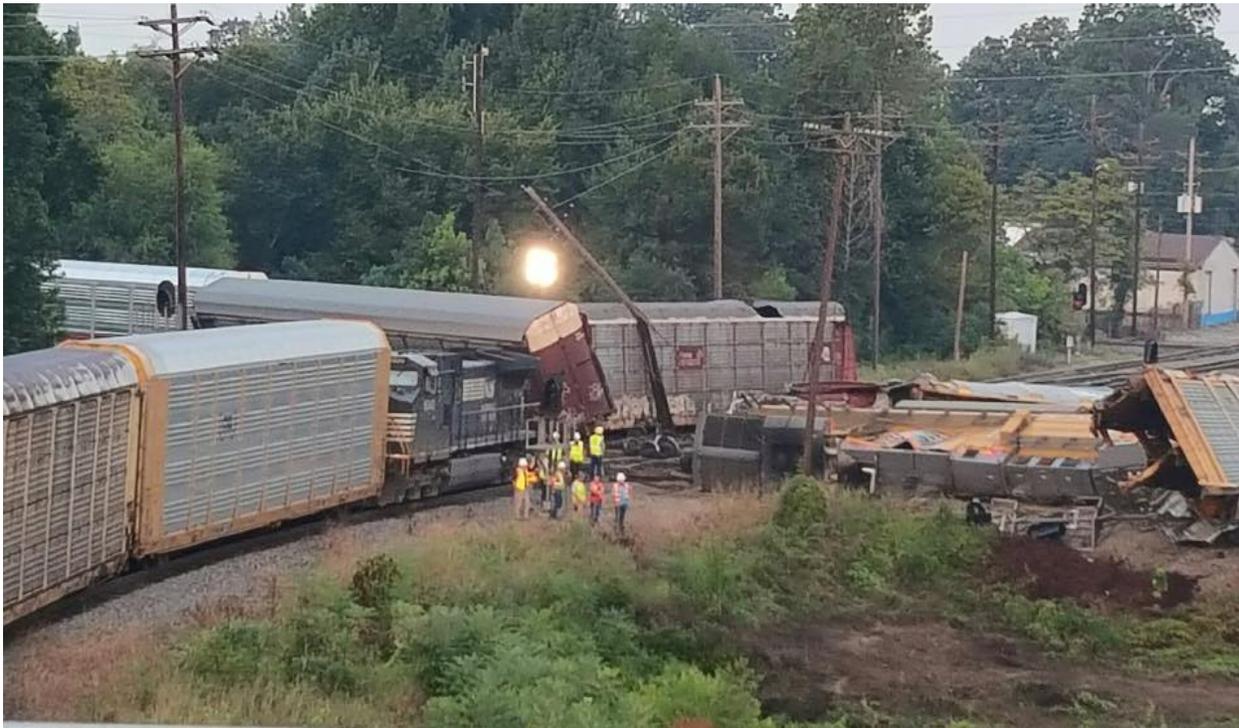
On September 8, 2015, at 12:34 a.m. central daylight time, westbound Union Pacific Railroad (UP) freight train AMNML-07 (striking train) collided into the side of northbound UP freight train ALDAS-06 (struck train) near Texarkana, Texas.<sup>1</sup> (See figure 1.) The striking train was traveling west on the main track of the Pine Bluff Subdivision, and the struck train was traveling north on the Little Rock Subdivision. The trains collided at a diamond crossing (Texarkana Interlocking) of the two subdivisions.<sup>2</sup> Two locomotives of the striking train and seven cars (numbers 13–19) of the struck train derailed. The engineer and conductor of the striking train sustained minor injuries; neither crewmember in the struck train was injured. The lead locomotive of the striking train released about 4,000 gallons of diesel fuel. The locomotive event recorder data indicated the striking train was traveling at 19 mph when the engineer made an emergency brake application. At the time of the collision, the train had slowed to about 6 mph. The estimated damage was \$4.66 million. At the time of the accident, it was dark, the sky was clear, the visibility was 10 miles or more, and the temperature was 82°F.

**Figure 1.** Accident scene. (Photo courtesy of News Radio KEEL, Shreveport, Louisiana.)

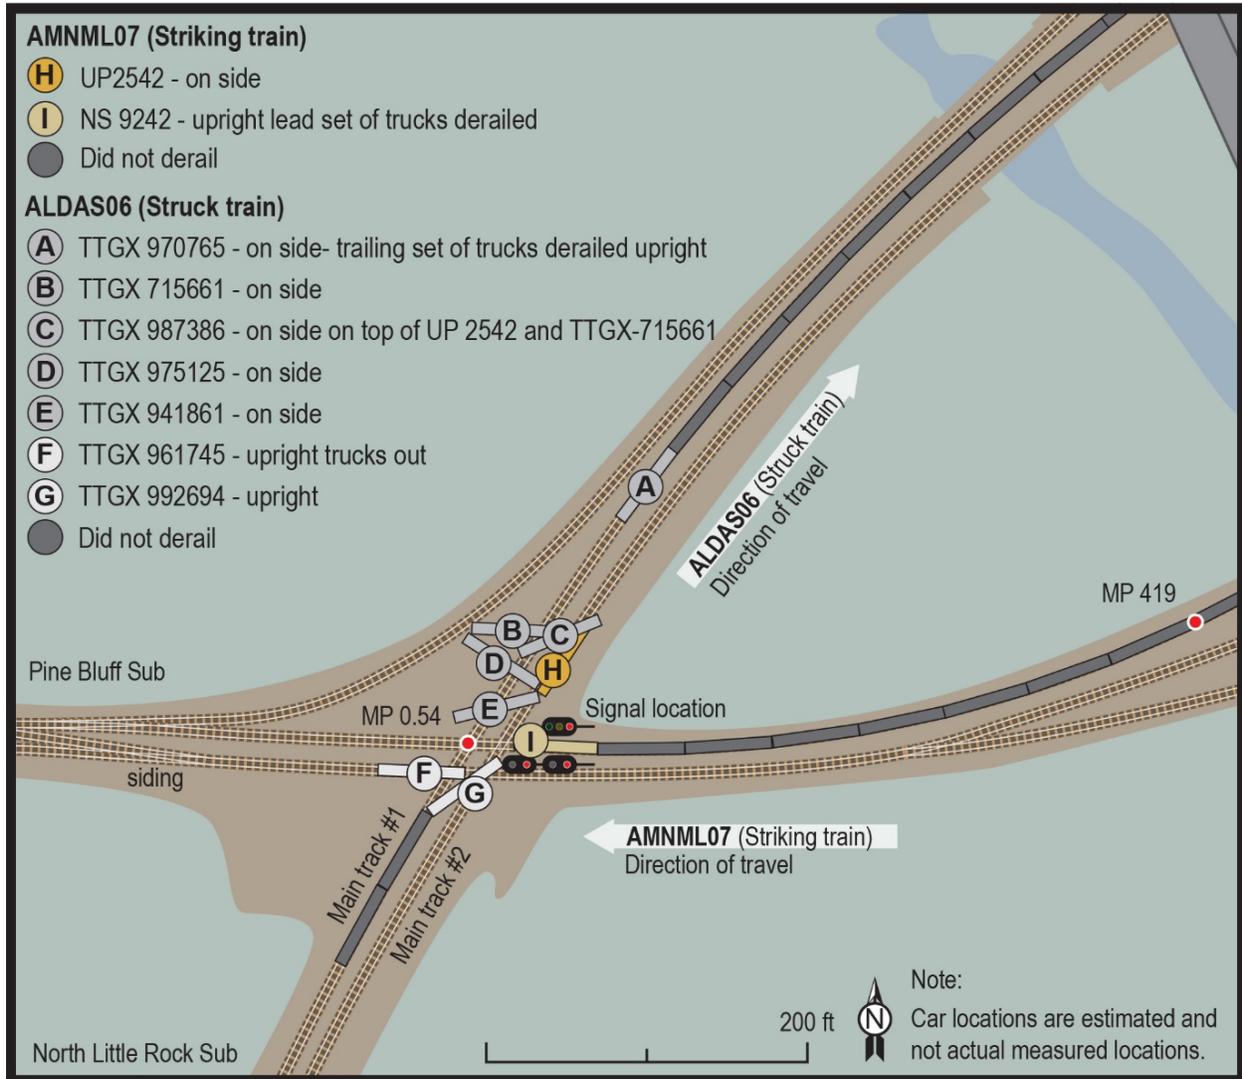
At milepost (MP) 419.1, a single main track and a siding track of the Pine Bluff Subdivision crosses the two main tracks of the Little Rock Subdivision MP 0.54. (See figure 2.) The maximum authorized train speed on the Pine Bluff Subdivision at the Texarkana Interlocking was 20 mph; the maximum authorized speed on the Little Rock Subdivision was 30 mph.

**Figure 2.** Accident diagram.

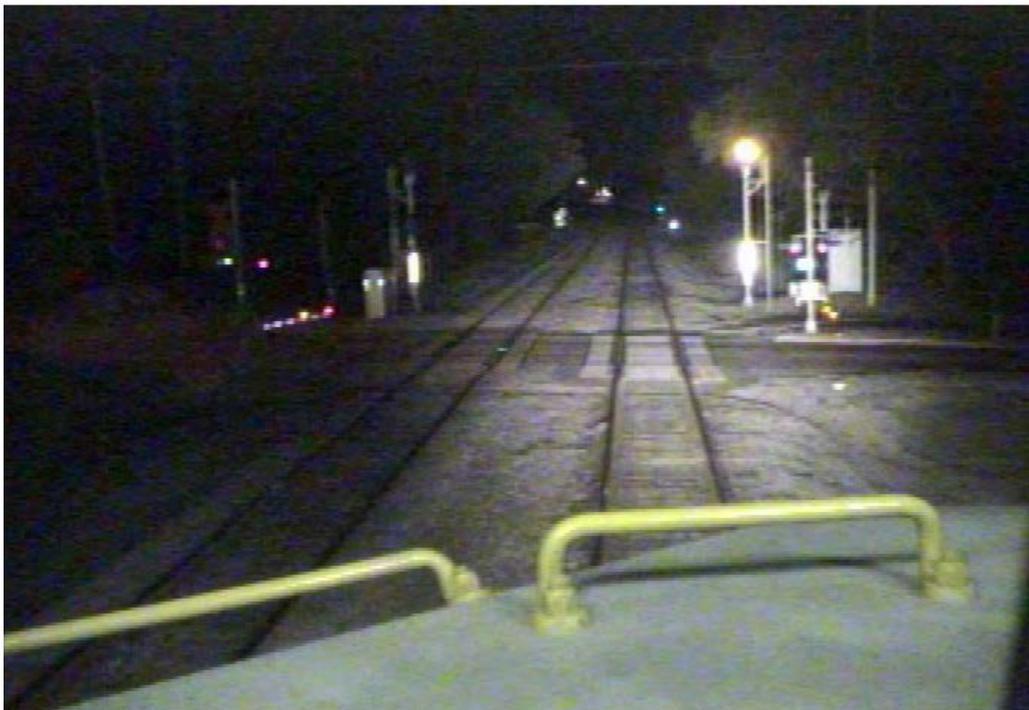
**Figure 3.** Approach signal.

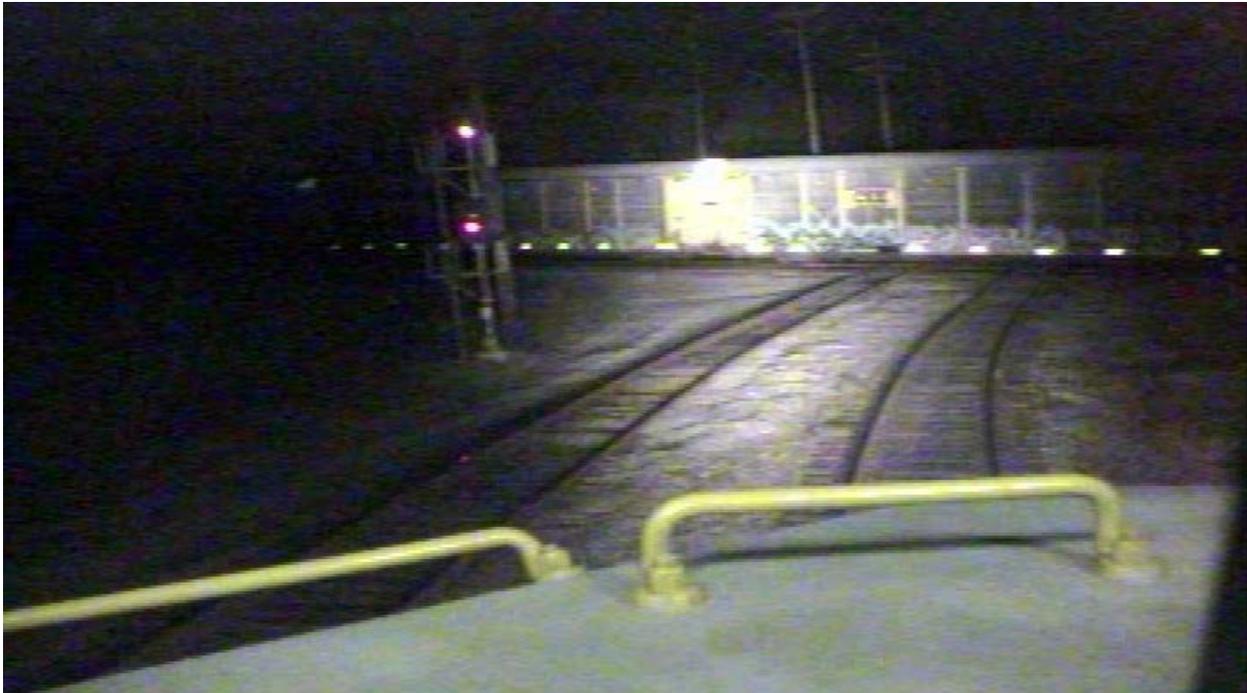
As the striking train was slowing, it struck the northbound train at about 6 mph. (See figure 4.) After the impact, the lead locomotive turned over on its side. The engineer and conductor of the struck train helped the crew of the striking train to exit their damaged locomotive. Emergency personnel transported the engineer and conductor of the striking train to a local hospital. They were treated for minor injuries and released.

**Figure 4.** Train AMNML-07 (striking train) approaching the occupied interlocking.
