National Transportation Safety Board

Railroad Accident Brief

South Florida Regional Transportation Authority Highway-Rail Grade Crossing Collision

West Palm Beach, Florida

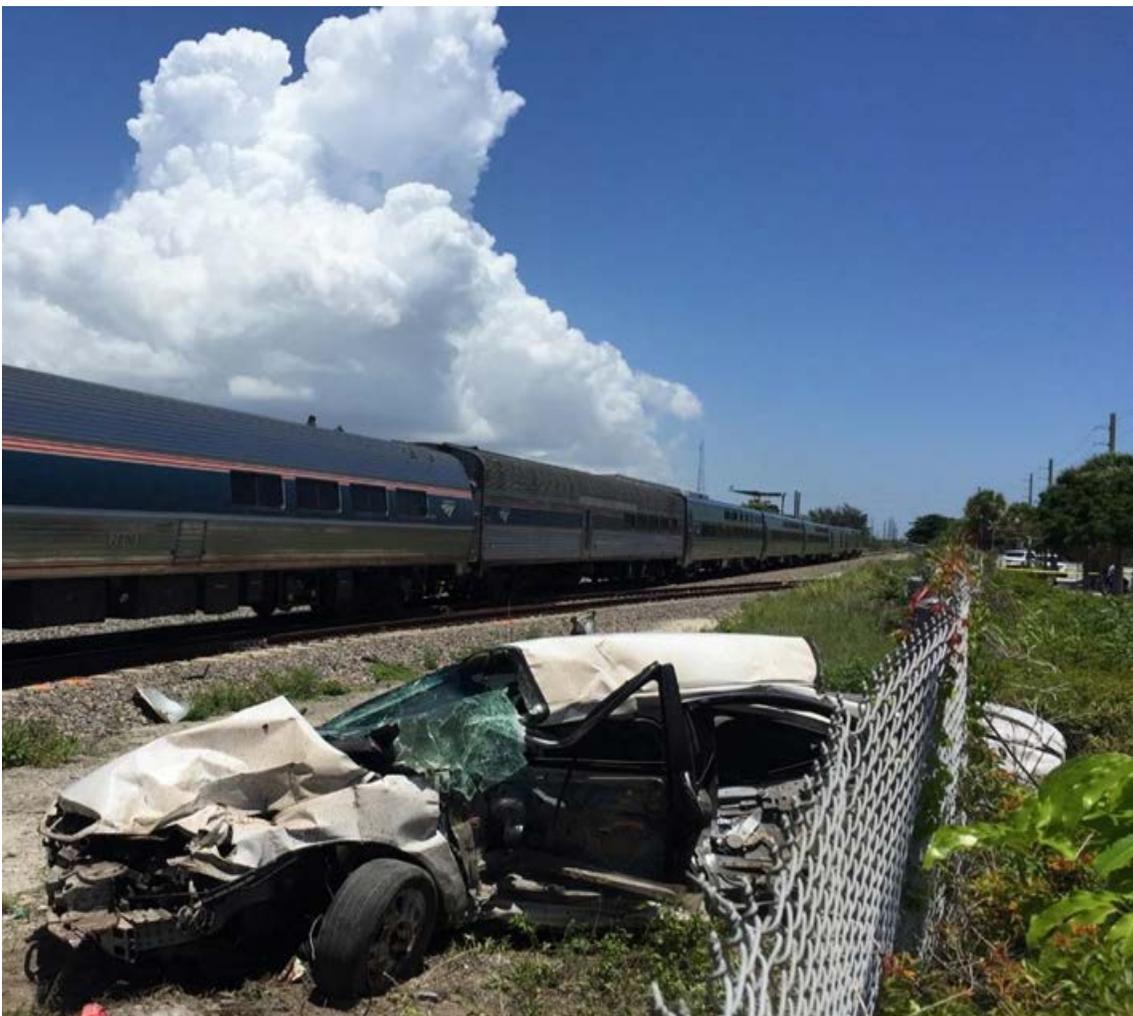
The train was en route from Miami, Florida, to New York, New York. The train did not derail. The train crewmembers and passengers were not injured. The damages to the train were estimated at \$16,300; the automobile was a total loss. At the time of the accident, the sky was clear, the visibility was 10 miles, and the temperature was 88°F.

Figure 1. The struck vehicle. (Photo courtesy of television station, WPBF Channel 25, West Palm Beach, Florida)

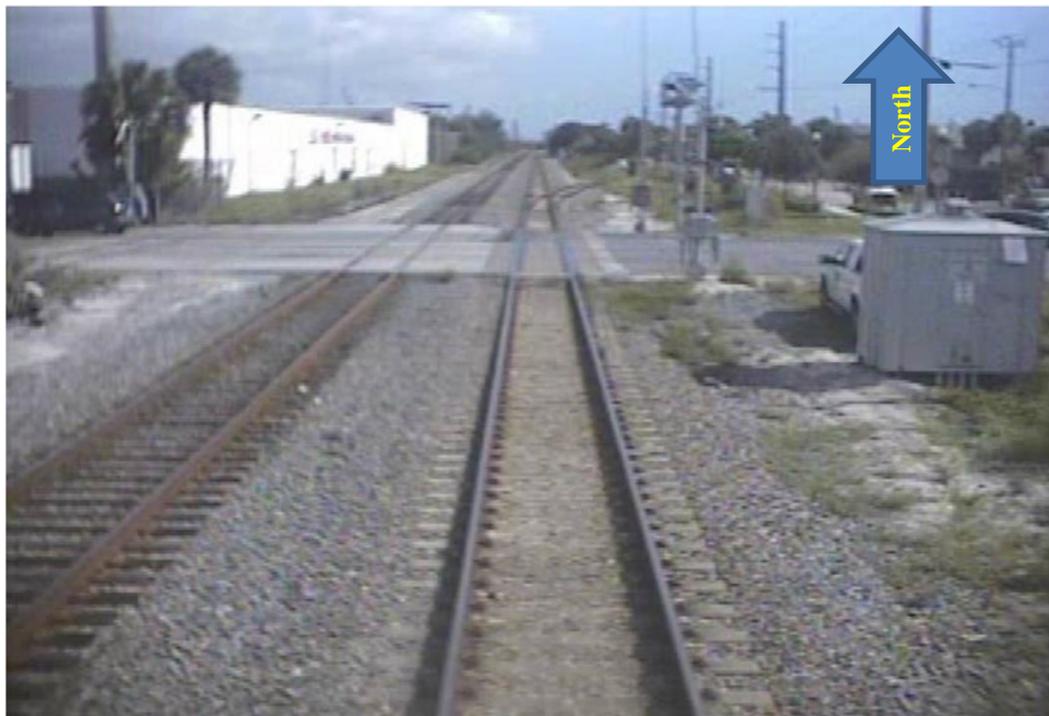
None of the crossing gates were down. (See figure 2.) At 9:59:37 a.m., a dark vehicle stopped prior to the tracks, while a white 2004 Mercury Sable continued across the grade crossing. At 9:59:38 a.m., the Amtrak train struck the Mercury while traveling 48 mph.

Figure 2. Photo from the locomotive video showing the grade crossing with gates in the upright position.

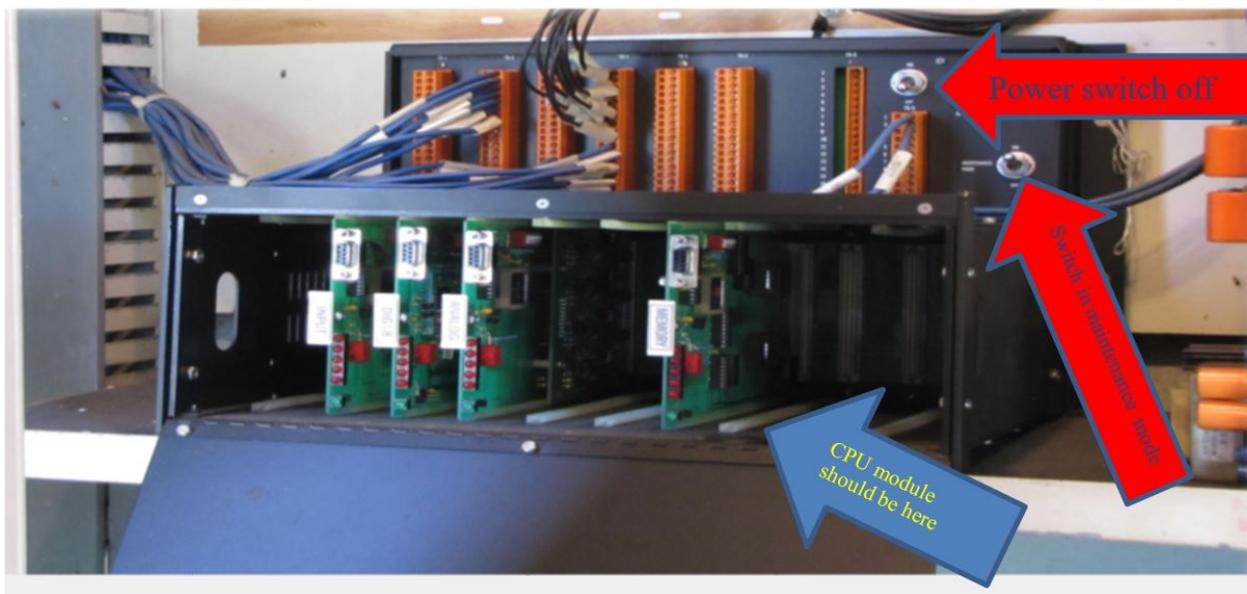
Figure 4. The external NAS event recorder and position of switches and missing CPU module.

The crossing warning system bungalow at 25th Street was equipped with a NAS event recorder. The recorder monitors some of the electro-mechanical relays, the crossing warning system operation, and island relay input voltage.⁸ This process of recorded events includes warning system activation, light activation, light flash rate, gate movement, train occupancy of the crossing, and crossing warning time. However, the NAS recorder does not monitor the control relay output of the GCP. The event recorder was found in the “off” position and in “maintenance mode” during the postaccident inspection. The CPU card was missing. Investigators used a replacement CPU card to retrieve the data. The event recorder showed that the crossing warning time was 1 second before the train struck the vehicle.⁹ (See Figure 5.)
