National Transportation Safety Board

Railroad Accident Brief

Collision of Two Union Pacific Railroad Freight Trains

Granger, Wyoming

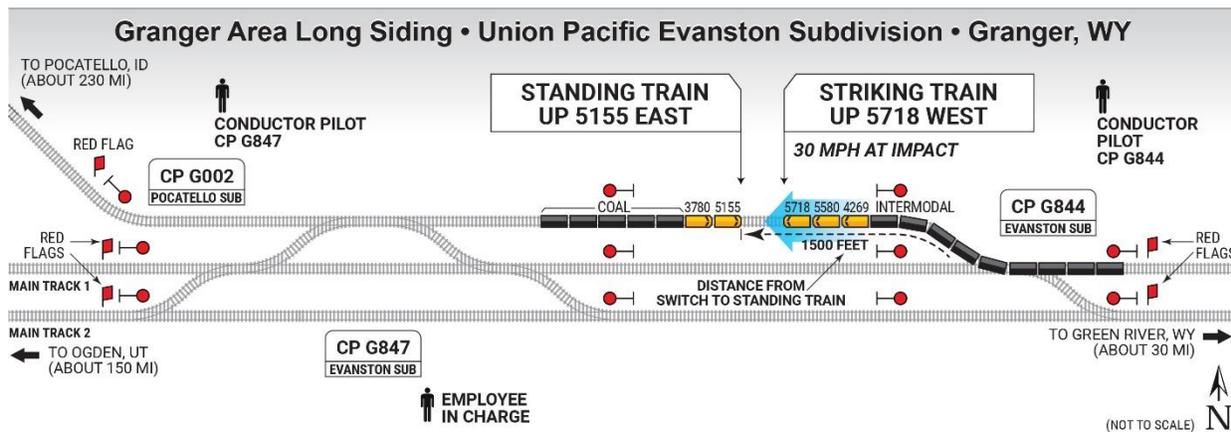
Figure 2. Accident diagram.

To install PTC between MP 865.7 and MP 843.9, UP suspended the signals and established absolute blocks between those mileposts and a procedure to guide trains through the suspension, which was managed by an employee-in-charge (EIC).³ The procedure is described below and shown in figure 2:

1. The train dispatcher talked with the EIC and described the proposed train route through the suspended section.
2. The EIC conferred with the signal EIC to verify that the proposed train movement could be made safely.⁴
3. The signal EIC ensured that employees were clear of the track and told the EIC that it was safe to authorize the train movement.
4. The EIC told the appropriate conductor pilot to authorize the train through the suspended section.
5. The conductor pilot verified that the switches were lined correctly for the proposed train movement.
6. The conductor pilot told the train crew to enter the suspended section and provided the designated route and the maximum speed.

When 5718 West entered the limits of the suspension on main track 1, it was travelling about 46 mph. The crew saw that the switch at CP G844 was lined so that their train would enter the Long Siding instead of continuing on main track 1.⁵ Typically switches were not lined until the dispatcher had decided the next movement through the switch; therefore, the switch was still in position (that is, lined) for the previous train movement. The engineer immediately applied the emergency brakes, and the train slowed to about 30 mph and collided with the stopped 5155 East at 9:41 p.m. When the crew on 5155 East saw the pending collision, they exited their stationary locomotive.
