National Transportation Safety Board

Railroad Accident Brief

New Jersey Transit Train Strikes Wall in Hoboken Terminal

Hoboken, New Jersey

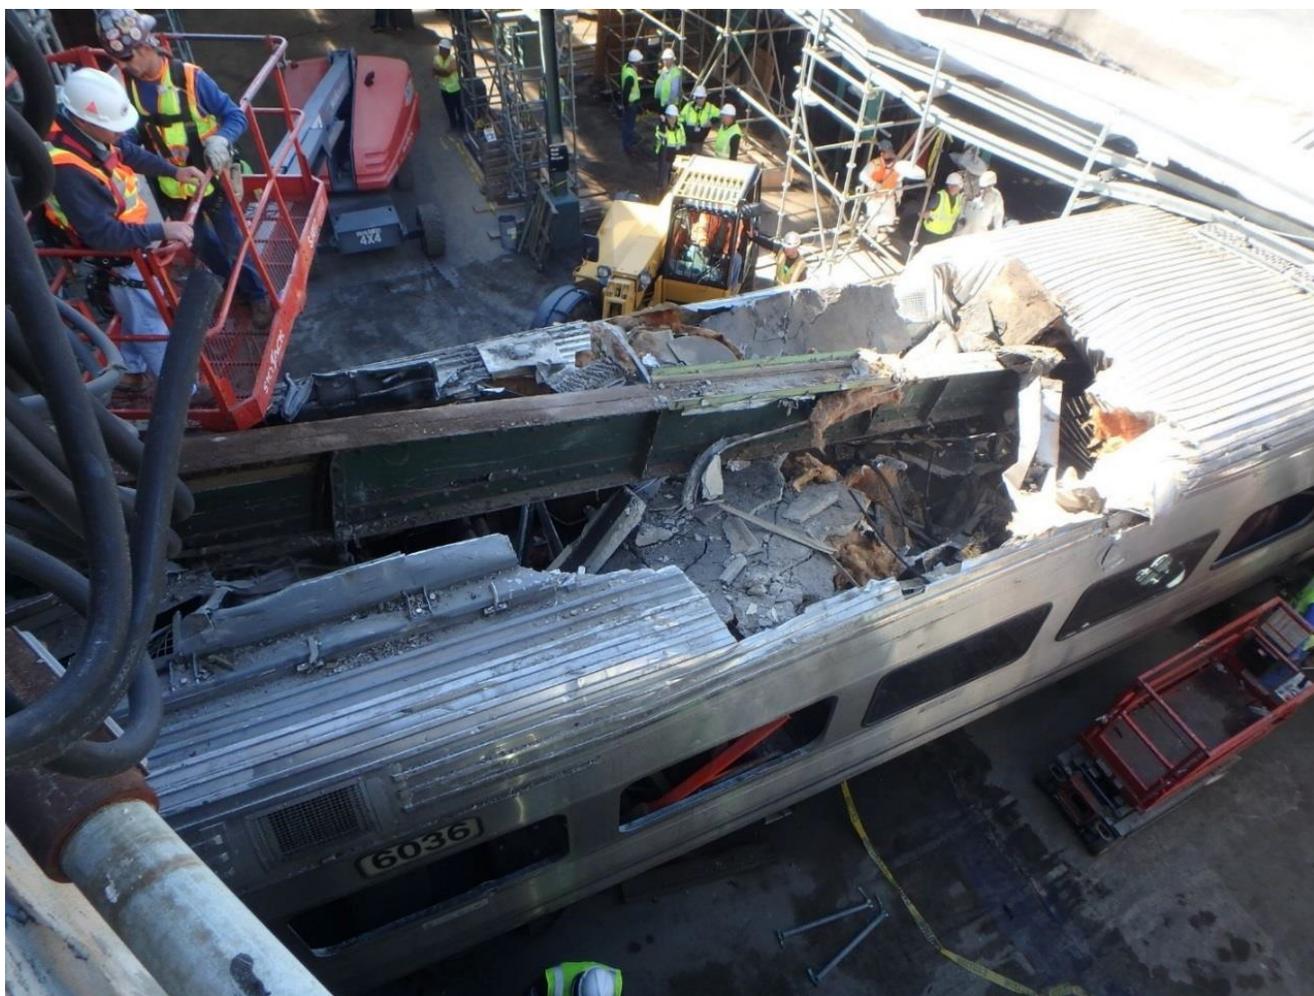
On September 29, 2016, about 8:38 a.m. eastern daylight time, New Jersey Transit (NJT) train 1614 failed to stop, overrode a bumping post at the end of track 5, and struck a wall of the Hoboken Terminal in Hoboken, New Jersey.¹ Train 1614 consisted of one controlling passenger car (cab car), three passenger cars, and one locomotive at the rear of the train. The train was traveling about 21 mph at the time of the accident.

Figure. Damaged controlling cab car.
