National Transportation Safety Board

Railroad Accident Brief

Southwestern Railroad Collision

Roswell, New Mexico

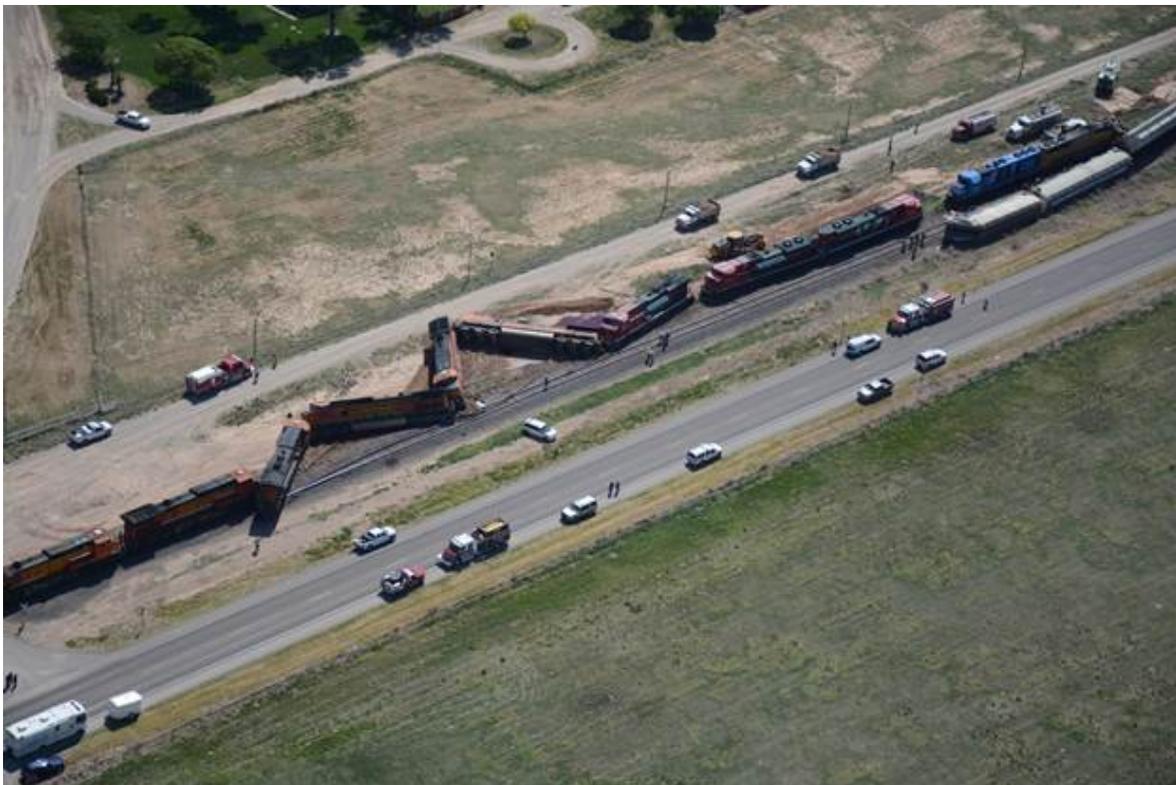
On April 28, 2015, at 6:23 a.m. mountain daylight time, a westbound Southwestern Railroad (Southwestern) freight train with nine locomotives and 79 cars collided with Southwestern's Roswell Local standing freight train. The striking train traveled through a switch that was in the reverse position at the east end of Chisum siding just south of Roswell, New Mexico. The two crewmembers on the lead locomotive of the striking train jumped before impact. (See figure 1.) The engineer died, and the conductor was seriously injured. Nine locomotives derailed from the striking train. Two locomotives and three empty hopper cars derailed from the standing train. Southwestern, which owned both trains, estimated the damage at \$2.01 million. Sunrise was at 6:14 a.m.—9 minutes before the accident; visibility was 10 miles.

Figure 1. Accident site. (Photo by New Mexico State Police.)

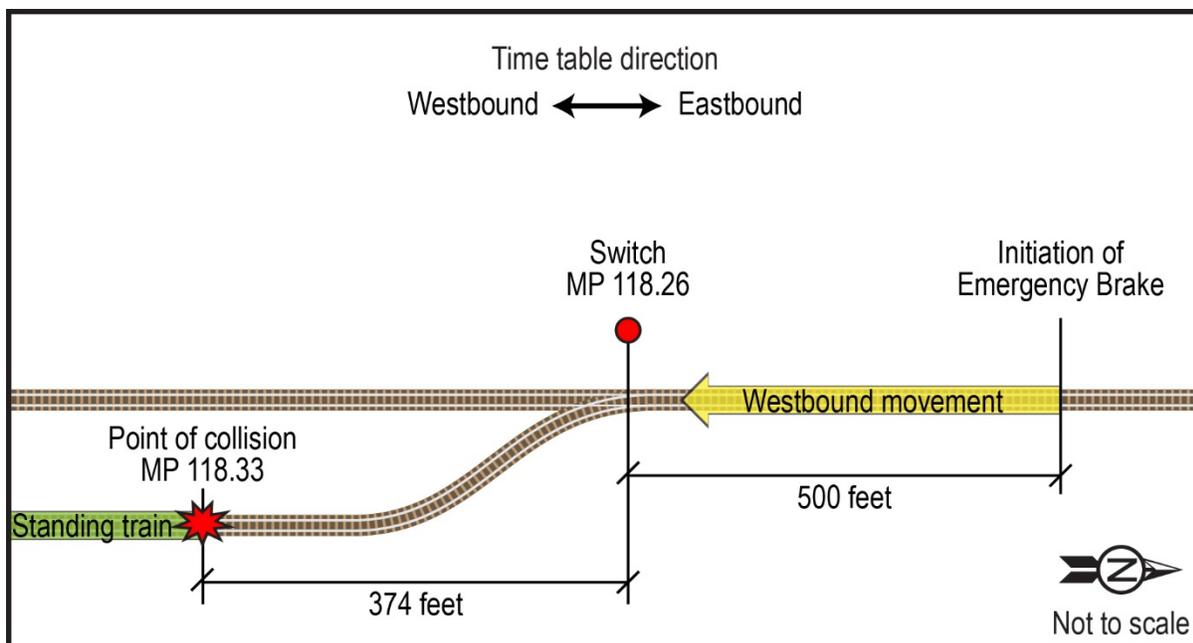
According to event recorder data, the striking train approached the east switch at Chisum siding at 42 mph, and the engineer began emergency braking about 500 feet before reaching the switch. The train entered Chisum siding traveling about 40 mph and went 374 feet before striking the standing train at an impact speed of 32 mph. The heavier striking train shoved the standing train more than 195 feet. All nine locomotives on the striking train derailed, but the freight cars stayed on the track. The two locomotives and the first three cars of the standing train derailed. (See figure 2.)

Figure 2. Diagram of accident site.

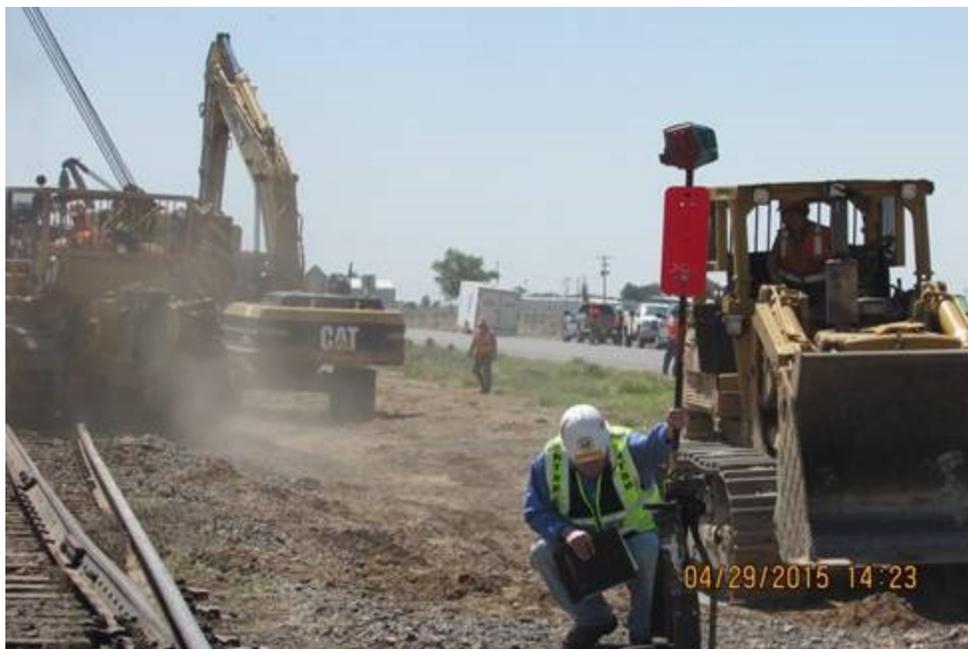
Investigators examined the conditions at and around the east switch of Chisum siding. (See figure 3.) The switch at the east of the Chisum siding was lined and locked for the siding. The switch was under the striking train's derailed locomotives. After Southwestern cleared the derailed train, National Transportation Safety Board (NTSB) investigators performed a sight-distance observation at the same time of day as the accident using a similar locomotive. They observed the switch target from 2,239 feet away.

Figure 3. Investigator inspecting the switch stand and operating rod.

Require railroads to develop a device or technique to eliminate the possibility of employees failing to perform critical tasks such as lining a switch, lining a derail, or ensuring cars are in the clear. (R-18-10)
