National Transportation Safety Board

Railroad Accident Brief

Southeastern Pennsylvania Transportation Authority Light Rail Collisions

Upper Darby, Pennsylvania

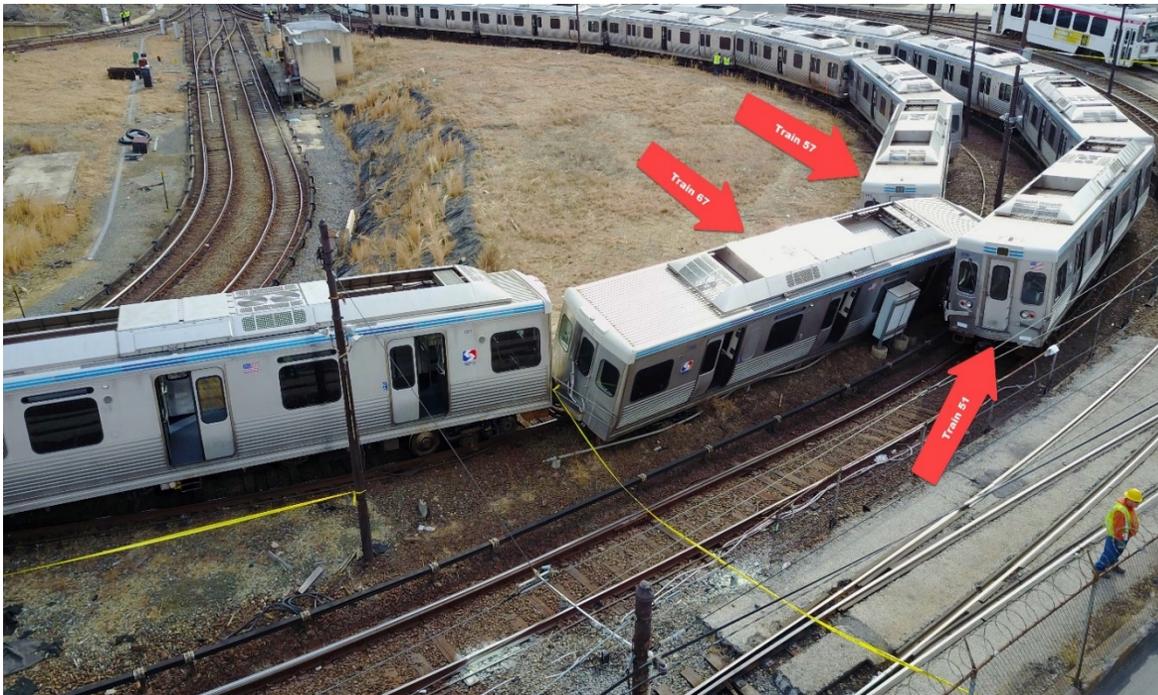
Figure 1. This postaccident photograph shows the three trains involved in the accident. (Photo courtesy of SEPTA).

Train 57, on the morning of February 21, 2017, consisted of six electrically powered multiple-unit passenger cars. It was manned by a single car operator located in the lead car control compartment when it arrived on the single track inbound platform (track number 1). Normal procedure was for the inbound train to take the first clear loop track and proceed to the outbound departure platform in preparation for the next trip back to downtown Philadelphia. However, because the train dispatcher had requested a move for train 51 on the number 1 loop track, the car operator of train 57 received a “Proceed Cab” signal in his control compartment. This cab signal indication required the car operator of train 57 to acknowledge the “Proceed Cab” signal and proceed at no more than 10 mph. Train 57 then departed the arrival platform at 69th Street and proceeded into the number 2 loop track. Recording devices on train 57 indicated that the train reached a speed of about 14 mph when the emergency brake system was applied. Train 57 struck the stopped train 67 at 8:10 a.m., derailing four cars of train 57 and three cars of the stopped train 67. The derailed lead car of train 57 also struck the lead car of train 51, operating on the number 1 loop track.

The National Transportation Safety Board determines that the probable cause of this accident was the temporary loss of awareness and lack of proper speed control by the train 57 operator as the train entered the 69th Street station loop track.

As a result of the accident, SEPTA made software updates to the computer-assisted dispatcher system that allows control of the loop tracks and enhances the protection for trains making reverse movements through the loop tracks.
