National Transportation Safety Board

Railroad Accident Brief

New York City Transit Train Strikes Two Flagmen

Brooklyn, New York

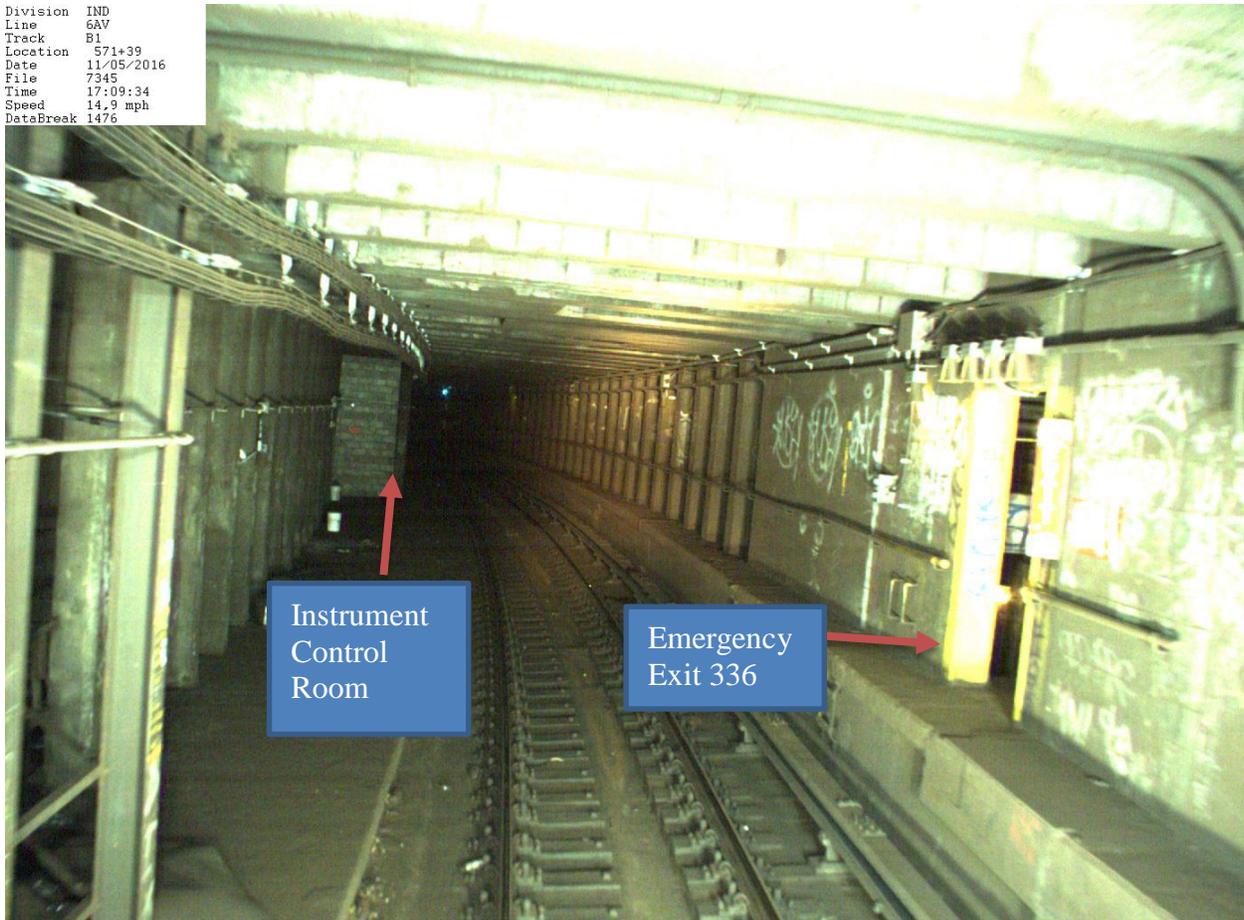
Figure 1. View of the instrument control room, bench wall and emergency exit on track B1 northbound at Church Avenue.

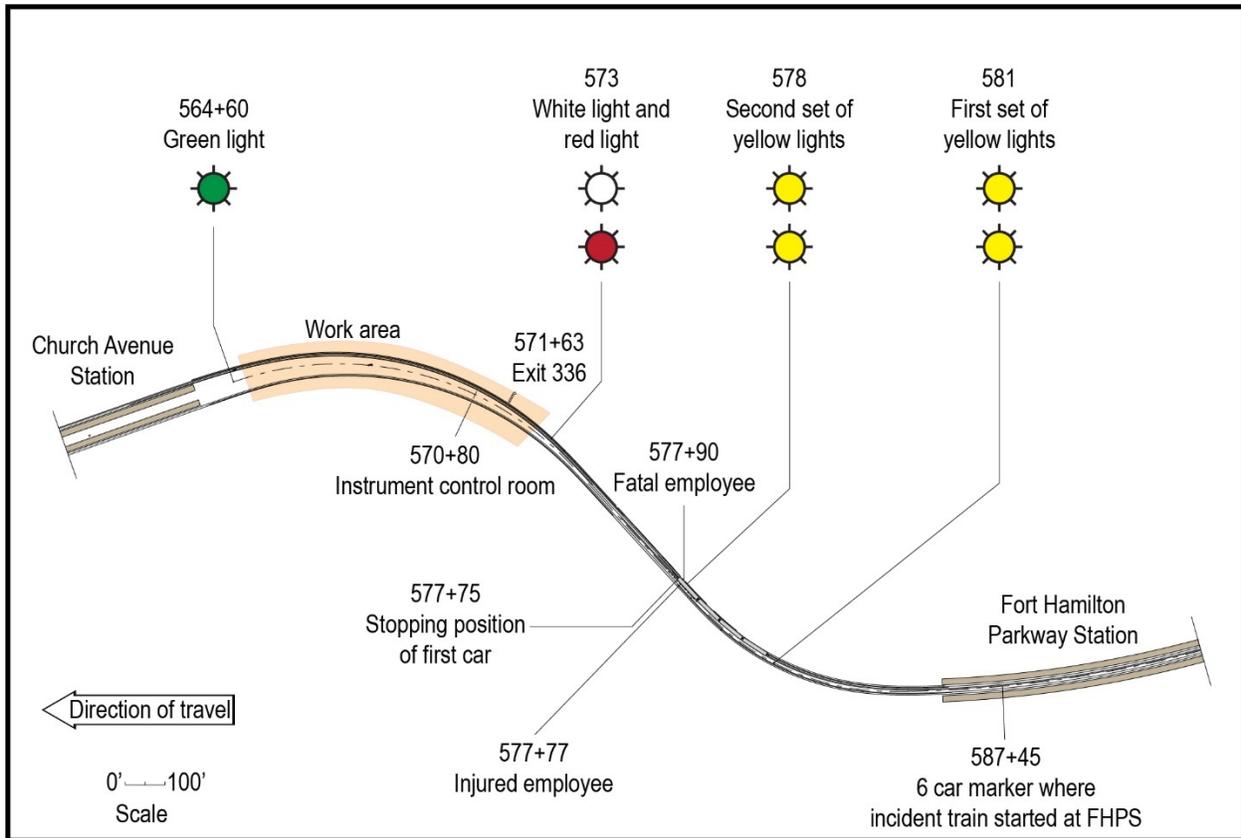
The two yellow placement flaggers walked further toward FHPS to place the two sets of lights. One of the two yellow placement flaggers was assigned to watch for and warn of approaching trains while the other placed the lights. One set of lights was placed at survey marker 578. In accordance with NYCT Flagging Rule 3.80(a), the flagger would have placed an additional two lights at survey marker 581. Figure 2 shows the planned placements of flagging protection and the location of the struck employees at the time of the accident. (See figure 2.) Prior to placing the additional lights, the flaggers were struck and pinned between G Line train car 5184 and the bench wall. The maximum authorized train speed at this location was 35 mph.

Figure 2. Planned flagging protection and the location of the struck employees.
