National Transportation Safety Board

Railroad Accident Brief

Metropolitan Atlanta Rapid Transit Authority Train 401 Strikes On-Track Equipment

Sandy Springs, Georgia

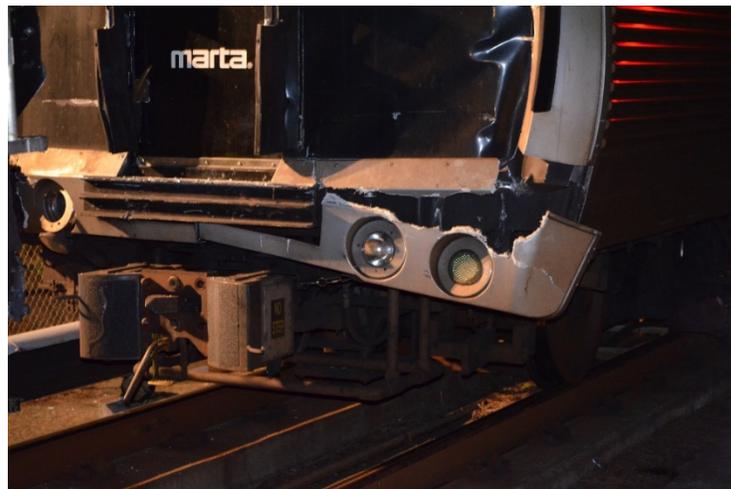
MARTA estimated the damages to the lead railcar at \$16,814.26. The OTE was damaged beyond repair; its replacement cost \$33,500. At the time of the accident, the temperature was 82°F, the sky was cloudless, and the visibility was 10 miles. Figure 1 shows the damaged railcar.

Figure 1. Postaccident photograph of front end of damaged MARTA railcar. (Photograph courtesy of MARTA.)

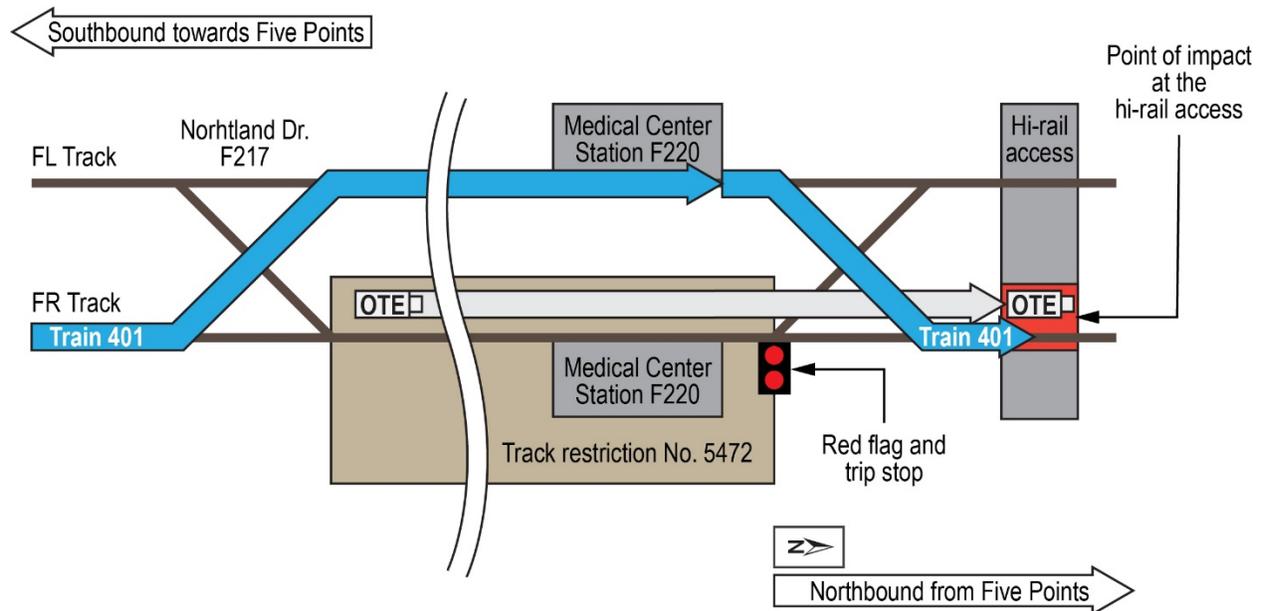
At the time of the collision, the OTE operator was standing between the gage of the rail in front of the OTE (north end). The striking train struck the rear of the OTE, which struck the OTE operator. The OTE was shoved about 108 feet in the collision. Figure 2 is a diagram of the accident scene.

Figure 2. Accident site.
