# National Transportation Safety Board

## Railroad Accident Brief

### Derailment of Metro-North Railroad Commuter Train

#### Rye, New York

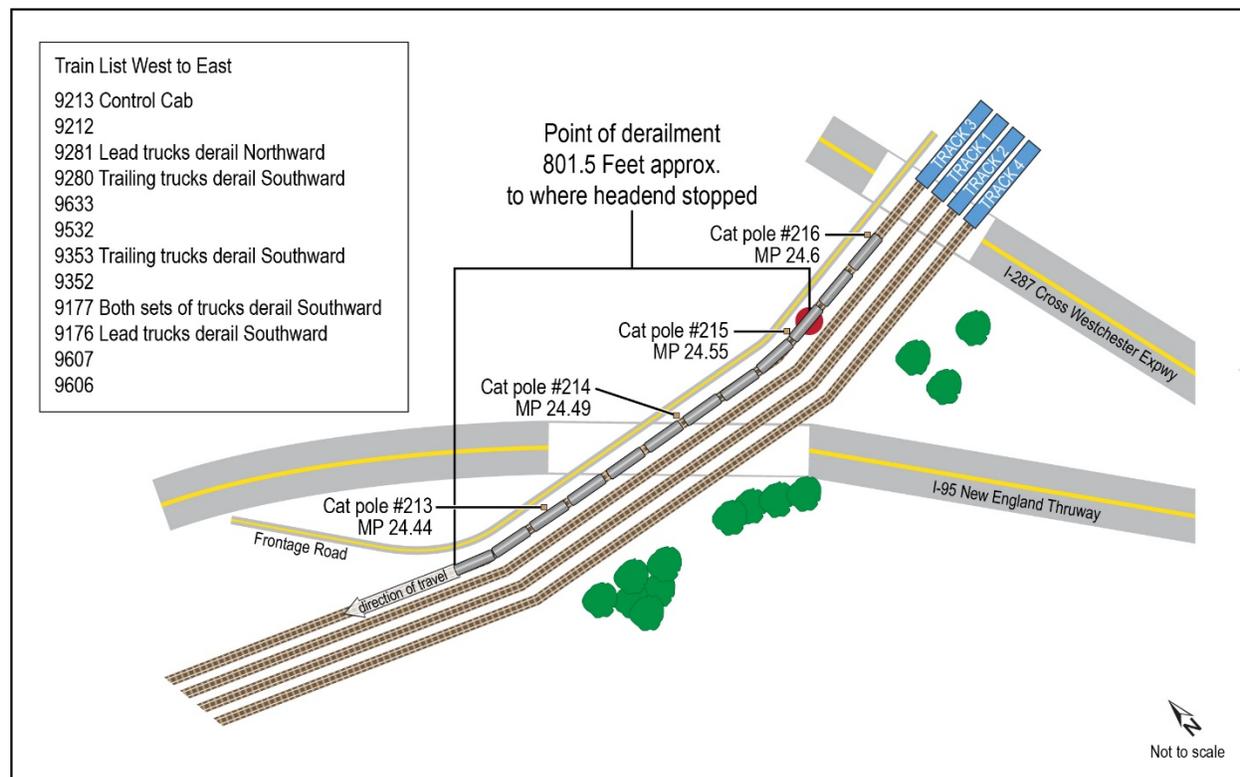
**Figure 1:** Site sketch of derailment area.

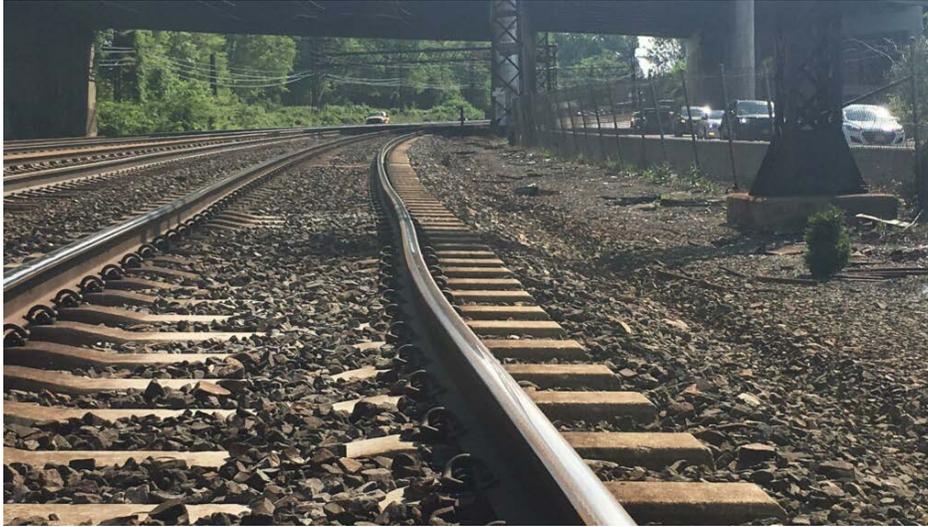
The track supervisor said that he thought that the track was misaligned about 2 inches, but he did not measure the deviation in alignment. The FRA Track Safety Standards (TSS) 213.55

allow for 5 inches of deviation of the mid-ordinate from a 62-foot cord for Class 1 track.<sup>9</sup> He watched about four trains pass over the area, and he said that the deviation was the same. At 4:30 p.m., as he was preparing to leave the area and make arrangements to have the track protected with slow boards and to make repairs, train 1371 passed through the area of the speed restriction at a speed that exceeded the 10-mph speed restriction that was in place.<sup>10</sup> The track supervisor reported the incident to the RTC and inspected the track again. He said that the alignment had not worsened. He departed the area. About 30 minutes later, he was called again by the RTC and was told that the area had worsened. As he started to return to the area, he was notified that train 1373 derailed at 4:56 p.m.

**Figure 2:** Preaccident view looking west toward catenary bridge 215 at the rail misalignment on track 3. (Photograph taken by Metro-North track foreman who responded to the track condition)

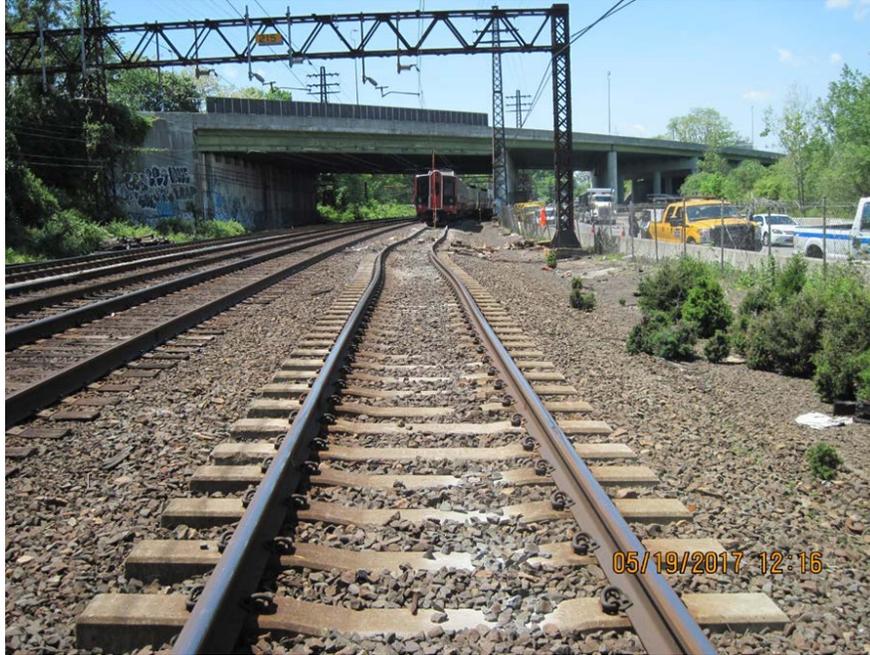
**Figure 3:** Postaccident view looking west toward catenary bridge 215 on track 3 toward the rail misalignment.

During the postaccident interview, the track supervisor said that when he and the foreman inspected the 10-mph slow order area, he thought that the area had insufficient track ballast. He said that he was going to make provisions to get ballast added to that location when the alignment was repaired.
