National Transportation Safety Board

Railroad Accident Brief

CSX Transportation Employee Fatality

Estill, South Carolina

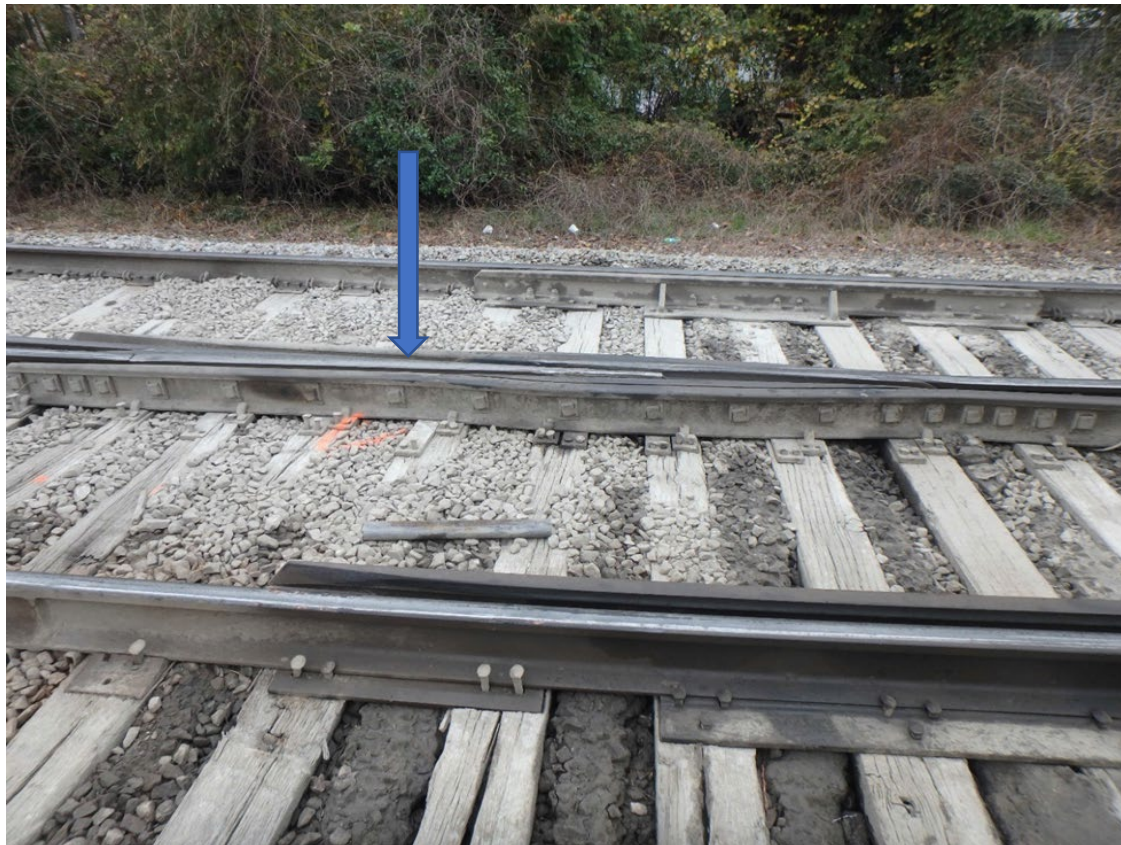
Figure. Photograph of track frog at the accident location.

Upon arrival at the work location, the welder informed the watchman that TAW would be the method of on-track safety protection; the welder started grinding on the frog of the switch. In a postaccident interview with NTSB investigators, the watchman said that the welder had followed the safety requirements of moving to a predetermined place of safety prior to the accident when a southbound train had traversed the track through the work location at a speed of 48 mph. However, when discussing what personal protective equipment was used, the watchman told NTSB investigators that he was wearing a yellow shirt with reflective stripes. He said that the welder was wearing a “yellow jacket” (welding jacket) while he was on the track welding, but that he removed his jacket once he had finished welding and was just wearing a black T-shirt.” In addition, the watchman said that the welder had at least one telephone ear bud in his ear and explained that neither he nor the welder were wearing hearing protection.⁵ NTSB investigators were unable to definitively determine if the welder was listening to music or some other source of distraction at the time of the accident.
