**Derailment of Canadian National Freight
Train M33371 and Subsequent Release of
Hazardous Materials in
Tamaroa, Illinois
February 9, 2003**

NTSB/RAR-05/01

**National
Transportation
Safety Board**

Abstract: About 9:04 a.m. central standard time on February 9, 2003, northbound Canadian National freight train M33371 derailed 22 of its 108 cars in Tamaroa, Illinois. Four of the derailed cars released methanol, and the methanol from two of these four cars fueled a fire. Other derailed cars contained phosphoric acid, hydrochloric acid, formaldehyde, and vinyl chloride. Two cars containing hydrochloric acid, one car containing formaldehyde, and one car containing vinyl chloride released product but were not involved in the fire. About 850 residents were evacuated from the area within a 3-mile radius of the derailment, which included the entire village of Tamaroa. No one was injured during the derailment, although one contract employee was injured during cleanup activities. Damages to track, signals, and equipment, and clearing costs associated with the accident totaled about \$1.9 million.

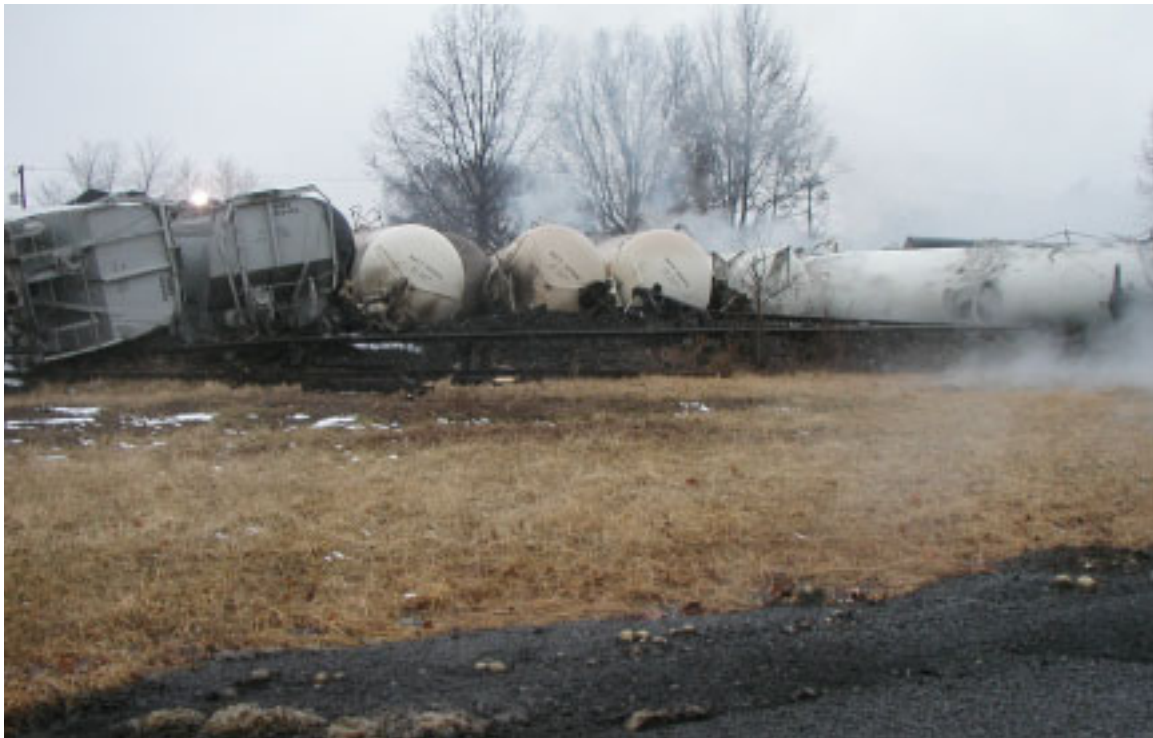
About 9:04 a.m. central standard time¹ on February 9, 2003, northbound Canadian National (CN)² freight train M33371, traveling about 40 mph, derailed 22 of 108 cars in Tamaroa, Illinois. (See figure 1.) Four of the derailed cars released methanol, and the methanol from two of these four cars fueled a fire. Other derailed cars contained phosphoric acid, hydrochloric acid, formaldehyde, and vinyl chloride. Two cars containing hydrochloric acid, one car containing formaldehyde, and one car containing vinyl chloride released product but were not involved in the fire. About 850 residents were evacuated from the area within a 3-mile radius of the derailment, which included the entire village of Tamaroa. No one was injured during the derailment, although one contract employee was injured during cleanup activities. Damages to track, signals, and equipment, and clearing costs associated with the accident totaled about \$1.9 million.

Figure 1. Post-derailment wreckage.

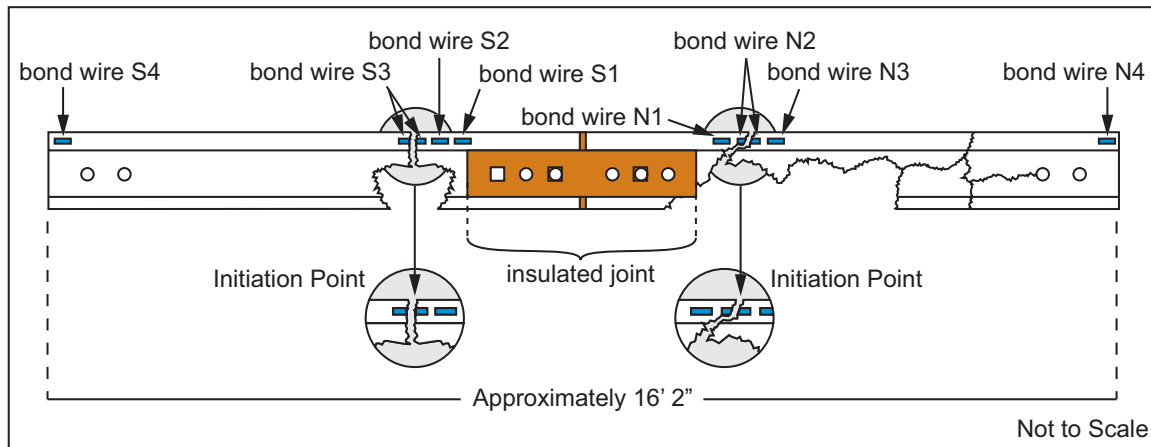
Fatigue cracking appeared to have originated at two exothermic bond wire welds.¹² (See figure 2.) Each of the three welds on either side of the insulated joint contained a single track bond wire. One wire was for the electronic track circuit code, the second wire was for an audio frequency circuit, and the third wire was for future use with a grade crossing predictor circuit.

Figure 2. Illustration of the insulated joint plug that failed at Tamaroa showing fracture locations. Three exothermic bond wire welds had been made at the head of the rail on either side of the insulated joint. (Letter designations indicate north or south portions of the plug.)

A CN welder for the Centralia Subdivision installed the insulated joint plug at the derailment site on January 23, 2003. (See figure 2.) The welder said that one of the two joint bars¹⁵ at an insulated joint was cracked. A new Allegheny insulated joint plug was delivered to the site, and the welder cut out the section of rail containing the defective insulated joint and replaced it with the Allegheny plug (which included a new, pre-assembled insulated joint). The new joint plug was not welded into place but was installed with standard 115-pound, 36-inch-long joint bars. The welder stated that he did not field-weld the insulated joint plug into the main track because the temperature was about 10° F

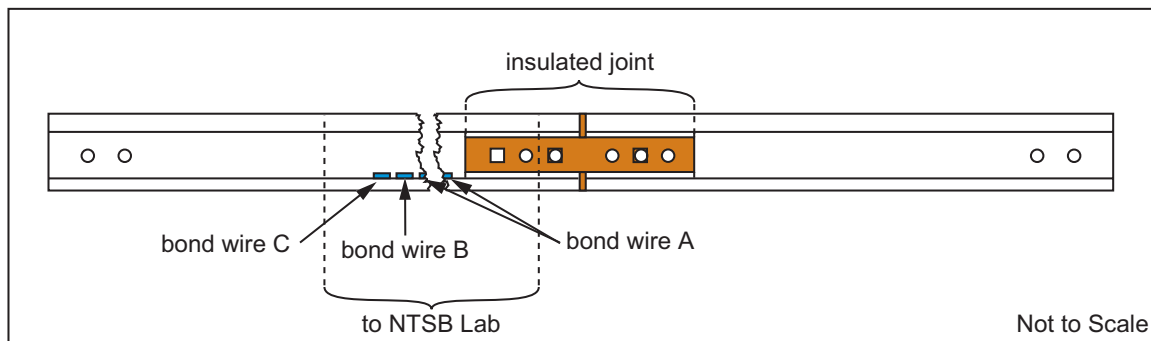
About 2 1/2 weeks before the accident at Tamaroa, a CN signal maintainer, while conducting his monthly inspection on January 23, 2003, discovered a broken rail at a signal bond wire weld at St. Johns station (milepost 285.45 on the Centralia Subdivision of the Gulf Division, about 5 1/2 miles from the derailment). The rail failure was in an Allegheny insulated joint plug at the St. Johns switch. (See figure 3.) No information was available to indicate how long the existing welds had been in place or whether there was any additional flexing of the rail due to inadequate underlying ballast support.

Figure 3. Illustration of insulated joint plug that failed at St. Johns showing fracture locations. Three bond wire welds had been made to the base of the rail outside the joint bar.

In the vicinity of the rail fracture, exothermic bond wire welds had been made on the base of the rail just outside the confines of the insulated joint bars. The top of the field side (outside) of the rail base contained three bond wire welds. The fracture appeared to emanate from an area near one of these welds, about 1 inch from the end of the insulated joint bars. Portions of the bond wire weld closest to the joint bars were present on both sides of the fracture.¹⁶
