Derailment of Washington Metropolitan Area Transit
Authority Train near the Mt. Vernon Square Station
Washington, D.C.
January 7, 2007

NTSB/RAR-07/03
PB2007-916303

Railroad Accident Report

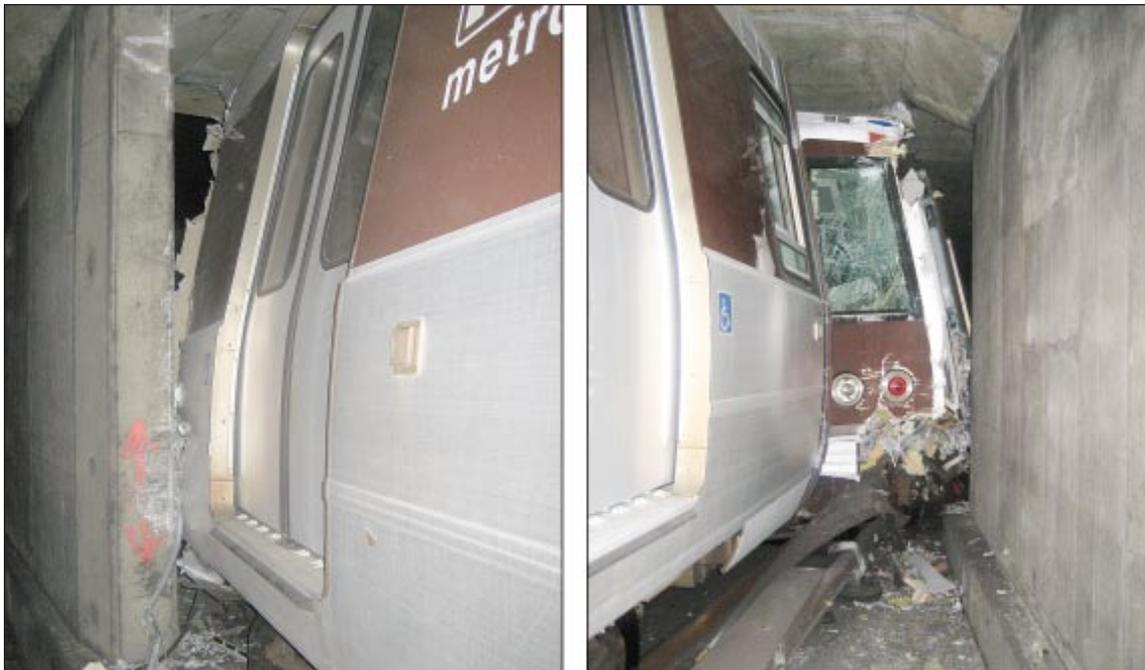
Figure 2. Front (left) and side (right) views of car 5152 where it struck tunnel wall.

Track turnout damage was limited to a few permanent spring clips that needed to be replaced. No other significant switch components required replacement. The contact damage at the tunnel wall and track damage accounted

for about \$1,000 in damages. WMATA estimated that it would cost \$3.8 million to replace the damaged vehicles.

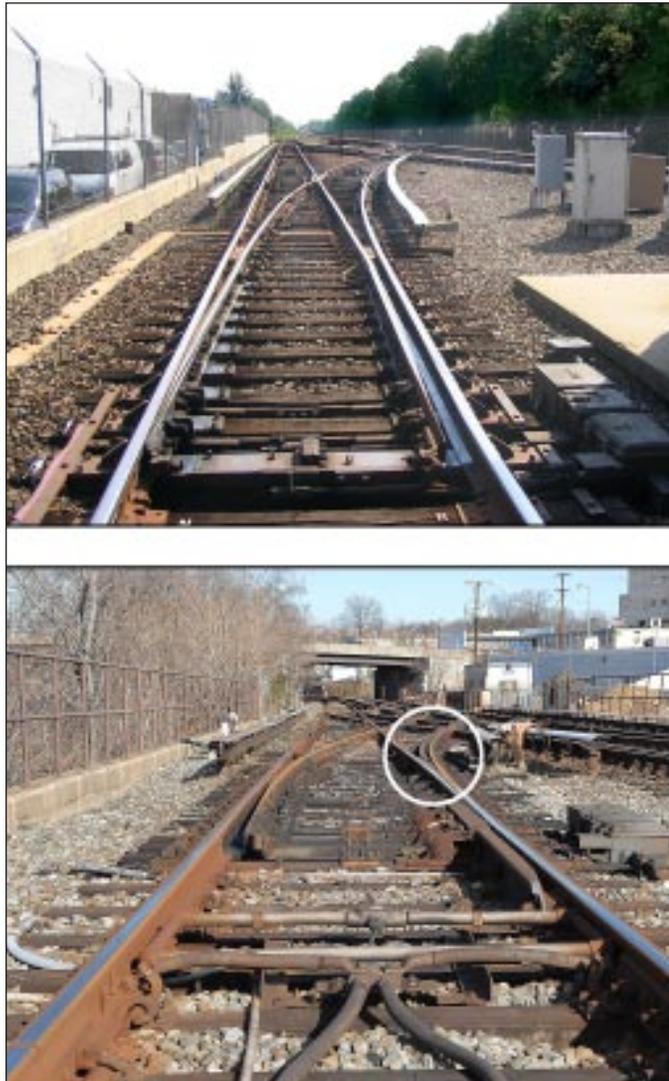
The derailment occurred as northbound train 504 entered the standard right-hand No. 8 turnout⁶ on main track 2 traveling about 18 mph. (A standard turnout differs from a guarded turnout because it lacks guard rails positioned along the switch's running switch point and running rail on the turnout side. WMATA maintains both guarded and unguarded, or standard, turnouts. See figure 3.) The train derailed three of the four axles of its fifth car at chain marker E2 23+24, which is located along the curved closure

Figure 3. Unguarded No. 8 turnout (top) and guarded No. 8 turnout (bottom).

The TTCI, APTA, and TCRP reports found that there is an increased risk of a wheel flange climb derailment when a transit car operates through a standard No. 8 turnout. Further, the TTCI report recommended in 2005 that WMATA replace standard No. 8 turnouts with guarded turnouts. WMATA has informed the Safety Board that it is replacing all standard No. 8 turnouts with guarded turnouts on its main track. Currently, WMATA is replacing an average of about 30 turnouts per year.

- WMATA should instigate as soon as possible its informally stated requirement that all yard curves with radii less than 500 feet should be equipped with restraining rails. This should also apply to No. 8 turnouts (and sharper). This improvement would significantly reduce the low speed derailments in yards and turnouts/switches.
- WMATA should implement a program to reduce vertical spring imbalance in the 2000- and 5000-series cars.
- Simulations of air spring imbalance and low air spring height were performed for a very limited set of conditions. Further simulations could be conducted to obtain a better understanding of the effects of air spring imbalance, different combinations of air spring height, and air-spring lap band for a variety of track geometric conditions.

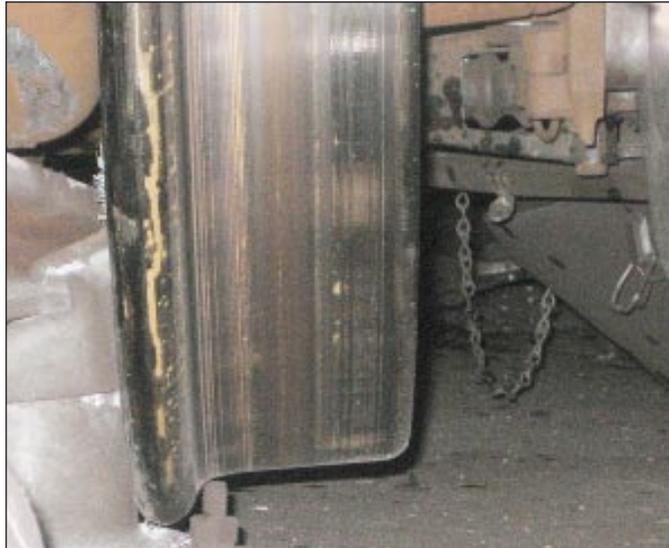
Investigators noted that all wheels on the right side of derailed car 5152 and the front truck of car 5153 had about 1/16 inch of wear even though the wheels on both cars had been trued on January 5 and 6, just a few days before the accident.

Investigators also examined the milling machine used to mill the wheels on car 5152. The alignment of the cutting head on the right side was about 1/16 inch closer to the inside than required. Further examination of the milling machine found worn parts.

Figure 6. Wheel #2 from car 5152 with fish scale pattern from recent milling.

pronounced ridges. The only smooth, polished area was about a 1/4-inch-wide line in the center where the wheel tread most frequently made contact with the rail head. WMATA milling machine operators did not polish wheel surfaces after truing operations. The TCRP report²⁵ indicates that a rough wheel surface finish from wheel truing increases the probability of a wheel climb derailment. The report further indicates that wheel surface conditions may be improved by addressing the final wheel surface. Addressing the final wheel surface can involve a light finishing cut, with no significant material removed, to smooth the roughness of the wheel tread surface. Newly trued wheel surfaces can also be polished by running the cars through curved yard tracks and turnouts until the rough finish is smoothed over the entire tread surface. The Safety Board concludes that WMATA's lack of measures to smooth wheel surfaces after truing increases the potential for a wheel climb derailment. WMATA has no explicit guidelines concerning the final surface texture. The Safety Board therefore believes that WMATA should develop a standard for maximum allowable wheel roughness and develop and implement post-wheel-truing procedures to meet that standard.

The investigation found irregularities in the dimensions of recently trued wheels at WMATA, including the wheel that derailed in this accident. Although the overall profile of the wheel was accurate, measurements indicated that more material was being removed during the truing operation than was necessary. The cutting head on the milling machine that was used on the wheel was found to be out of alignment. The milling machine's internal bearings were replaced, and the alignment was corrected. The Safety Board concludes that although the misalignment of the milling machine used in WMATA's wheel-truing operation did not contribute to the wheel climb, it does indicate inadequacies in WMATA's quality assurance process. The Safety Board therefore believes that WMATA should implement quality assurance procedures to ensure accurate wheel truing, including the regular alignment and indexing of cutting heads on wheel milling machines.
