Collision of Amtrak Passenger Train 371 and Norfolk
Southern Railway Company Freight Train 23M
Chicago, Illinois
November 30, 2007

NTSB/RAR-09/01
PB2009-916301

Railroad Accident Report

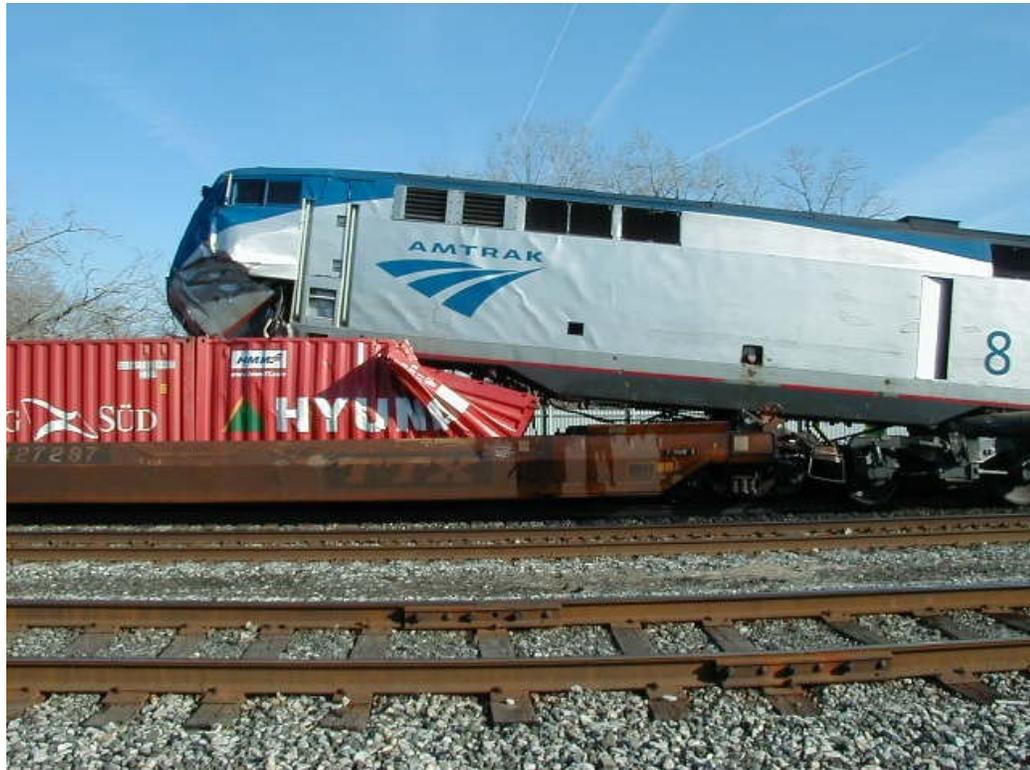
The Amtrak locomotive was the only derailed piece of equipment. The leading truck assembly⁶ ruptured the left front section of the fuel tank, and about 300 gallons of diesel fuel

spilled from the tank. Both front windows of the cab were dislodged during the collision. The rear window on the right side of the cab was shattered but still in its frame.

Figure 3. Amtrak locomotive resting on top of container on rear car of Norfolk Southern freight train.

Just inside the rear door to the cab from the engine room, the floor was lifted 7 inches and was arched upward in the cab. The engineer's seatback was about 5 1/2 inches from the roof of the cab, the center seatback was about 2 1/2 inches from the roof, and the left seatback was touching the roof. Normally, the seatbacks are 23 inches from the roof.

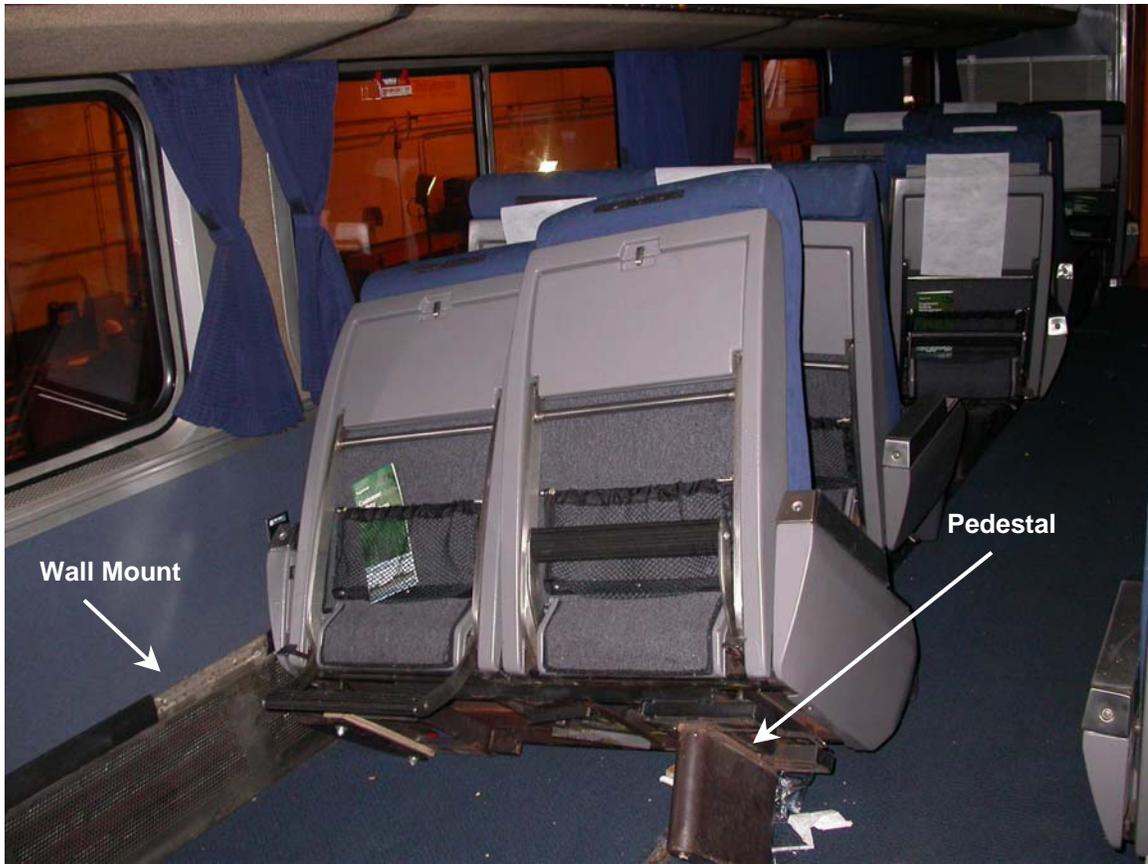
Figure 4. Seat pair 19-20.

The two fractured mount studs from seats 7-8 and the fractured mount stud from seats 19-20 from car 34054 were sent to the Safety Board's Materials Laboratory. The Materials Laboratory compared the accident mount studs that failed with an exemplar mount stud of the type that did not fail. The head profile of each mount stud was measured and the material was tested for hardness. Minor differences in head profiles and average hardness values were noted.

The fractures on two of the mount studs contained crack arrest marks that are typical of fatigue cracking emanating from the relief radius between the shank and head portion of the mount stud. The fractures on the head of the third mount stud had fine-grained features that are typical of overstress separation with no evidence of fatigue cracking. The exposed fracture faces showed metal flow that is consistent with the mount stud pulling up relative to the floor-mounting track. The upper side portion²¹ of the heads in areas that corresponded to a fatigue crack had fretting²² damage.

As a result of the collision, three seat pairs were detached from the guides on the floor of the car. The Safety Board’s Materials Laboratory examined the mount studs that attached the seat pedestals to the mounting guides on the floor. The head portions of two mount studs contained preexisting fatigue cracks that contributed to the detachment of each seat pedestal during the accident. The fatigue cracks were a stress riser that reduced the impact resistance of the mount studs.

The Safety Board concludes that some of the seat mount studs experienced fatigue cracking that resulted in seat pedestals detaching from the floor. Amtrak reviewed its existing inventory and found no seat mount studs of the type that fractured in this accident. All mount studs on the seats involved in this accident were replaced before the passenger cars were returned to service. During Amtrak’s ongoing overhaul program, replacement mount studs of the type that did not fracture are being installed in all seat pedestals on Superliner passenger cars. This replacement program will be completed within 4 years.
