Collision of Dakota, Minnesota & Eastern Railroad
Freight Train and 19 Stationary Railcars
Bettendorf, Iowa
July 14, 2009

Accident Summary Report

NTSB/RAR-12/03/SUM
PB2012-916303

NTSB/RAR-12/03/SUM
PB2012-916303
Notation 8396
Adopted April 30, 2012

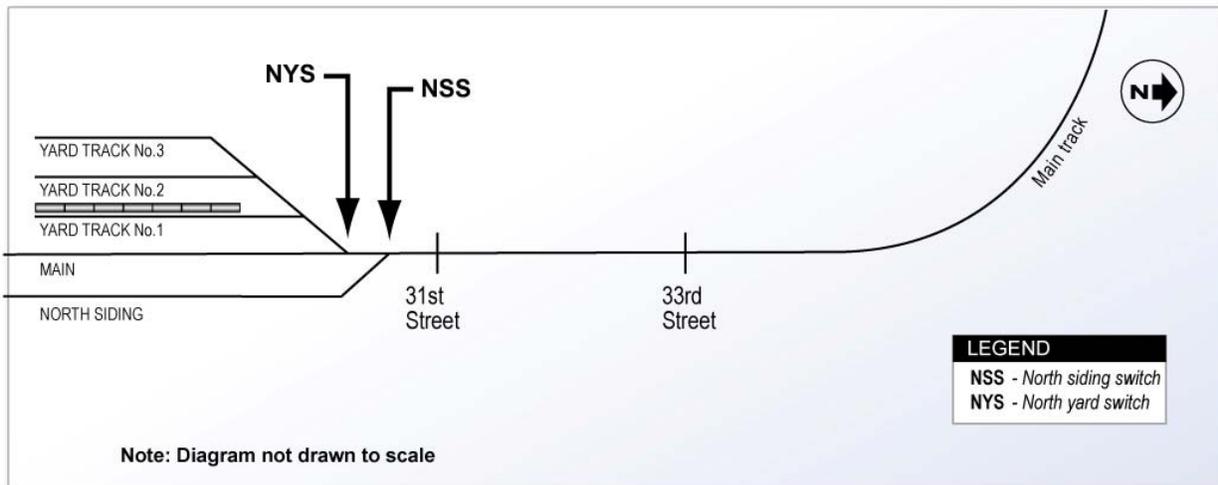
Figure 2: Bettendorf Yard immediately before BNSF local crew placed cars on yard tracks Nos. 2 and 3.

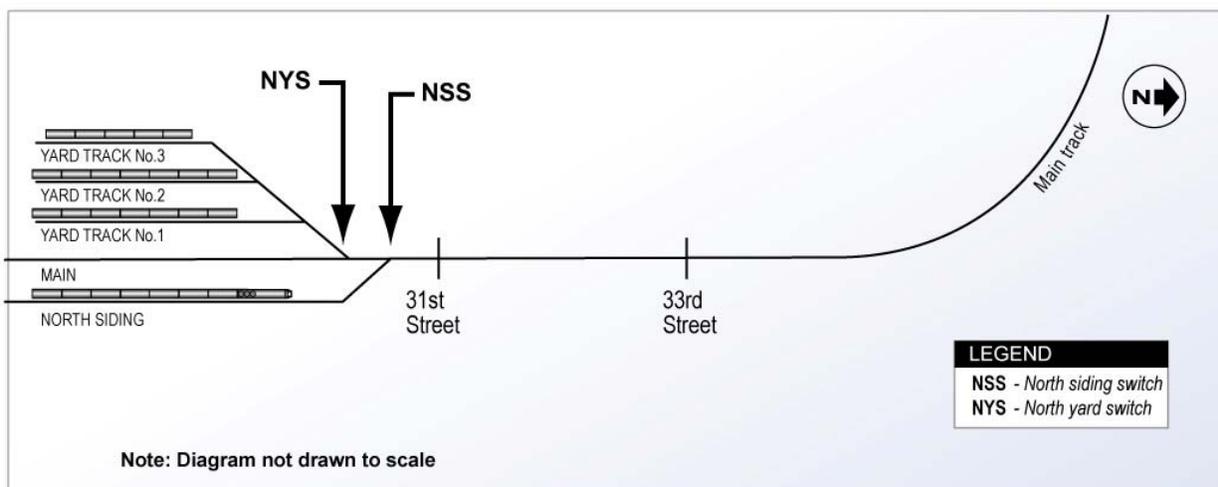
Figure 3. View of Bettendorf Yard after BNSF local cleared onto north siding.

After the BNSF local completed its movement onto the north siding, the remote-controlled north siding switch automatically lined itself back for the main track. However, the north yard hand-operated switch remained lined toward yard track No. 3. In compliance with the *General Code of Operating Rules (GCOR)*⁸ Rule 5.9.2, the BNSF local engineer turned the locomotive's headlight off to avoid adversely affecting the vision of the crew of the oncoming DME train.
