Collision Involving Three BNSF Railway Freight Trains
near Amarillo, Texas
September 25, 2013

NTSB/RAR-15/02
PB2015-105169

Railroad Accident Report

Collision Involving Three BNSF Railway Freight Trains

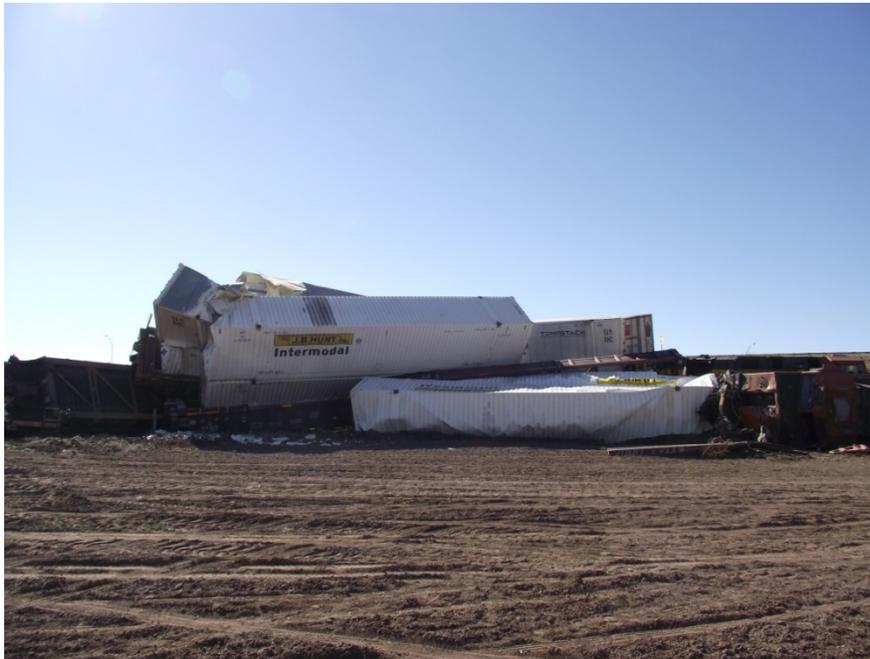
On September 25, 2013, at 4:17 a.m. central daylight time, BNSF Railway (BNSF) eastbound train BLACWSP223A (7891 East) struck the rear end of BNSF train SLHTLPC223A (6746 East) on main track no. 2 near Amarillo, Texas.¹ Several cars from 7891 East derailed and fell across the adjacent track, main track no. 1. Approaching BNSF westbound train ZWSPSBD724L (6943 West) struck the derailed cars. (See figure 1.)

Figure 1. Derailed cars from trains 7891 East and 6943 West.

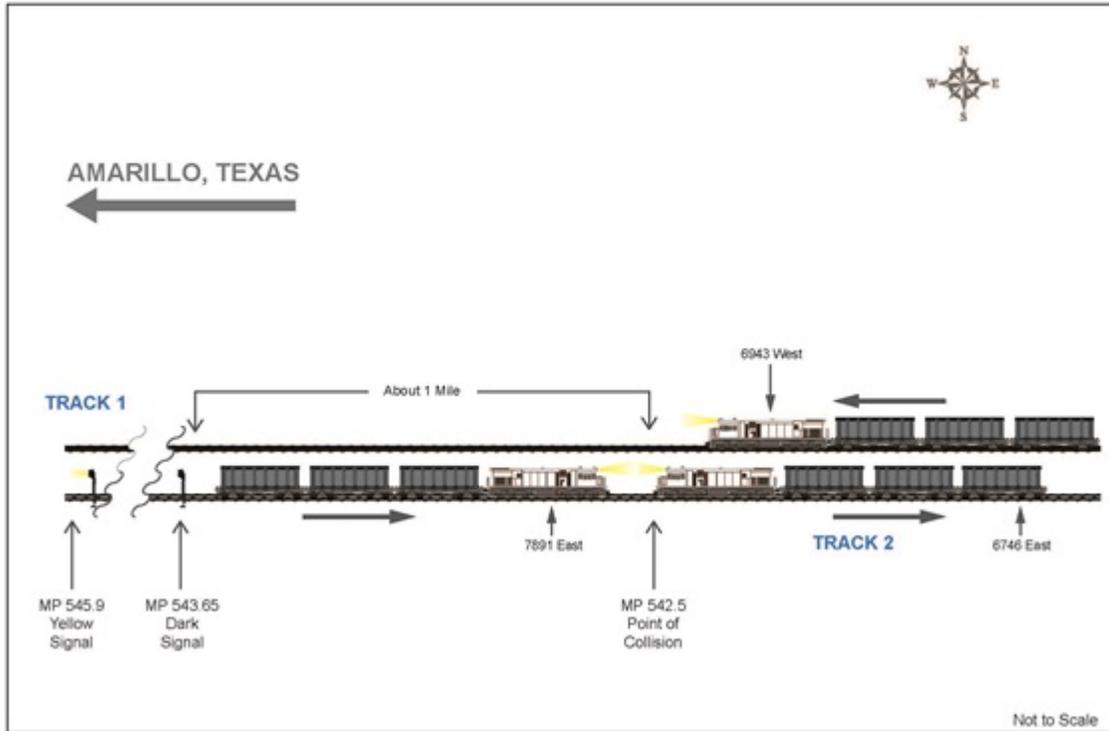
Figure 2. Diagram of the tracks and signals at the accident scene.

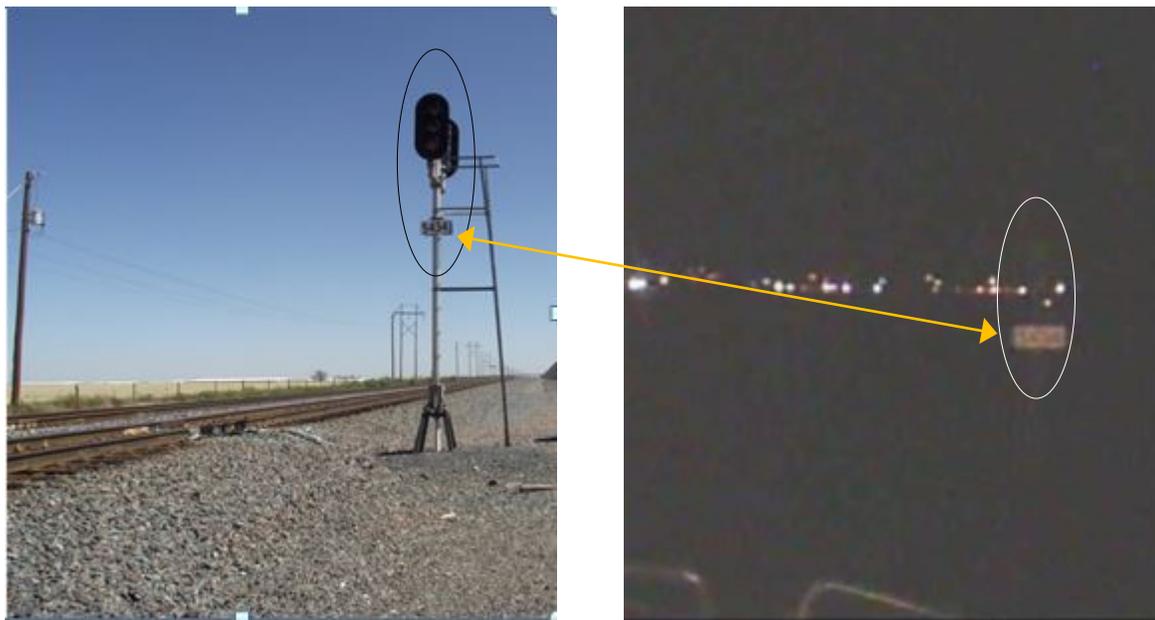
³ NTSB investigators confirmed that the signal at MP 545.9 displayed a yellow aspect and the signal at MP 543.65 was dark. Testing confirmed that only the signal lamp used to display a red aspect was burned out; The *General Code of Operating Rules*, Sixth Edition, Effective April 7, 2010, Rule 9.4, “Improperly Displayed Signals or Absent Lights,” requires that a dark signal be regarded as displaying the most restrictive indication.

Investigators reviewed forward-facing video of the dark signal from the lead locomotive and determined that it was visible for about 2 seconds on approach. (See figure 3.)

Figure 3. Day and night photos of signal at MP 543.65. Photo on right is from the forward-facing camera of train 7891 East.

⁵ The signal had three aspects—green, yellow, and red—illuminated by separate lamps. The only lamp that was burned out was the red aspect. If the previous train had either a yellow, flashing yellow, or green signal aspect, the crew would not have encountered the dark signal.

The current design of PTC includes automatic block signal locations. Although the lamp was burned out in this particular signal, the signal circuitry would have identified this as a stop location. A PTC system would have warned the engineer in the locomotive cab of the upcoming restrictive signal. If the engineer had not responded, the PTC system would have automatically applied the brakes and stopped the train before the train passed the signal at MP 543.65. Therefore, the NTSB concludes that had the territory been equipped with PTC, the train would have been stopped at the signal at MP 543.65, regardless of the light's being burned out.

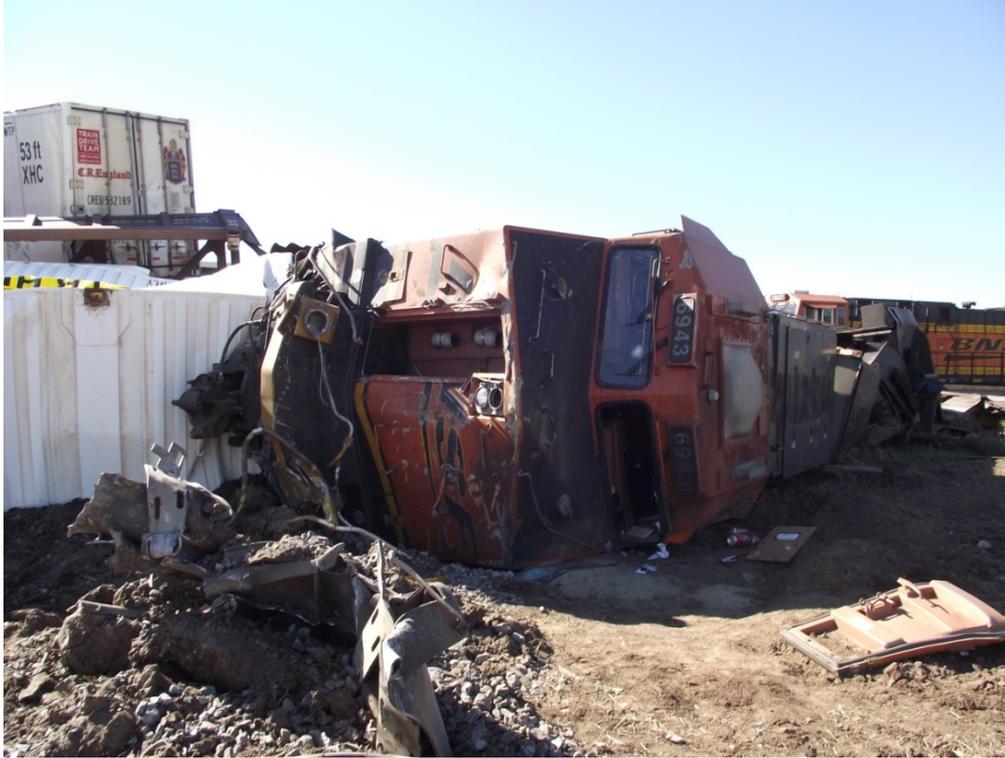
Train 6943 West departed Wellington, Kansas, at 12:09 a.m. The engineer and the conductor had gone on duty September 24, 2013, at 10:00 p.m. The engineer told NTSB investigators that, while operating on main track no. 1 and passing an eastbound train on main track no. 2 near MP 542.0, he heard the conductor from 7891 East announce on the radio “emergency, emergency, emergency.” He also heard the conductor on 7891 East advise him to stop the train. Just seconds later, he observed a railroad car lying crossways on main track no. 1. He applied the emergency brakes, and both crewmembers braced for impact. (See figure 4.)

Figure 3. Lead locomotive of 6943 West.
