Washington Metropolitan Area Transit Authority L'Enfant
Plaza Station Electrical Arcing and Smoke Accident
Washington, D.C.
January 12, 2015

Accident Report

NTSB/RAR-16/01
PB2016-103217

National
Transportation
Safety Board

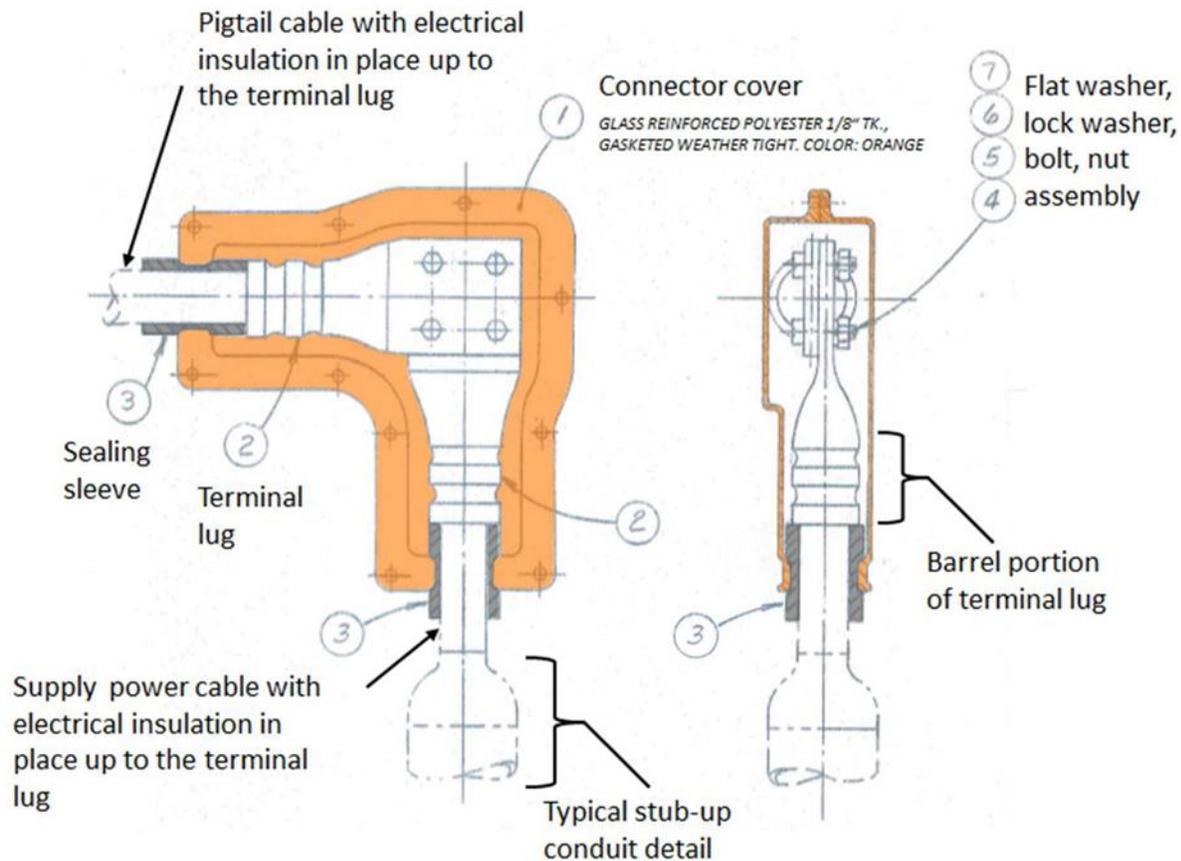
Figure 5. Cable connector assembly.

NTSB investigators found that electrical arc tracking can occur at a cable connector assembly if the power cable terminal lugs are not sealed in a weathertight connector, called a sealing sleeve, allowing contaminants in the external environment access to the bare lugs inside the connector.³² Under these conditions, electrical arc tracking can occur when contamination extends between the conducting surface of the terminal lugs and ground, creating an electrically conductive path along the outside surface of the cable. The presence of moisture is a necessary condition for the accumulated contaminants to become electrically conductive. Arc tracking is a relatively low-current phenomenon and will not instantly result in a high-power short circuit. Over time, cumulative degradation of the insulating material caused by the electrical arc tracking can cause a low resistance path between the lugs and ground, creating a short circuit that can generate fire and smoke in tunnels.

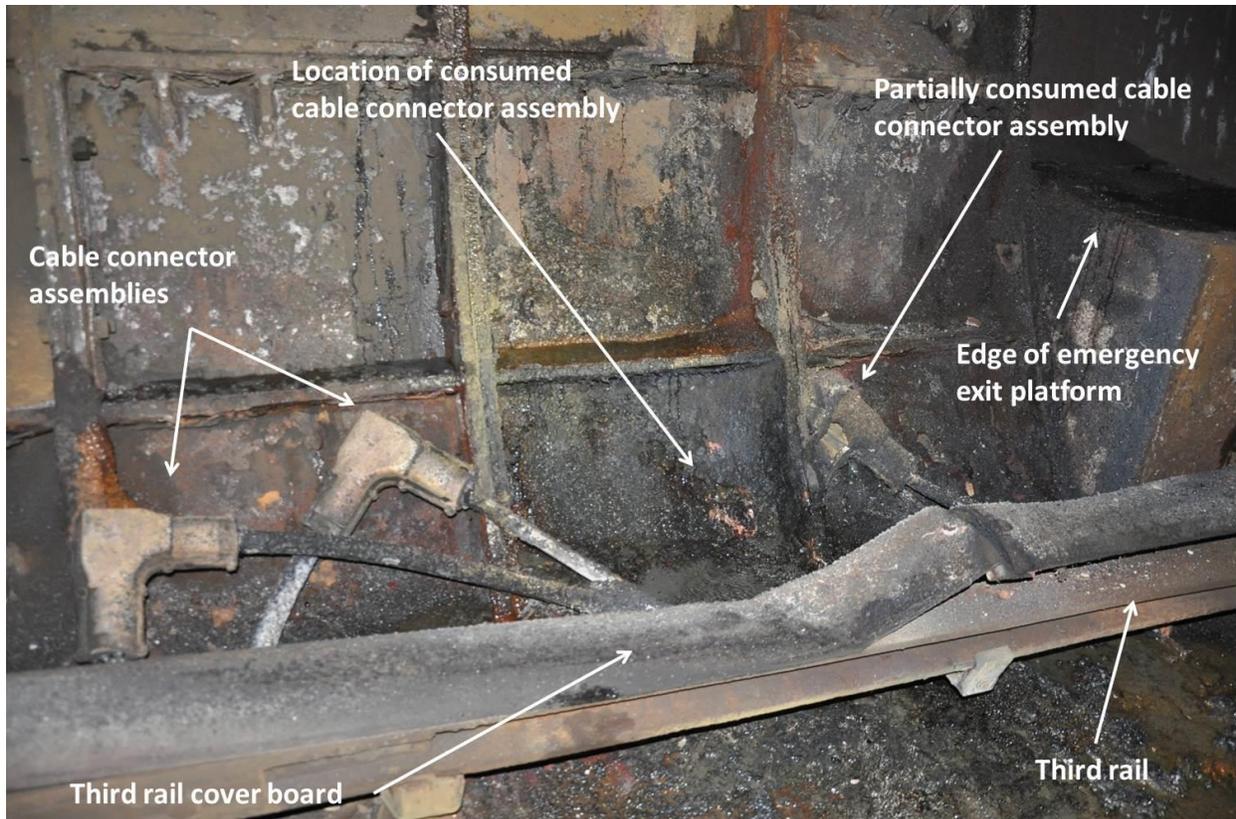
Figure 6. Damaged cables and cable connector assemblies, and cover board.

Investigators observed an area where the third rail components, including cables, cable connector assemblies, and portions of the third rail cover board, were damaged or consumed entirely. The majority of the damage was concentrated in the area around the cable connector assemblies of the cables where the third rail terminated to accommodate the emergency exit platform at the north end (the end closest to train 302). (See figure 6.)

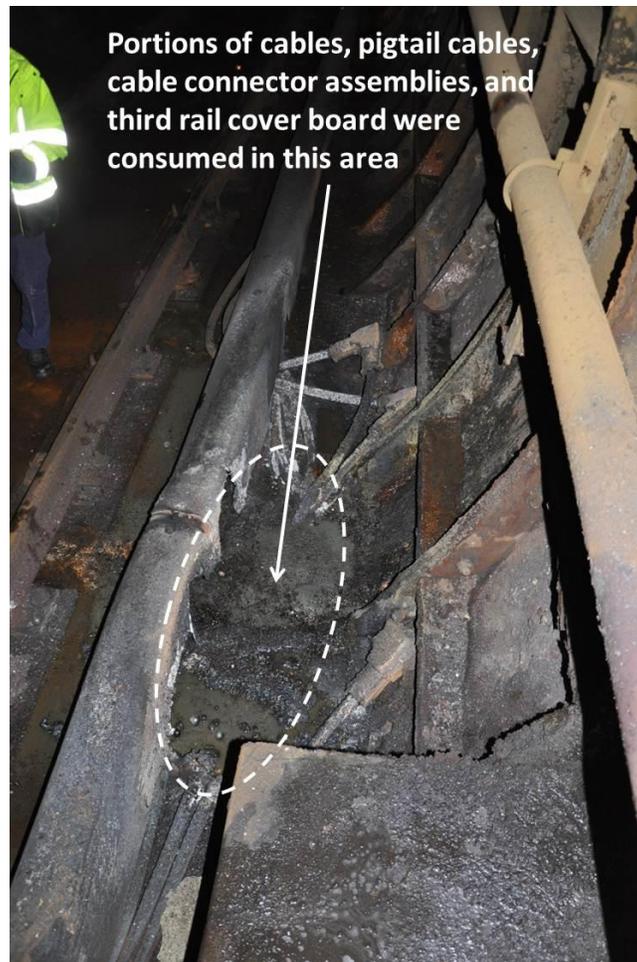
Figure 7. Location of consumed third rail components.

The tunnel wall casing in this area was constructed of ribbed plate steel sections bolted together. Investigators noted resolidified molten copper on one of the steel plates near the floor, directly behind an area where a cable connector assembly had previously been, before it was consumed in the accident. Another cable connector assembly in this area was partially consumed. Portions of all four of the cables had been consumed. (See figure 7.) The ends of the severed cables exposed the copper conductor that melted and beaded, and the insulating sheathing had been burned and thermally damaged, leaving the remaining copper wire strands bare. The melted and beaded copper conductors at the ends of the severed cables is consistent with conductors that have experienced electrical arcing.

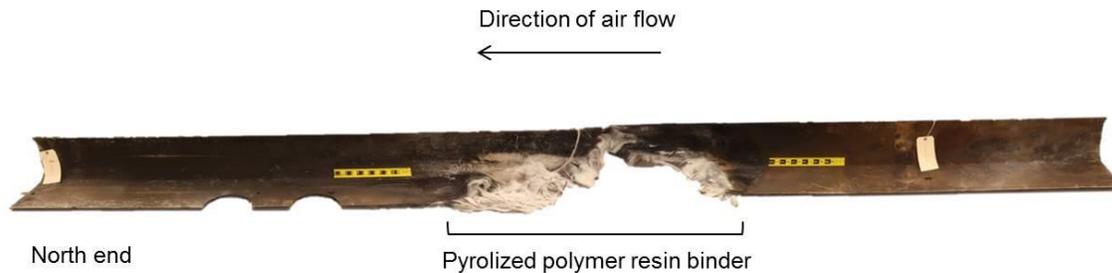
Figure 8. Thermally damaged third rail cover board.

Investigators noted that the third rail cover board exhibited an area where the polymer resin binder had been completely burned and pyrolyzed, leaving just the fiberglass reinforcement behind.²⁹ (See figure 8.) The damaged portion of the third rail cover board was adjacent to the location of the cables and cable connector assemblies that were damaged by electrical arcing. A horizontal soot trail and gradient of thermal damage along the interior face of the third rail cover board was consistent with air flow in the tunnel that drifted north toward the L'Enfant Plaza station at the time of the accident.

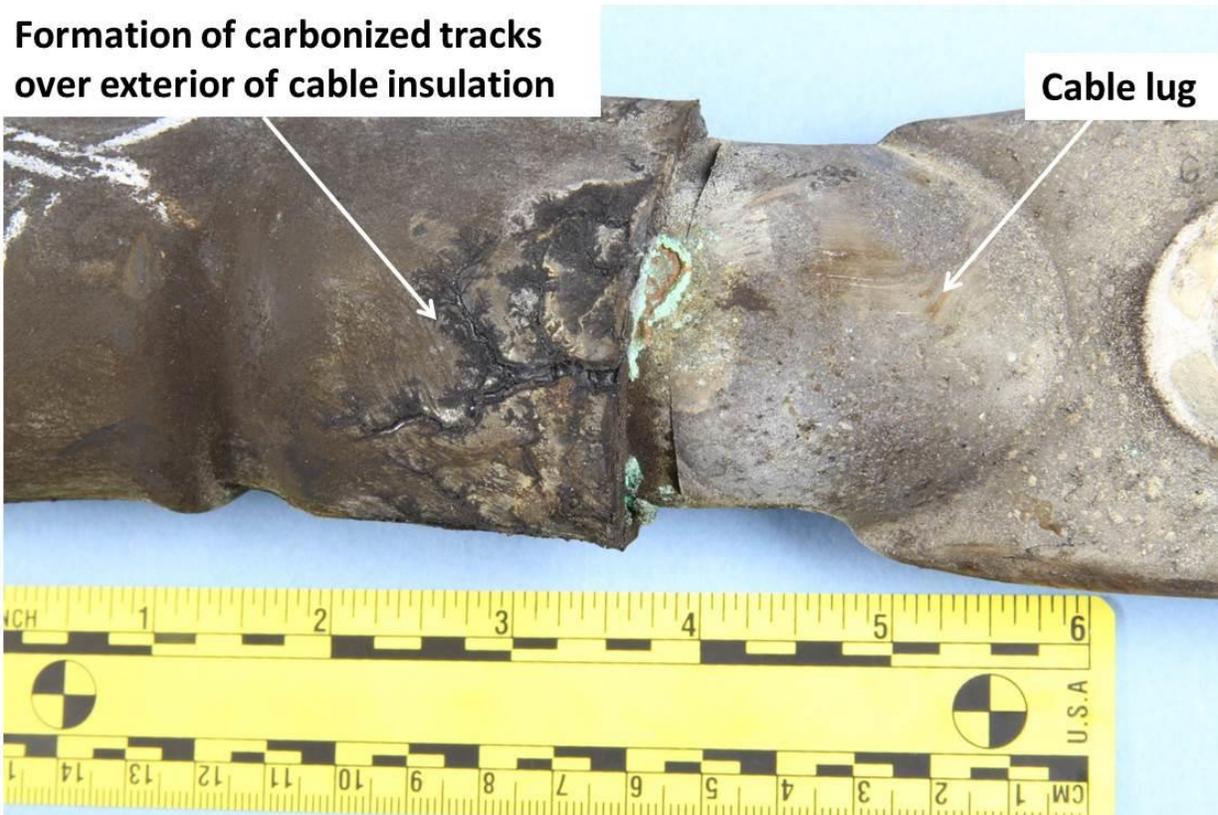
Figure 9. Pigtail cable from Friendship Heights incident.

The L’Enfant Plaza electrical arcing event consumed about 16 feet of the affected third rail power cables and portions of the cable connector assemblies. The consumption of these materials hindered the examination of material evidence at the incipient point of failure. Therefore, it was necessary to examine similar electrical arcing and smoke events within the WMATA network to collect additional evidence and establish a probable failure mechanism. Two smoke incidents occurred in the WMATA tunnel system after the January 12, 2015, accident: February 11, 2015, at the Court House station and May 19, 2015, at the Friendship Heights station. NTSB investigators examined materials from these incidents along with those from L’Enfant Plaza to help understand the cause of these smoke events.

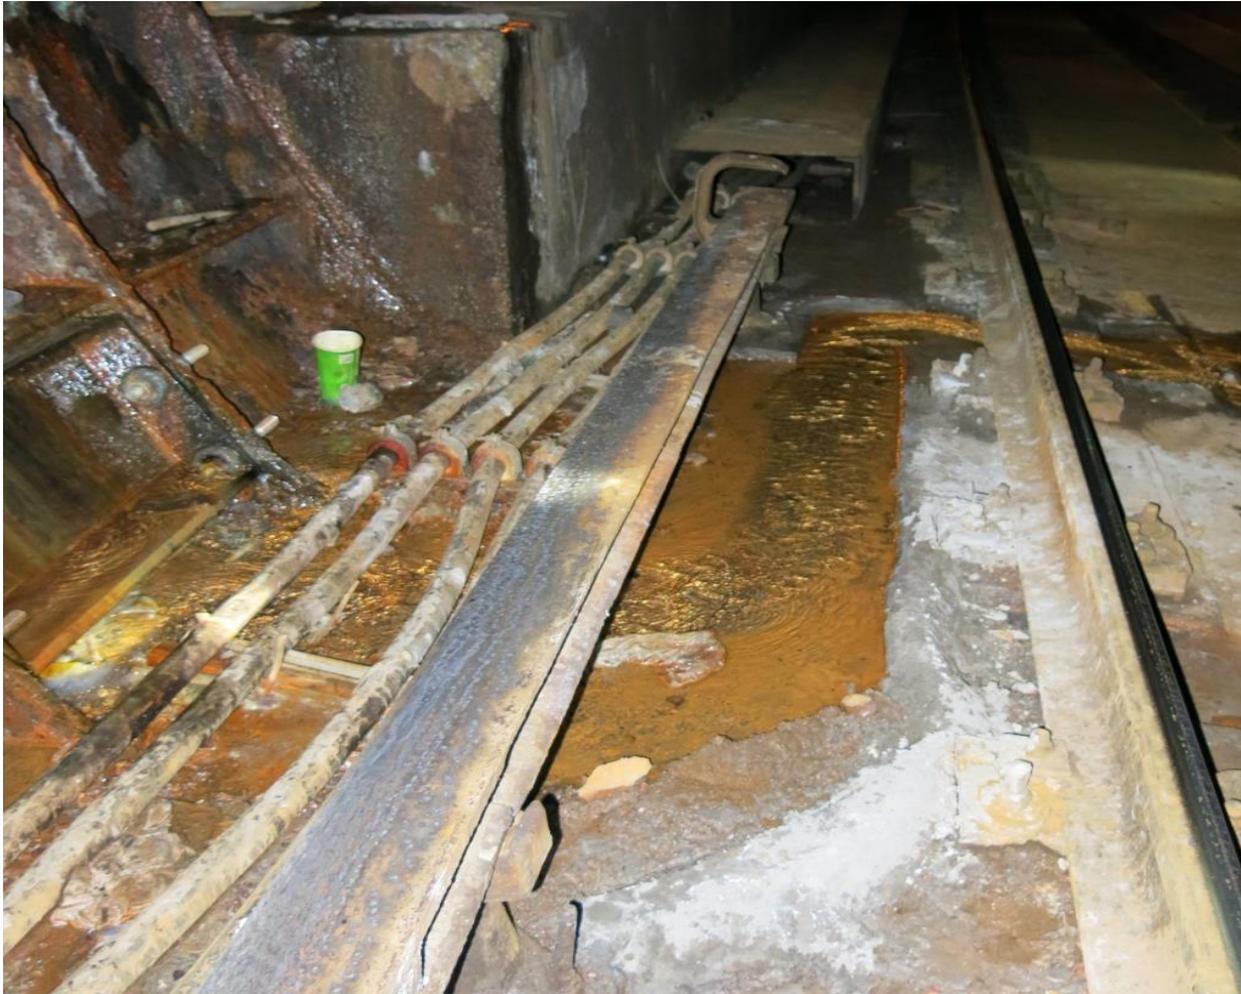
Figure 10. Standing water near north end of third rail (postrepair photo).

consumed. (See figure 10.) Investigators also saw water flowing between the wall casing plates in an area where electrical damage was observed. They also saw water dripping from the tunnel casing above the location of the electrical damage onto third-rail components.

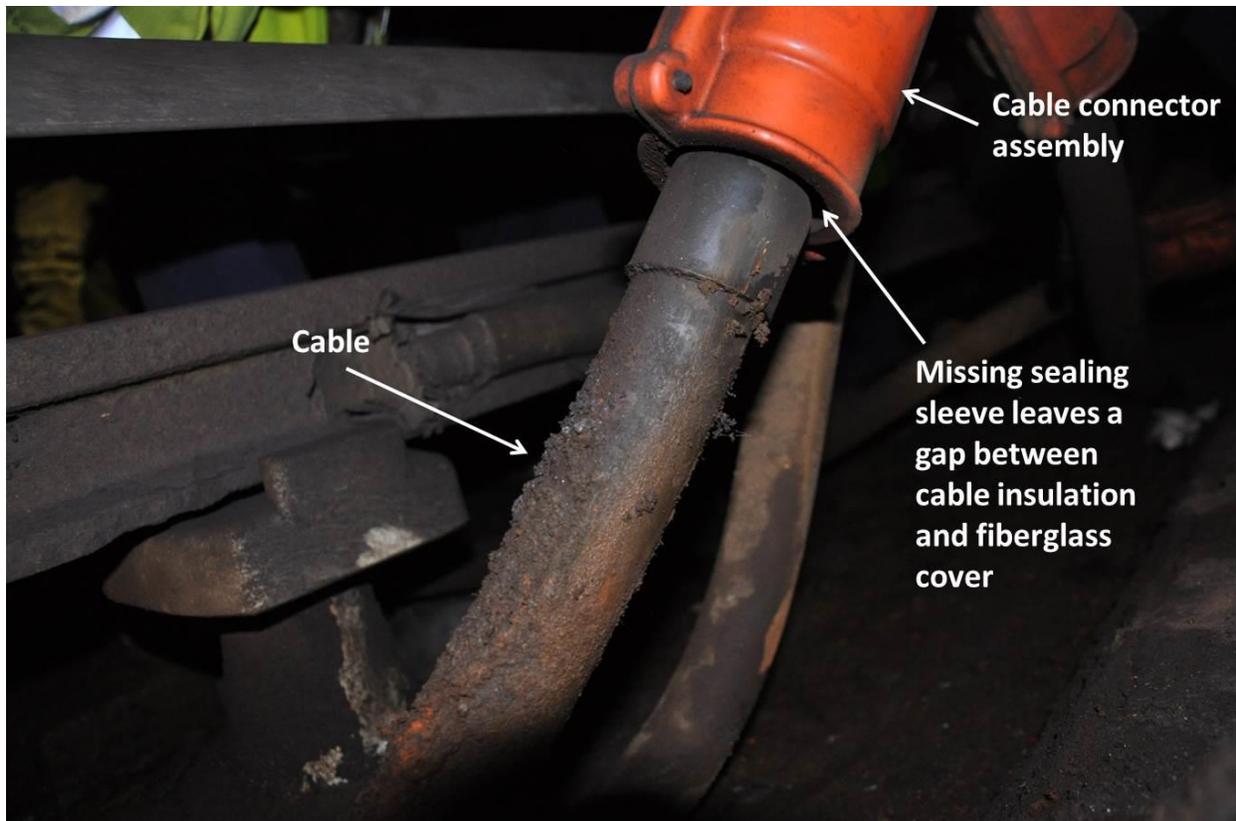
Figure 11. Track 1 cable coated with moist mud-like contaminants, and cable connector assembly without sealing sleeve.

Track 1 (northbound track) of the Yellow Line south of L'Enfant Plaza had a cable installation similar to that used on Track 2 (accident track) to bridge the gap in the third rail along the length of the emergency exit platform. The environment where the cable connector assemblies were lying was not as wet as what was seen in track 2. However, there was moisture and water puddles along the track bed. The cables were coated in moist, mud-like debris. (See figure 11.)

Examination of installed and undamaged cable connector assemblies at L'Enfant Plaza revealed that sealing sleeves intended to make the assemblies weathertight were missing. (See figure 11.) If the sealing sleeve is not used, a gap between the cable and the connector cover provides a route for contaminants and moisture to enter the cable connector assemblies where the lug ends of the cables are bolted together. After the accident, NTSB investigators examined cable connector assemblies in multiple locations and found that many were not in accordance with WMATA's engineering design specifications, including some that had been replaced after the accident. Contamination and moisture inside the cable connector assembly and along the cable's insulation can create a path to an electrically grounded surface such as a steel tunnel liner or a wet track bed. Both of these electrically grounding surfaces existed at the origin of the electrical arcing. The NTSB concludes that electrical arc tracking was aided by the presence of contaminants and moisture on third rail cables and inside cable connector assemblies. The NTSB further concludes that WMATA's third rail electrical power cable systems are susceptible to electrical arc tracking at improperly constructed power cable connector assemblies, which can lead to short circuits that can generate fire and smoke in tunnels. The cable connector assemblies were at the center of the area where electrical components had been consumed; one connector assembly was entirely consumed, and one was half consumed. The ends of the pigtail cables that would have attached to the third rail from this set of cables did not show any signs of distress. The NTSB concludes that the electrical short circuit initiated from either the consumed or the damaged cable connector assembly.
