NATIONAL TRANSPORTATION SAFETY BOARD

RAILROAD ACCIDENT REPORT

**DERAILMENT OF
NEW YORK CITY TRANSIT AUTHORITY
SUBWAY TRAIN
NEW YORK, NEW YORK
DECEMBER 12, 1978**

NTSB-RAR-79-8

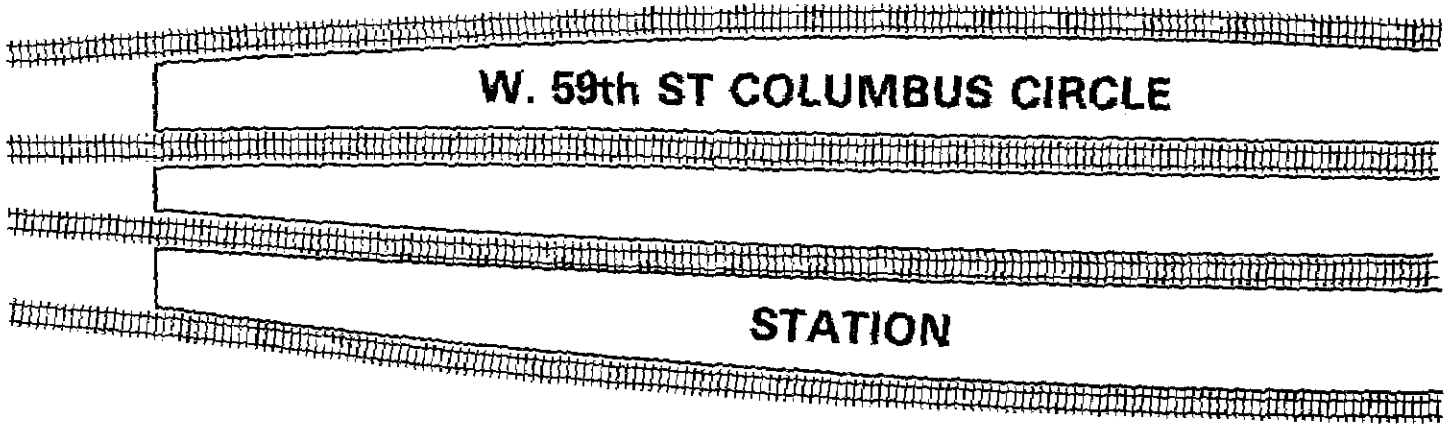
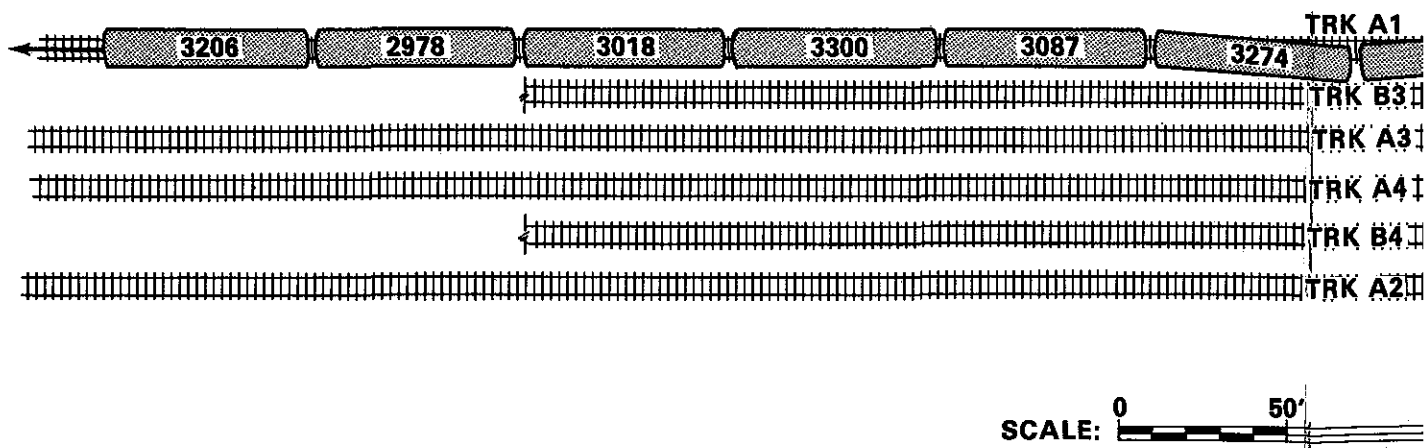
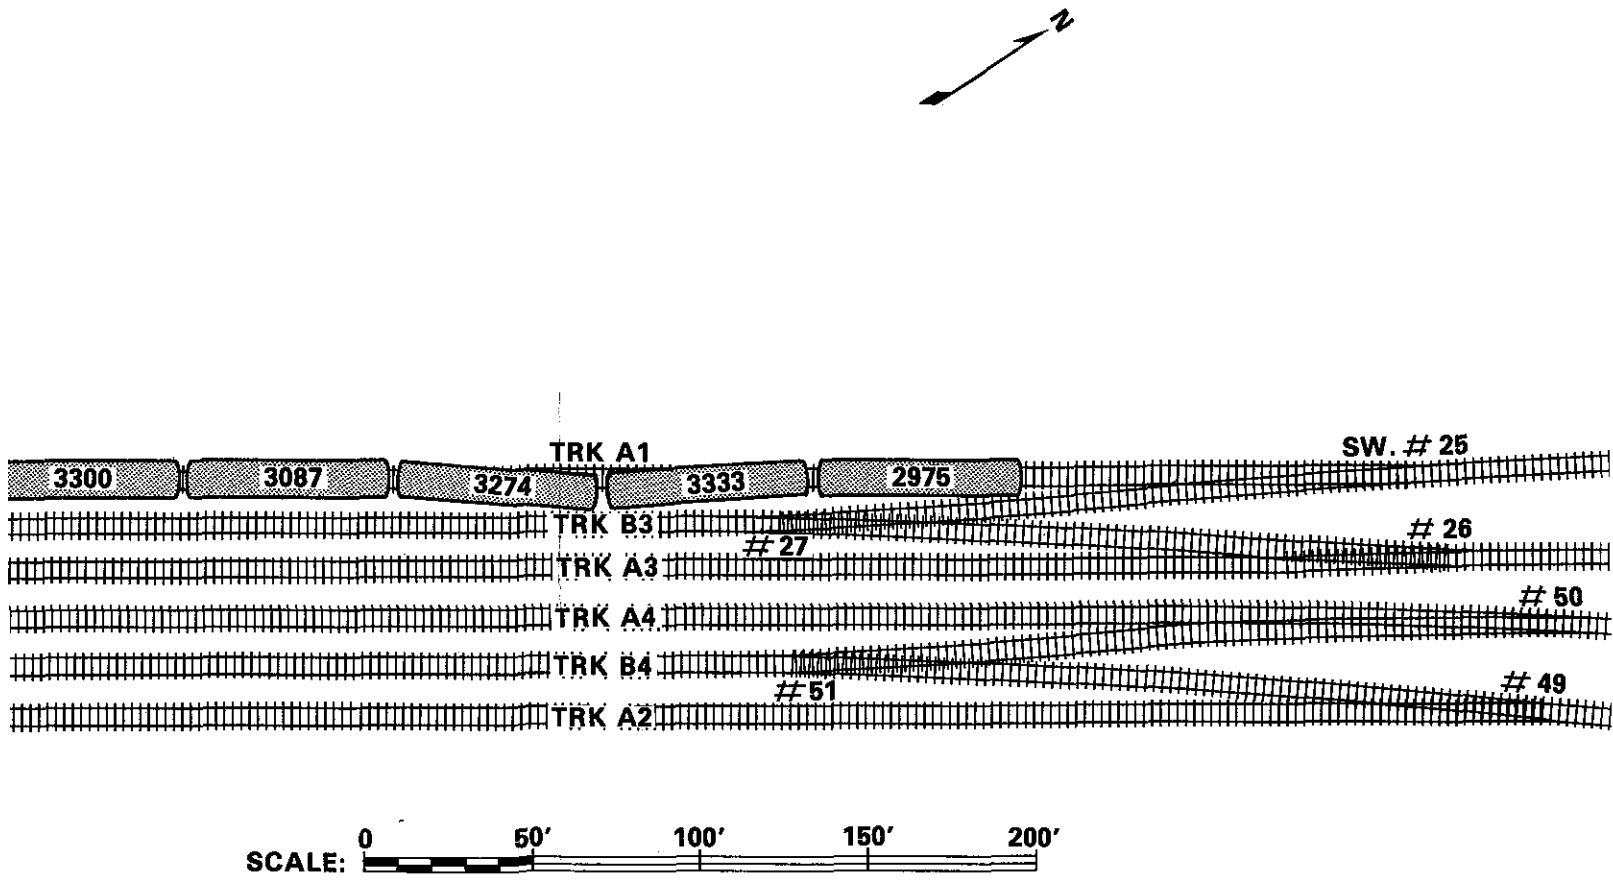
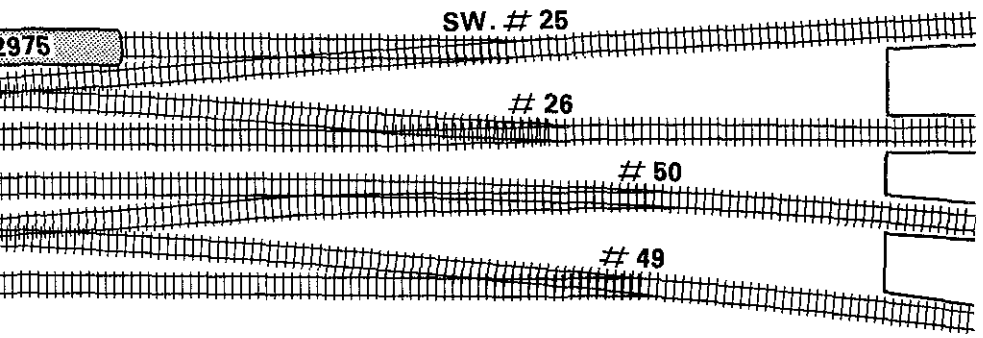
FIGURE 1. PLAN OF DERAILMENT — COLLISION AREA.

In the December 12, 1978, derailment, the force of the collision with the curtain wall caused extensive damage to the sixth and seventh cars. The body of the sixth car was twisted, both sides of the car were pushed inward around the center area, and the car floor and the interior car body were buckled. The motorman's cab of the seventh car was destroyed; the side of the car opposite the motorman's cab was torn off from the end to the middle of the car; seats and frames were destroyed; and the center and side sills were cut, cracked, and twisted to the center of the car.

The first three columns of the curtain wall were destroyed, and 12 linear feet of the 6-inch concrete wall was destroyed. Another column approximately 32 feet south of the leading edge of the curtain wall was destroyed. Twenty of the horizontal bracings above the track were deformed and 25 were destroyed; however, there was no structural damage to the roof of the tunnel.

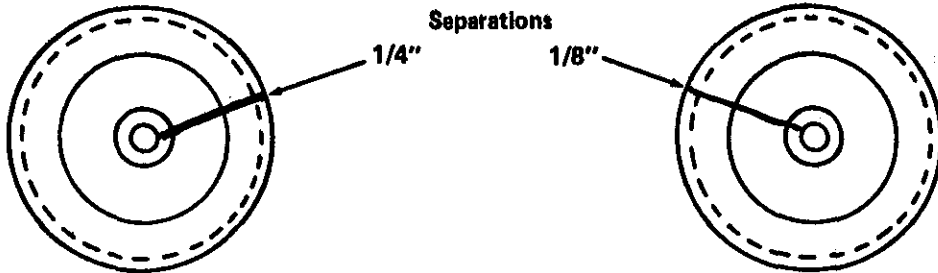
After the December 12, 1978, derailment, two wheels on the same axle of the sixth car were found broken. Metallurgical tests revealed that the wheels broke because of a thermal crack in the flange of each wheel that extended through the rim and plate and into the hub. The cracks expanded and permitted each wheel to become loose on the axle. Both wheels were discolored by heat. (See figure 2.) The wheels had been inspected 1 1/2 days earlier.

Figure 2. Broken wheels from the December 12, 1978 derailments.

Tests were conducted on the fractured wheels from the December 12, 1978, derailment in the National Transportation Safety Board laboratory. Oxidation on the fractured wheel rims and overheated zones on the flanges indicated that the rims of the fractured wheels had been excessively heated. The fracture on one of the wheels stemmed from a fatigue crack in the flange area. Weld material applied subsequent to the fracture had totally obscured the fracture area on the other wheel. A radial microsection prepared near the fracture at a location that was removed from the area of welding disclosed several overheated zones along the flange surface. The largest zone consisted of untempered martensite with varying amounts of fine-grained pearlite, and was located in the fillet where the flange blended into the tread. Martensite forms upon cooling from a temperature above approximately 1,350° F. The width of this area on the mounted section was approximately one-half inch. Its total width, however, is unknown, because the area extended beyond the mounted flange portion. The maximum depth of the overheated area was 0.04 inch.

Another major overheated area was found closer to the top of the flange. This area measured 0.09 inch wide and 0.015 inch deep and consisted largely of untempered martensite. An extensive amount of flowed metal accompanied the overheated area suggesting that the overheating condition was produced by contact wear with another surface. Much of the flange surface outside of the two major overheated areas contained a thin layer of flowed metal and/or a very thin overheated layer of untempered martensite indicative of excessive heat.

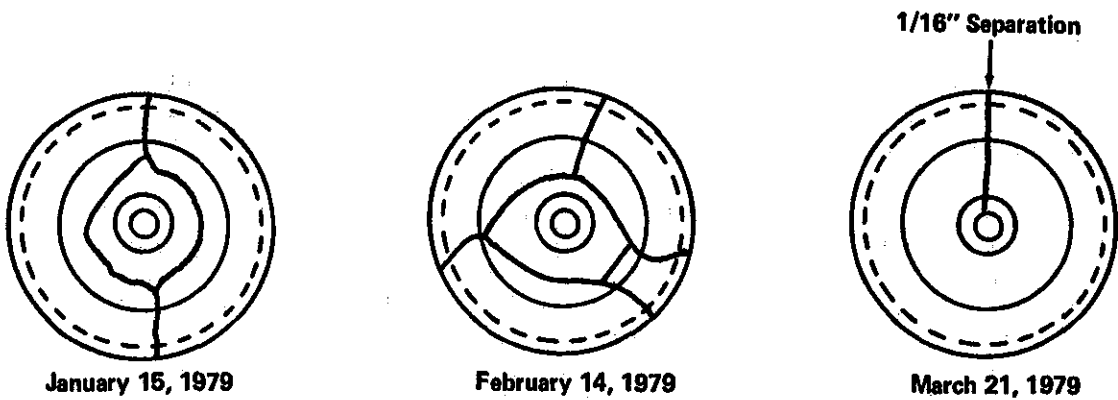
After the January 15, 1979, derailment, a wheel that had broken into three pieces was found on the fourth car. Investigators determined that the wheel broke because of a thermal crack which originated in the flange. The crack extended through the rim and into the wheel plate where it went around the circumference of the plate and joined another thermal crack which extended through the rim and flange. The wheel was also discolored by heat. (See figure 3.)

After the February 14, 1979, derailment, a wheel that had broken into five pieces was found on the seventh car. Investigators determined that the wheel broke because of a thermal crack that originated in the flange. The crack extended through the rim and into the plate and went around the full circumference of the plate. It also broke through the rim and flange at three other locations. (See figure 3.) The wheel had been inspected 18 days earlier.

After the March 21, 1979, derailment, a broken wheel was found on the first car. Investigators determined that the wheel broke because of a thermal crack in the flange. The crack extended through the rim and plate and into the hub. The wheel then became loose on the axle. The wheel was also discolored by heat. (See figure 3.) The heat discoloration was a red color which extended from the flange and rim into the plate. The wheel had been inspected 4 days earlier.

Figure 3. Broken wheels from three subsequent derailments.

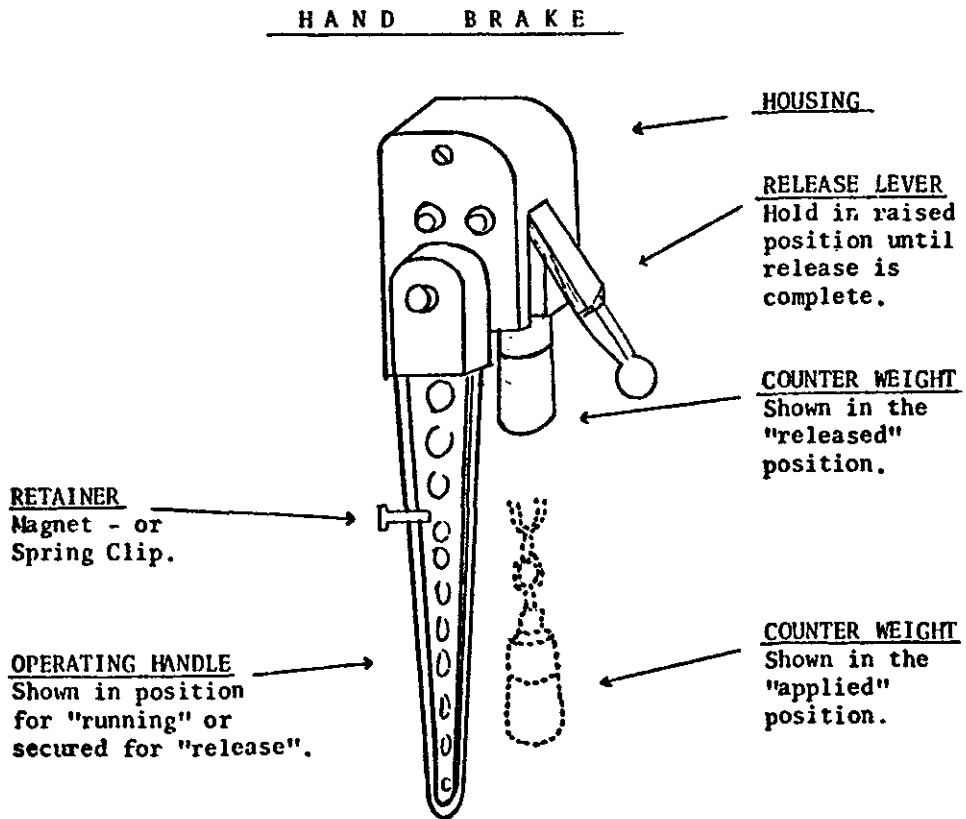
Figure 4. Peacock Handbrake Used on NYCTA Subway Cars.

lever to set the brakeshoes against the wheels. This condition of the handbrake could not be determined by looking at the counterweight through the opening in the handbrake housing. This partially applied brake would not release if the release lever was operated.

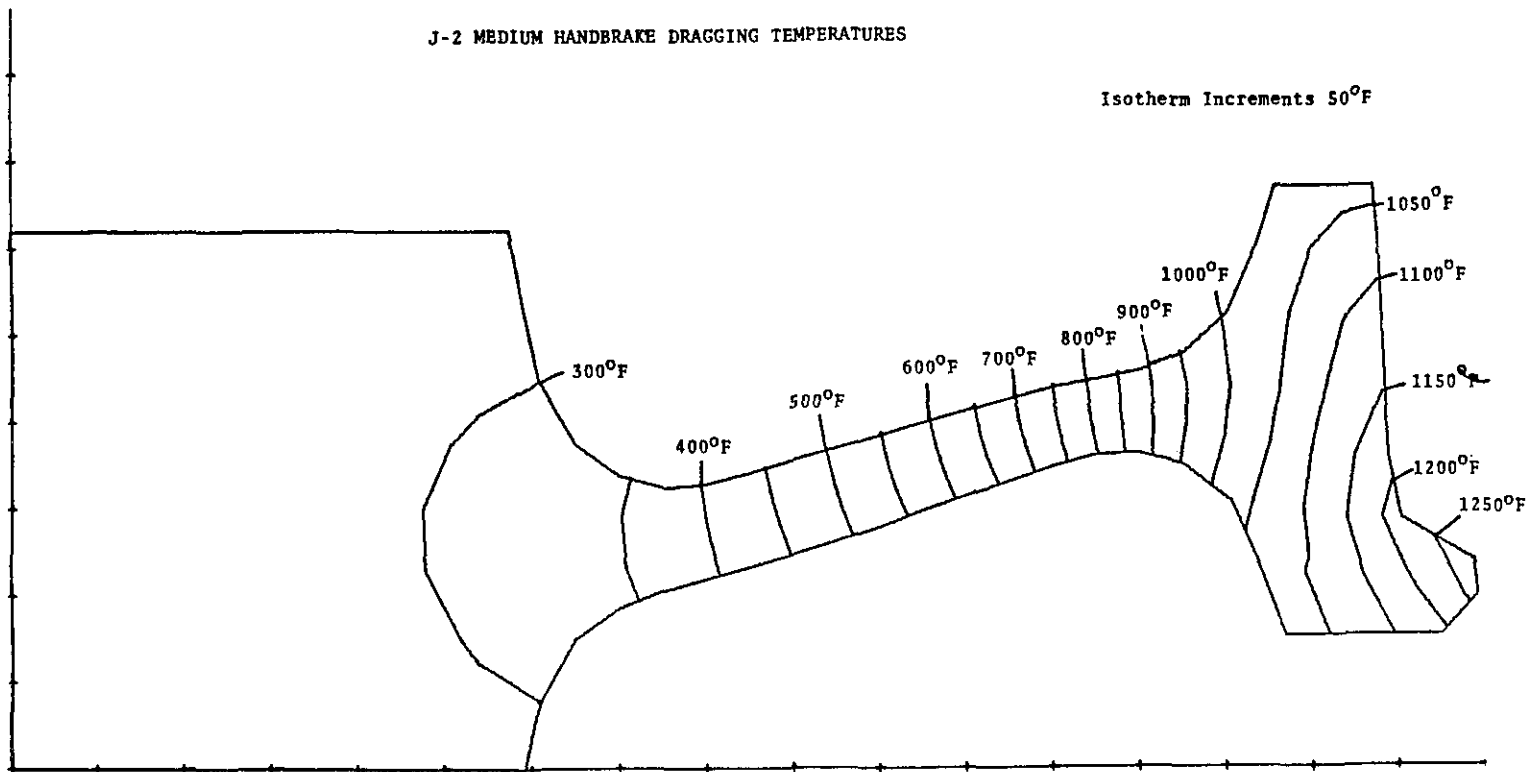
J-2 MEDIUM HANDBRAKE DRAGGING TEMPERATURES

The Abex analysis indicated a maximum temperature after one round trip (two runs with a 10-minute interval between runs) of about 1,250° F at the flange tip and an equivalent stress of about 110,000 psi based on elastic strain only at the flange tip. This stress is well above the yield point and will cause permanent damage. (See appendix D.)
