# NATIONAL TRANSPORTATION SAFETY BOARD

## RAILROAD ACCIDENT REPORT

COLLISION AND DERAILMENT OF TWO SUBWAY TRAINS  
METROPOLITAN TRANSPORTATION AUTHORITY  
NEW YORK CITY TRANSIT  
IN BROOKLYN, NEW YORK, ON FEBRUARY 9, 1995

**Adopted: March 19, 1996  
Notation 6531A**

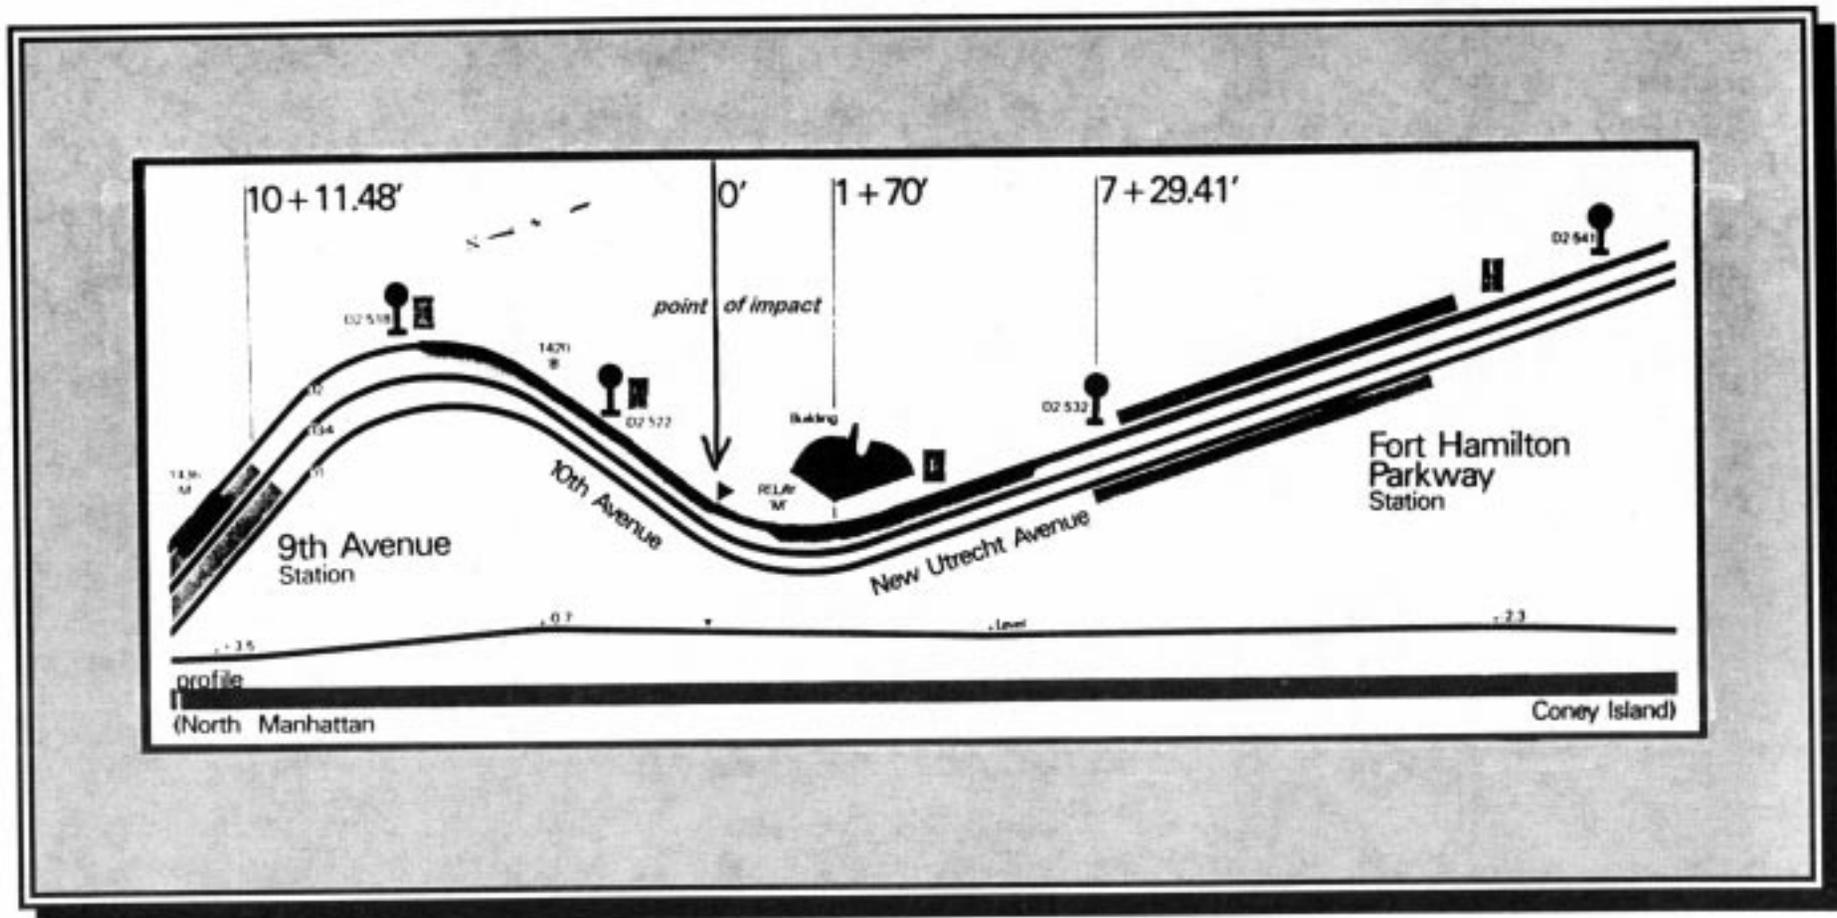
**Figure 2--Profile of collision site.**

NYCT track personnel who were first on scene observed that the rail surface was dry and that skid marks on the rail head started between 100 and 150 feet south of the POI. Safety Board investigators detected no preexisting track anomalies during their postcollision track inspection.

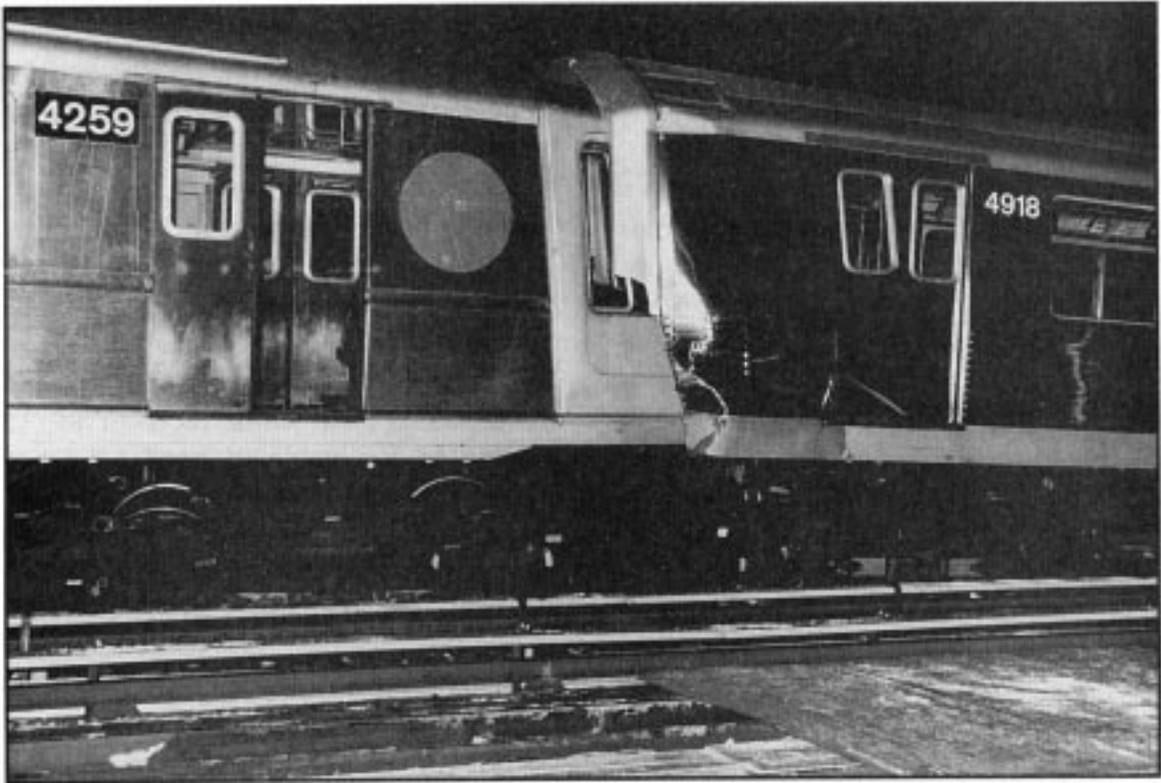
Figure 3--Rear car 4259 of B train penetrating lead car 4918 of M train.

The lead car 4918 of the M train underrode the anticlimber of the rear car 4259 on the B train, causing extensive damage. The anticlimber was pushed in 5 to 6 feet and had the deepest penetration slightly to the right of the center (facing forward). The inner fiberglass was destroyed with the left side deflected outward to the first door. The interior floor of car 4259 was penetrated and buckled upward and inward.

There was extensive damage to the two cars (4259 & 4918) directly involved in the collision. The two cars telescoped into each other approximately 5.5 ft. Heavy damage, including broken drawbass and cars leaving the center castings of the truck, was observed on several cars in each of the trains.

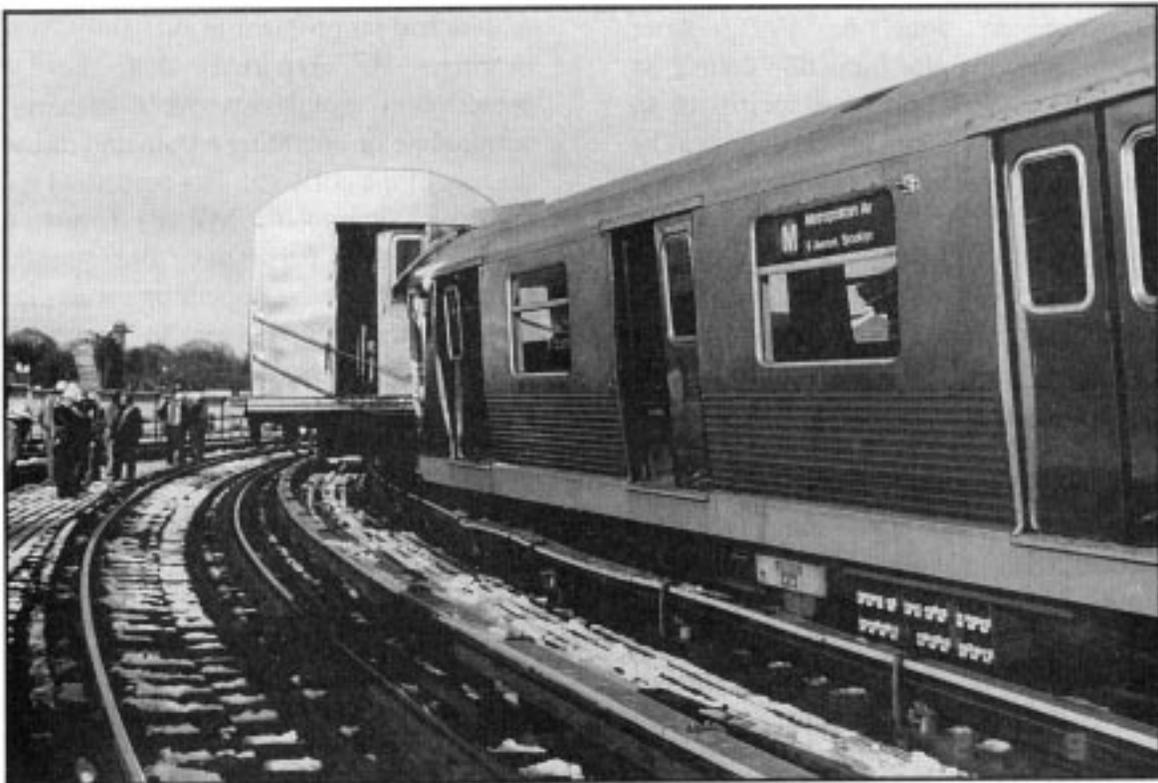
Figure 4--Third car 4939 of M train blocking D3/4 track.

The third car 4939 of the M train derailed and had displaced sideways. The car had exterior damage to its right rear and had interior panel displacement. The passenger compartment had no interior car body penetration.

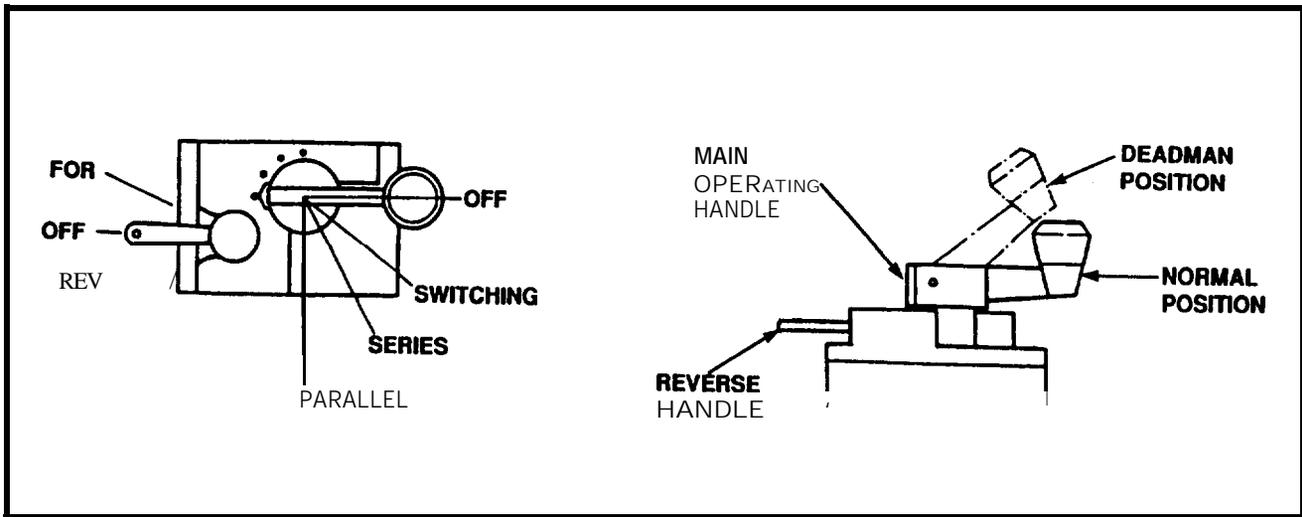
Speedometers--The M train was not equipped with a speedometer. No Federal, State, or local regulations require NYCT trains to have speedometers. Instead of the trains being equipped with speedometers, according to the senior director of Operations Support and Review for Rapid Transit Operations (RTO), the operators are

**Figure 5--Master controller.**

taught the relationship between the speed and the master controller three points of power (switching, series, and parallel). The assistant chief mechanical officer explained that a master controller has four positions: off; switching (one point of power), for speeds up to 10 mph; series (two points of power), for speeds between 10 and 20 mph; and parallel (three points of power), for speeds as great as 55 mph, depending on the grade. (See figure 5.)

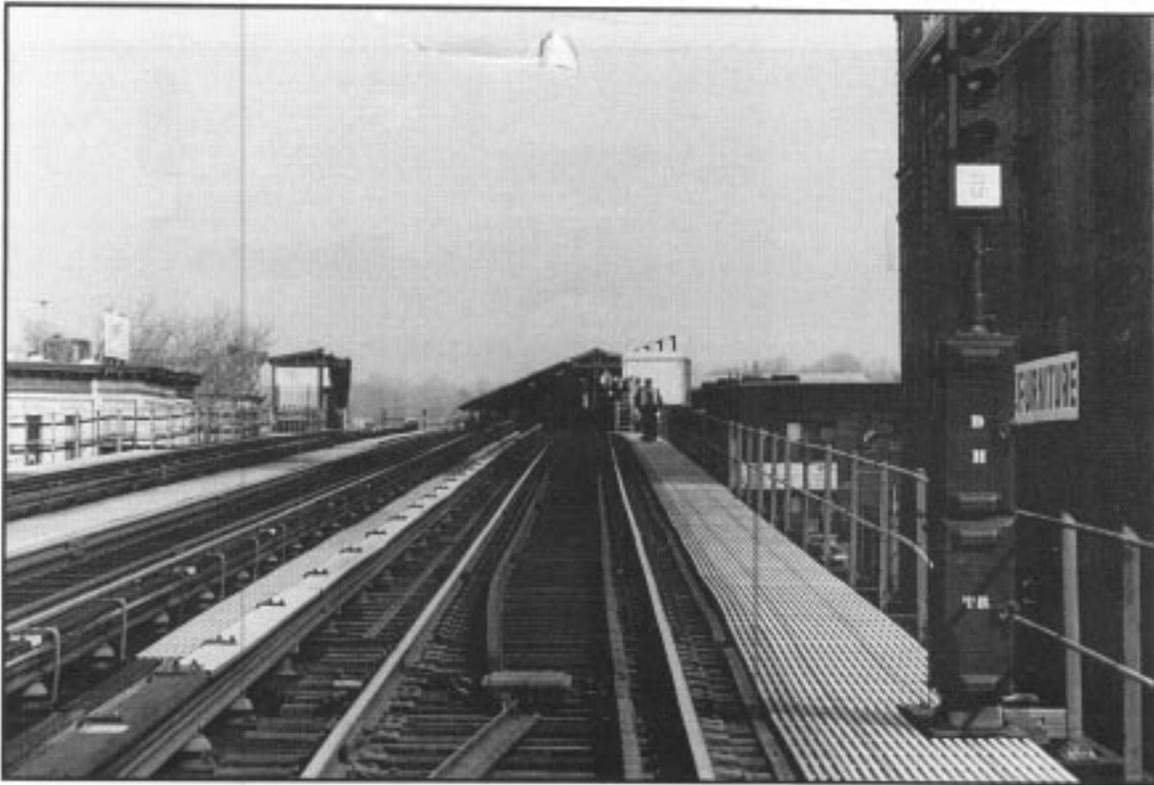
Figure 7--Signal D2-541.

Signal D2-541, located about 300 feet south of Fort Hamilton station (see figure 7), displays either a red (stop) or a yellow (proceed with caution, be prepared to stop) aspect. Train occupancy of the track ahead determines the signal aspect displayed. If a

train is on track D2 within the next two signal circuits, D2-541 displays a red aspect until that train clears the signal block. If the track is unoccupied, then D2-541 displays a yellow aspect that permits a train to enter the signal block. A green (proceed) aspect cannot be displayed from D2-541 because the next signal (D2-532), a grade time (GT) controlled signal,<sup>6</sup> enforces a predetermined speed (on descending grades or at other locations) and trains exceeding such speed are automatically stopped.

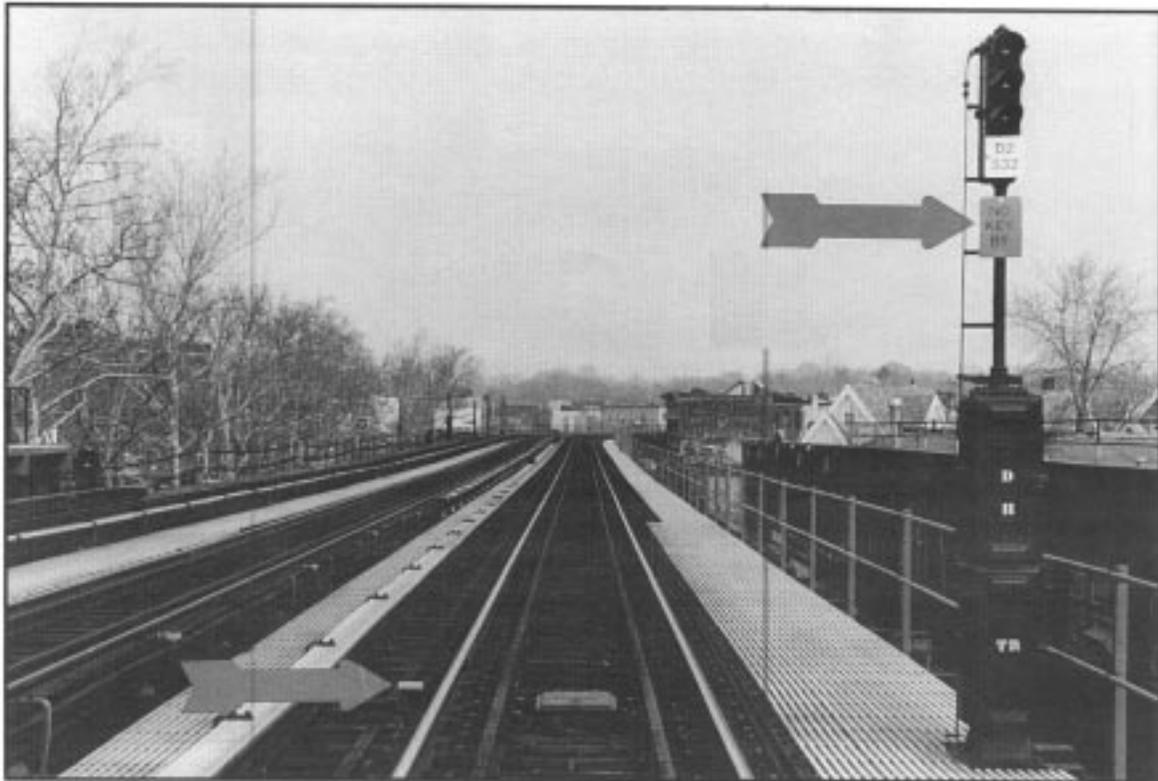
signal D2-532, have no lunar aspect. An NYCT electrical systems manager told Safety Board investigators that GT signals without a lunar aspect "are probably old installations that were built way before we adopted the new design standard of providing lunar lights." The manager said that new installations are equipped with lunar aspects on any signal that has a one-shot GT control, but a retrofit of the existing signals, which lack lunar white aspects, is not currently planned.

**Figure 8--Signal D2-532**

(left arrow indicates automatic stop arm; right arrow indicates sign installed after collision).

The M train operator told Safety Board investigators that as his train neared signal D2-532, he remembered looking at the stop arm but not the signal and that he saw the stop arm go down and continued to proceed. The stop arm being outside of the left rail opposite signal D2-532 may explain, in part, the M train operator's assertion that he did not remember viewing the signal when he observed the stop arm go down. In the key-by feature test conducted after the collision, the test M train operator slowly passed the IJ (stop marker) to key by the signal. When she observed the stop arm move down, the test train was stopped, and the operating compartment was directly across from the signal. The test operator could not see the signal aspect from the normal sitting or standing positions. In addition, the stop arm and the signal have a 10-foot separation horizontally and vertically. When the M train crossed the IJ about 9.75 feet in approach of the signal, the arm and signal, as viewed from the operator's position, were separated visually by a 45° angle, which made it difficult to keep the arm and the

Signal D2-532 will display a red (stop) signal when a train is ahead in the block. The signal worked properly during the stopping distance tests conducted with the test train after the collision, which indicated that signal D2-532 was working as designed. The Safety Board, therefore, concludes that the M train operator failed to comply with published operating rules that require stopping at a red signal and requesting and obtaining RTO permission to proceed.

7. The safety of operations at signal D2-532 has been enhanced by the deactivation of its automatic key-by feature.
8. The M train operator failed to comply with published operating rules that require stopping at a red signal and requesting and obtaining Rapid Transit Operations permission to proceed.

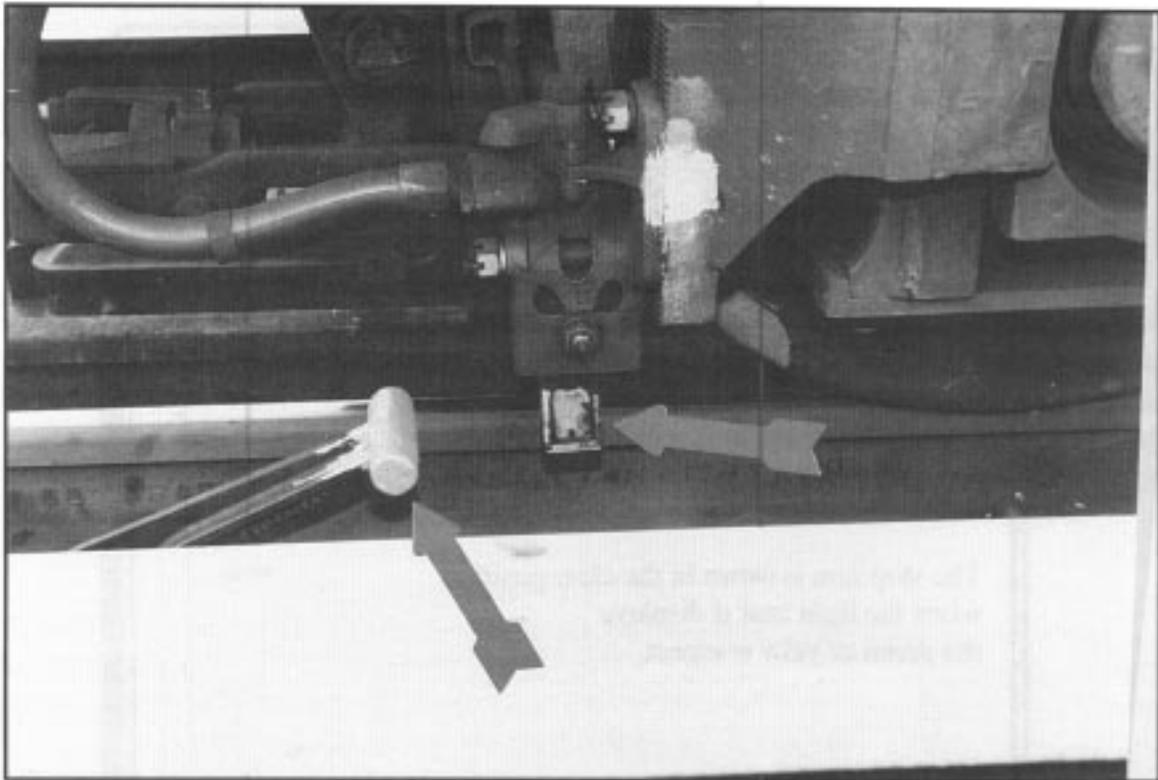
**Figure 10--Automatic stop arm in tripping position and trip cock on car (left and right arrows, respectively).**

stopping the train, as demonstrated in this collision. The stop arm can be bypassed as currently implemented, and it can be done by an operator who passes the stop marker at less than 5 mph approaching the signal, which causes the stop arm to go down while the signal remains red.
