RAILROAD ACCIDENT REPORT

**DERAILMENT OF UNION PACIFIC RAILROAD UNIT
FREIGHT TRAIN 6205 WEST NEAR KELSO, CALIFORNIA
JANUARY 12, 1997**

**Adopted: February 6, 1998
Notation 6921A**

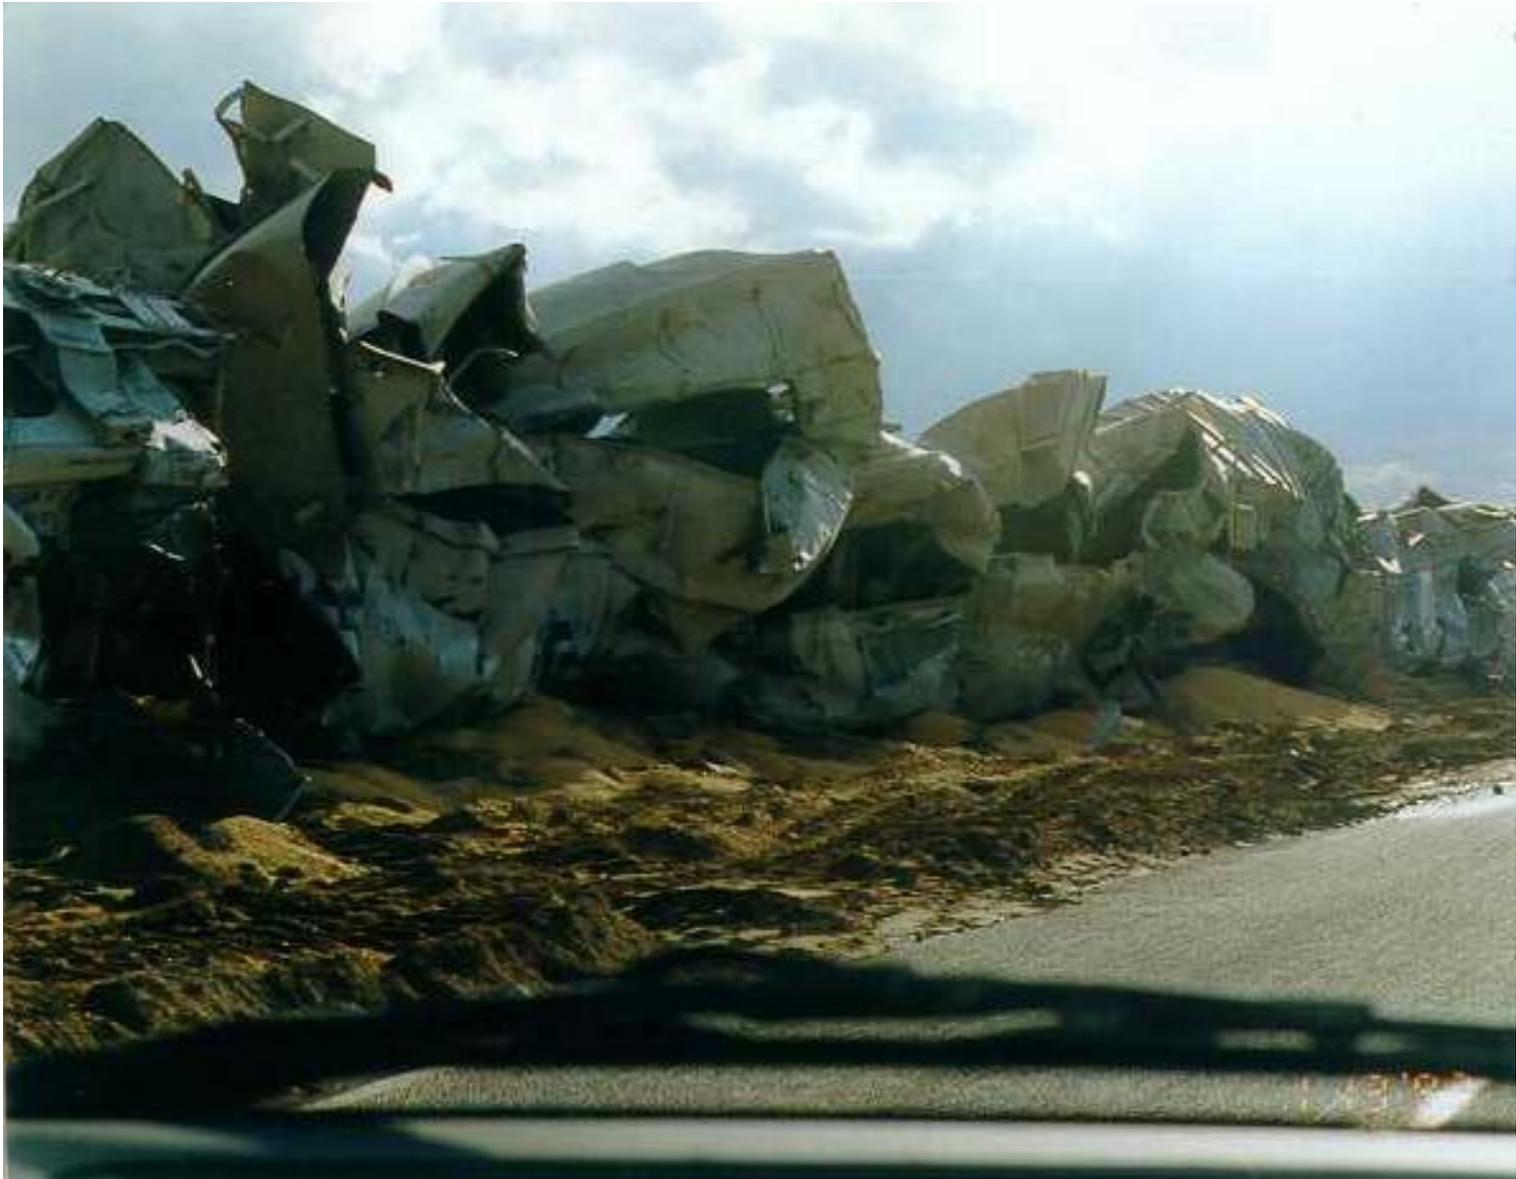
Figure 1—Derailed UP freight train 6205 west

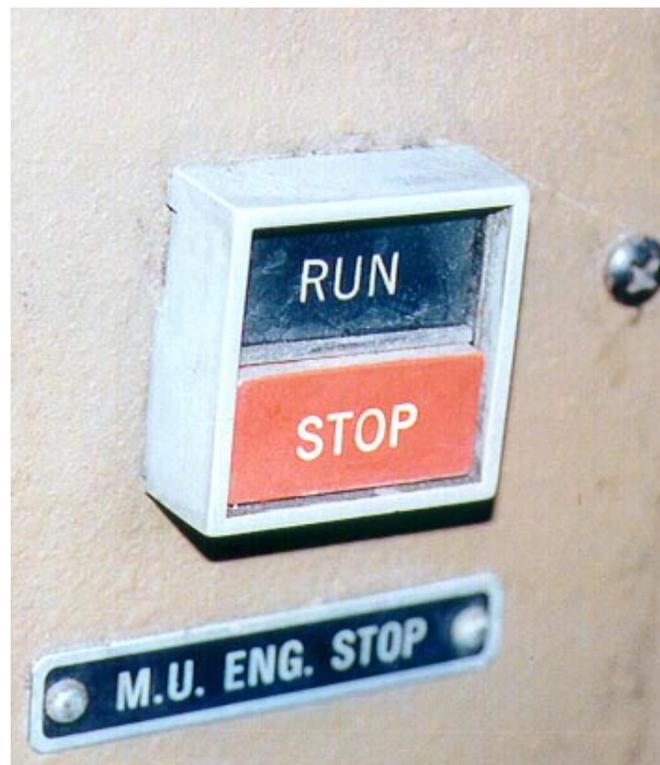
Depending on the locomotive make and model, the MU engine stop switch may be located in various places and have one of several designs. The switch in this accident was composed of two rectangular buttons mounted within a 2-inch square, box-like frame that protruded from the wall of the lead locomotive. The top button was black with "Run" imprinted on it in white letters; the bottom button was red with "Stop" imprinted on it in white letters. (See figure 3, below.) The switch was mounted on the lower left panel of the engineer's control console; it was about 18 inches above the locomotive floor and near the cab heater switch and the "attendant call" and "ground reset" buttons.

Figure 3 -- MU engine stop switch (undamaged)

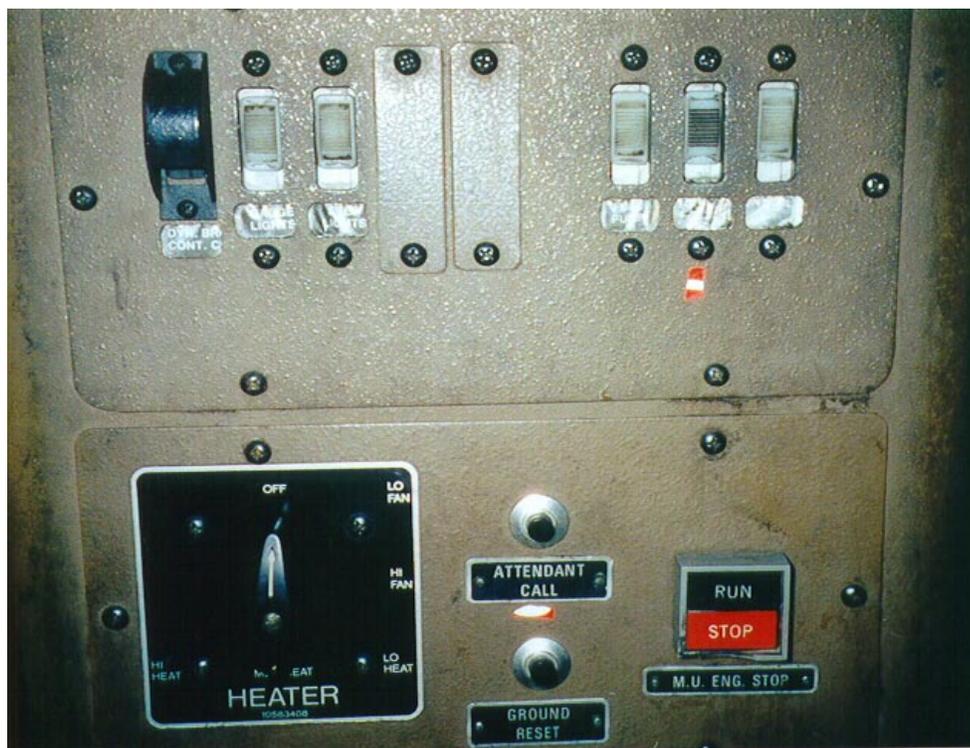
The surrounding frame of the lower lefthand corner of the MU engine stop switch on the lead locomotive had been broken off and was missing. The missing portion would have extended over two-thirds of the bottom of the

switch and up about 1/2 inch of its left side. No broken parts remained in the area surrounding the frame, and grime was found on the broken surfaces. (See figure 4.)

Figure 4 -- Engineer's control console

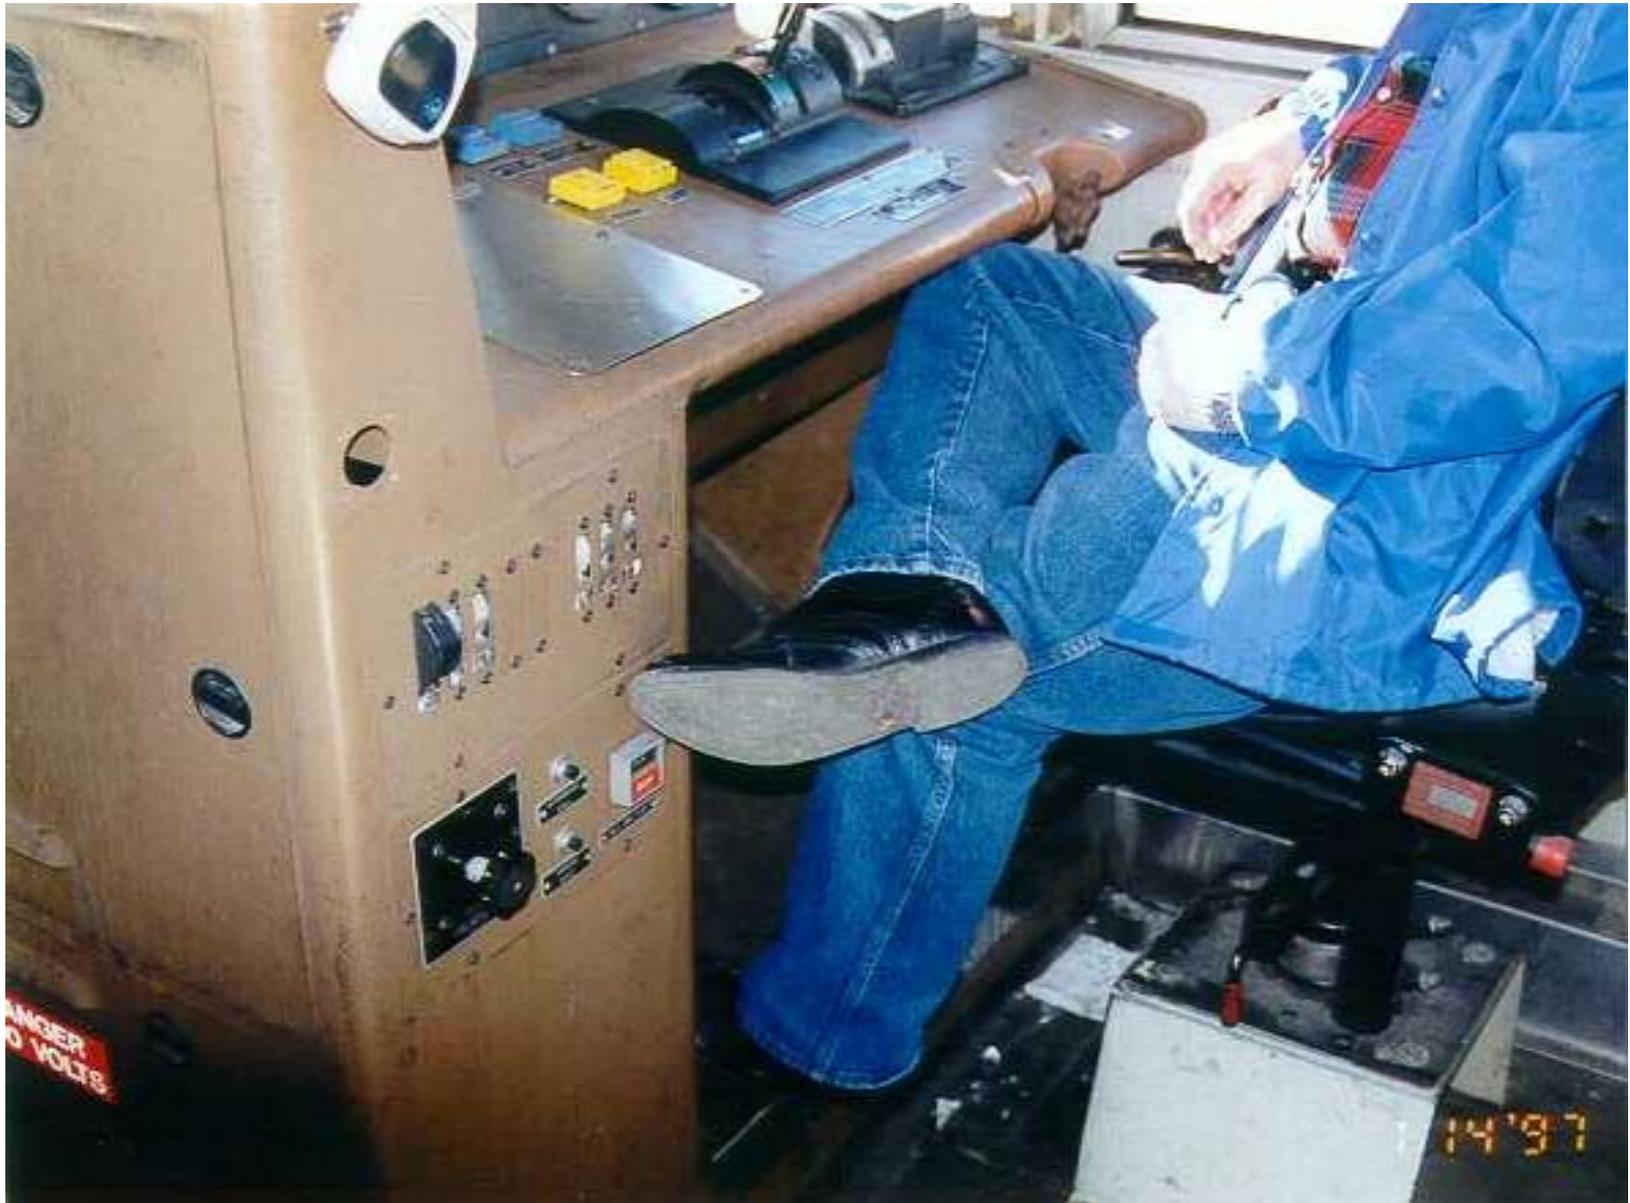
Footwear-shaped marks, grease, and dirt were all around the MU stop switch and the sliding light switches located above it. The discolored and dirty area was on the right half of the panel that extended down from the left side of the console. The area appeared to be one in which engineers sitting at the console might have rested their feet when they crossed their legs or leaned back. (See figure 5, next page.)

Figure 5 – Proximity of engineer's control panel to seated engineer
